Clear View Property Inspections
Suite 1A-59 Level 2
802-808 Pacific Highway GORDON 2072
P: 02 8329 7997
E: admin@cvpi.com.au
W: clearviewpropertyinspections.com.au

PROPERTY & TIMBER PEST REPORT AS4349.1-2007 & AS4349.3-2010

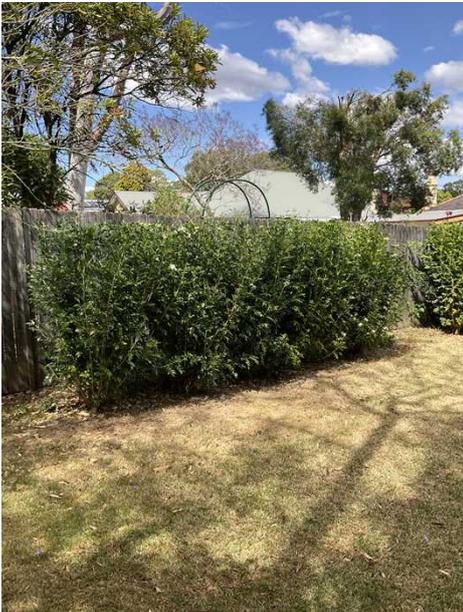
Showing example of landscaping and gardens

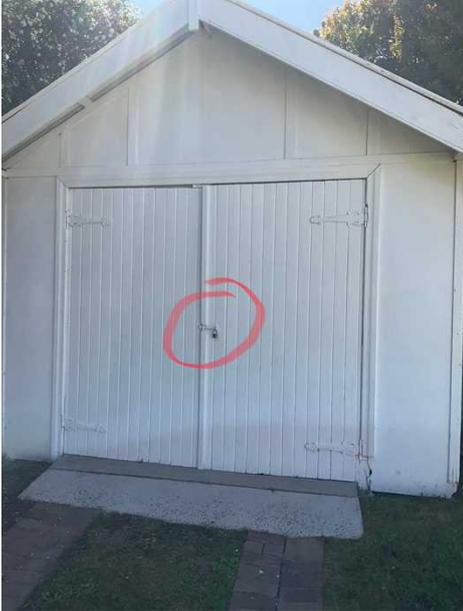
Yes there was areas not accessible. No access to garage. Locked.

+ Showing no access to garage.

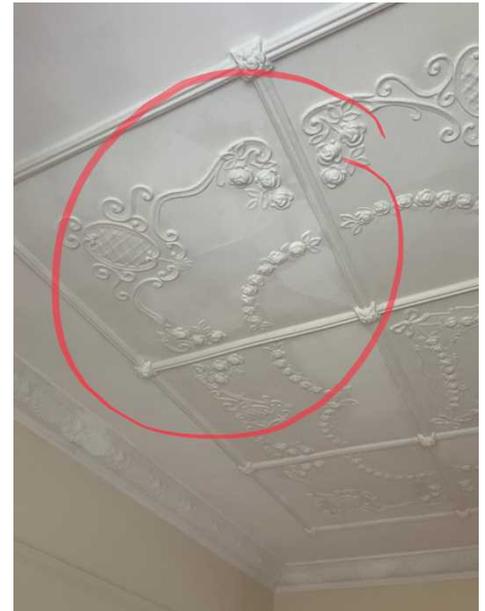
Sagging ceiling lining. Engage plasterer for repairs to prevent further deterioration., + Bedroom 1 has a bulge in the ceiling. Likely large crack and ceiling is sagging in this area. Ceilings of this age are at the end of their lifespan and require ongoing maintenance or replacement. House has foundation movement and floors are sinking which adds to the ceiling movement causing cracks and delaminating. Recommend engaging engineer for advice to prevent and control further deterioration.

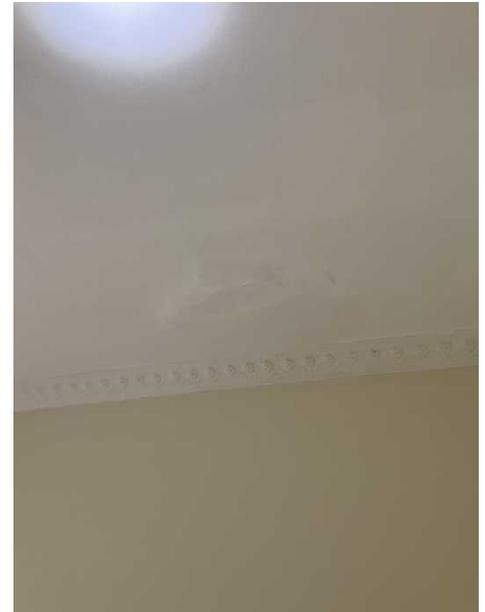
+ Major cracks and ceiling sagging to ceiling in kitchen. As per other rooms. Ceiling is 120 years old and reached its life span. Home has major foundation movement. Will require ongoing maintenance to control cracking.

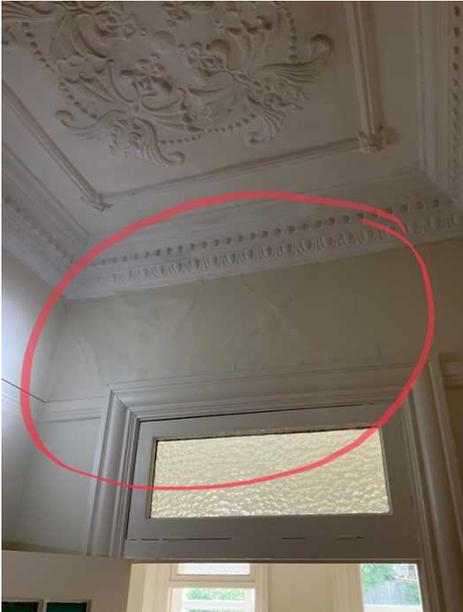
+ Major cracks to wall in corridor. Entrance to kitchen.
Has been repaired but is in quite bad condition.
Engage engineer for advice to prevent further deterioration.

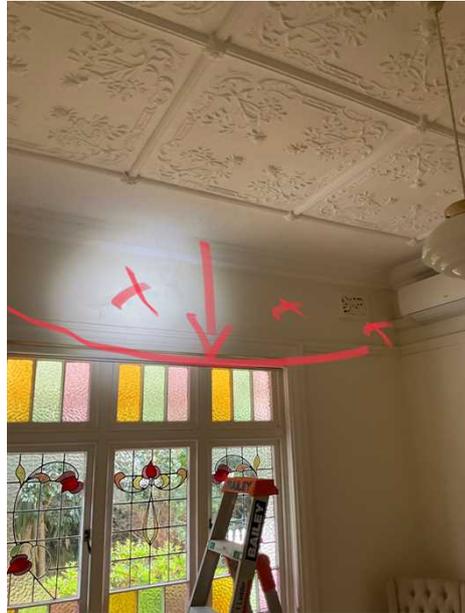
Wide cracks identified to parts of the walls.
Engage Structural engineer for advice to prevent further deterioration., + Bedroom 2, major cracking evident, sagging walls and floors.
Has been repaired but is extremely noticeable.

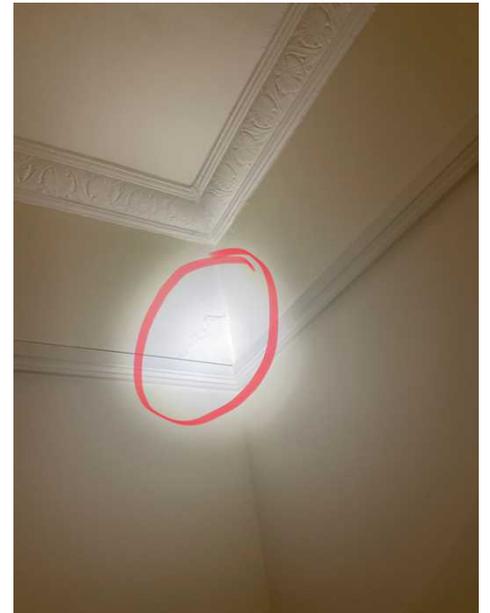
+ Example of cracking to bedroom 2. Covered up to hide cracks.

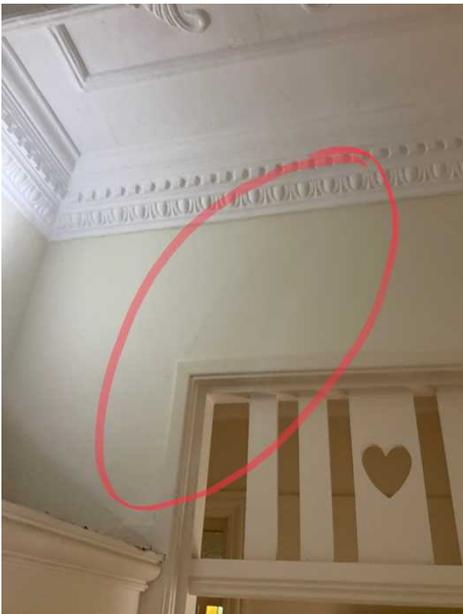
+ Example of cracking to wall in corridor leading to main bathroom. As per all cracks they have been covered up to hide cracks for the sale of the property.

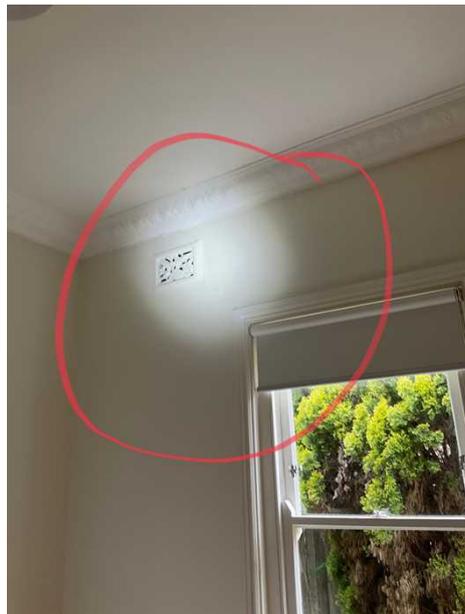
+ Example of major cracking to bedroom 3 wall.

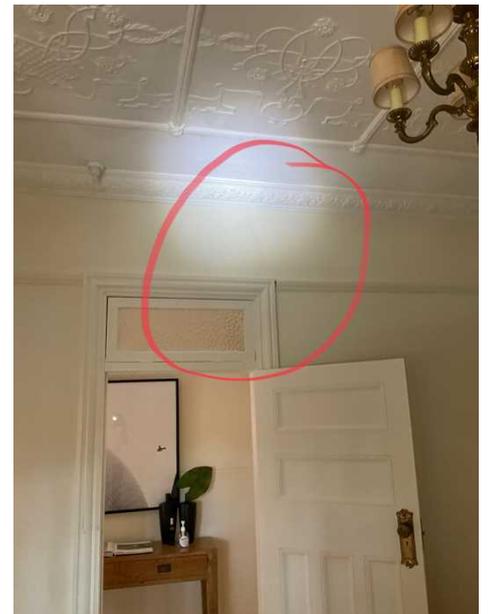
+ Example of cracking to bedroom 1.

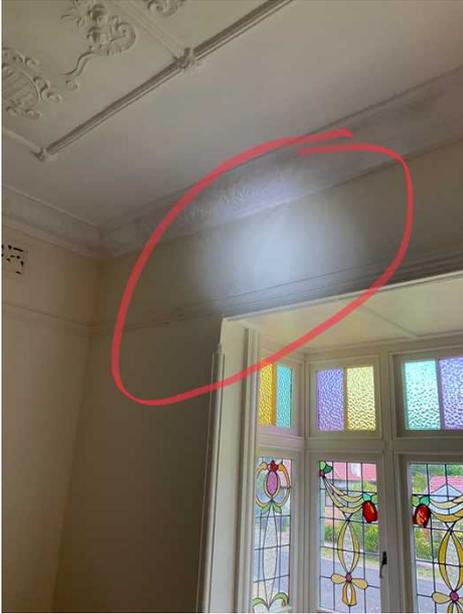
+ Example of cracking to living room.

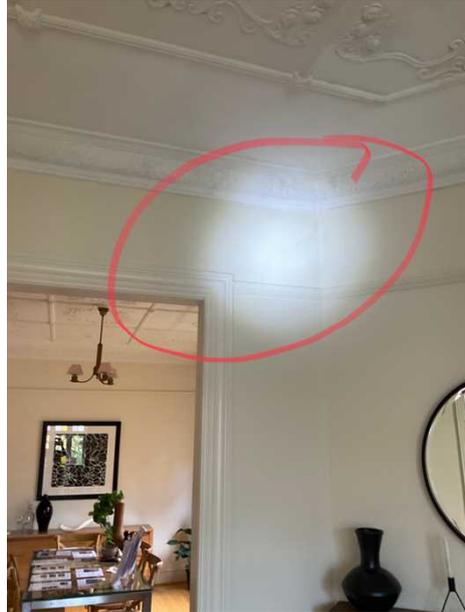
+ Example of cracking to living room above fireplace.

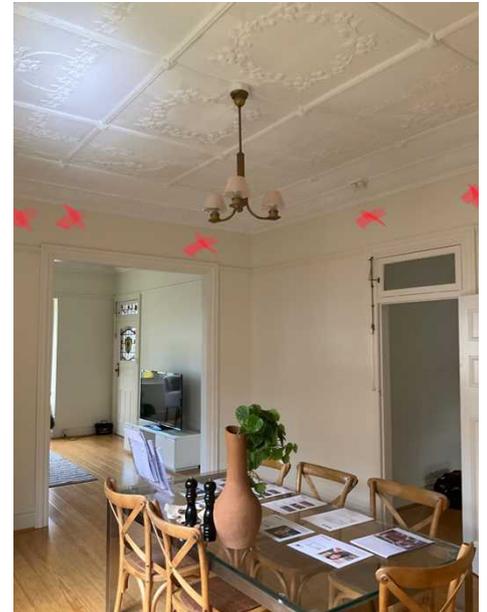
+ Example of cracking to dining room. Cracks recently repaired but will return in the near future.

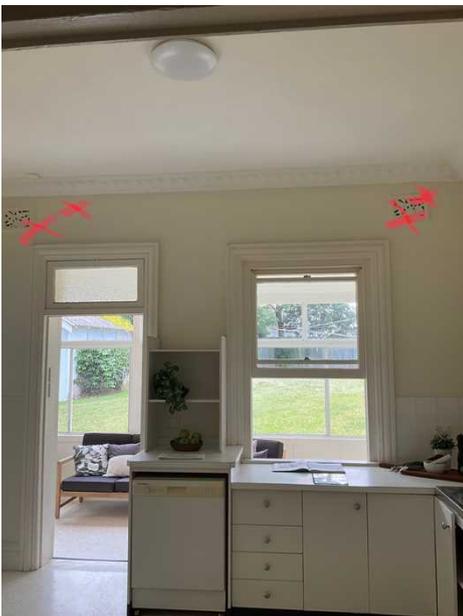
+ Example of cracks to kitchen. As per most cracks in the house they have tried to cover up. These are major cracks and will return in the near future.

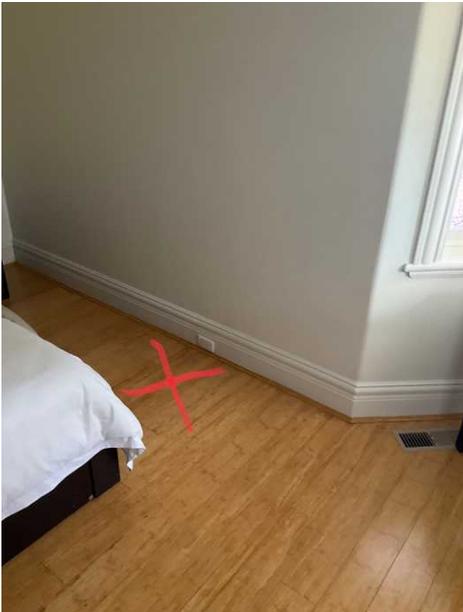
+ Flooring or floor joist has no support to underside. Floor movement very evident. Likely cause by sagging or leaning piers. Entire house has undulated flooring. Engage engineer and seek advice to prevent further deterioration.

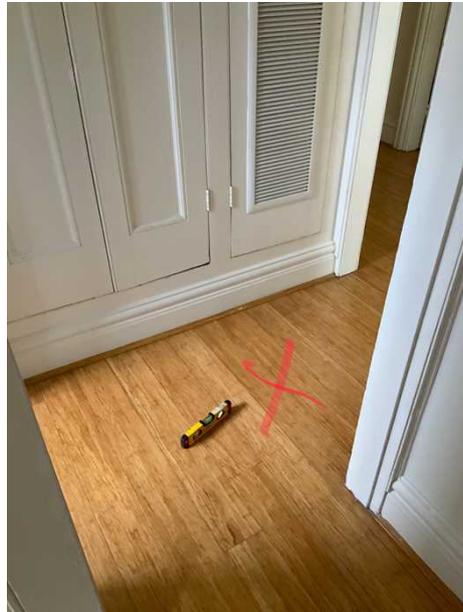
Undulating/uneven floors- recommend engaging a builder for rectification to prevent further deterioration., + Located at corridor of bathroom and bedroom 3.

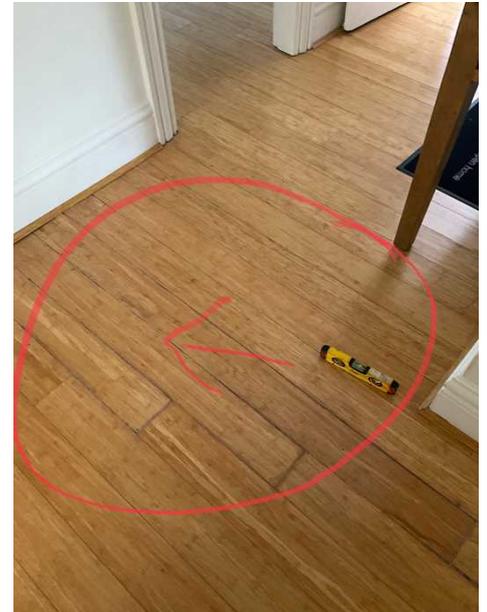
Undulating/uneven floors- recommend engaging a builder for rectification to prevent further deterioration., + Located at corridor between bedroom 1 and dining.

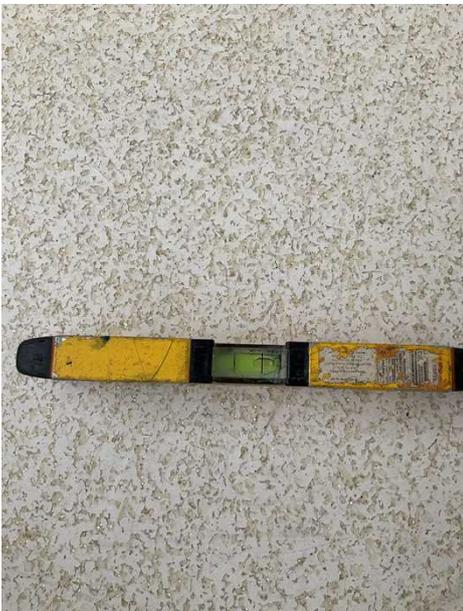
+ Flooring to sunroom and study has major fall. Engage builder or engineer for advice.

+ Example of fall in sunroom and study floor.

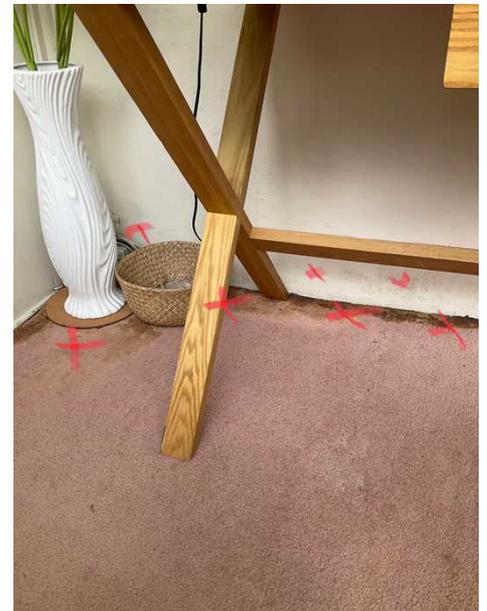
+ Moisture damage to carpets in study. Was dry at the time of inspection. Engage builder for water test to identify cause to prevent further water ingress and damage.

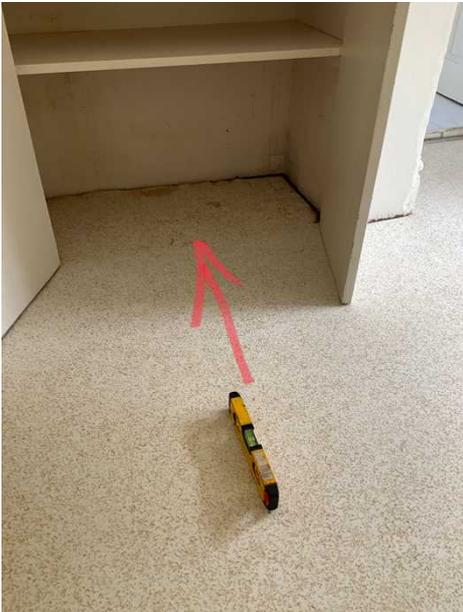
+ Sagging floors in kitchen, also high moisture readings to lower walls and floors in this area.

Engage builder to gain access to subfloor for further advice.

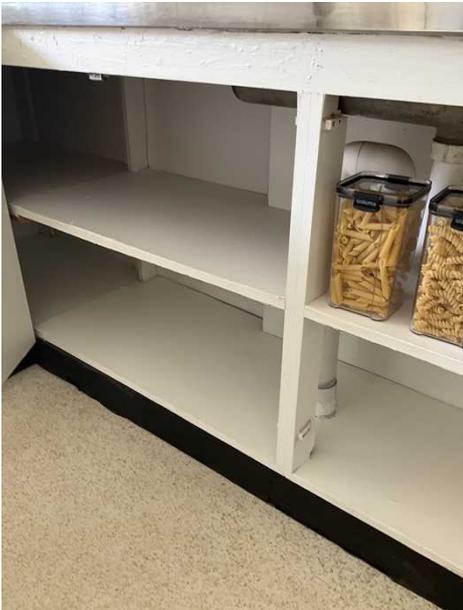
+ Cabinets to kitchen are old and moisture damaged. they have been given a coat of paint to hide deterioration. Missing doors. Will require replacement in the near future.

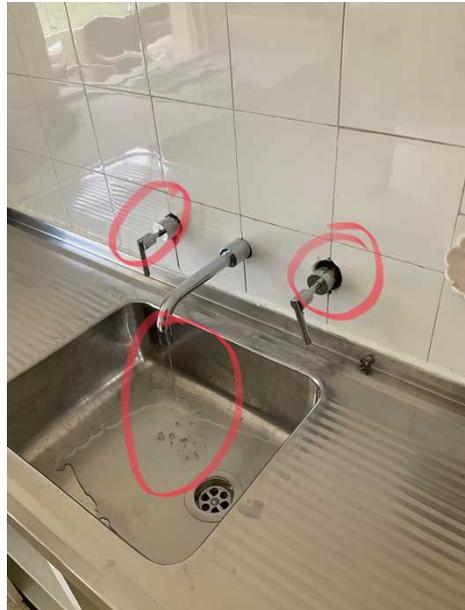
+ Unsealed Tap hardware within wall. Engage joint sealer to seal gaps to prevent water ingress within walls. Engage plumber to replace seals in taps to stop leaking taps.

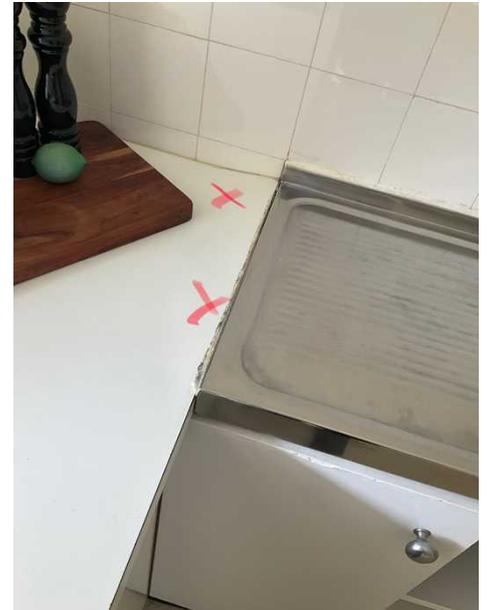
+ Water damaged top to kitchen. Swelling visible. Engage carpenter for replacement to prevent further deterioration.

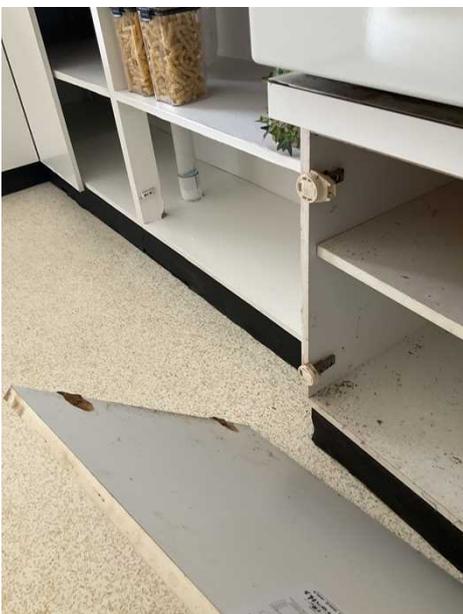
+ Example of kitchen door falling off when I opened it. Timbers are old and deteriorated. Complete new kitchen required in the very near future.

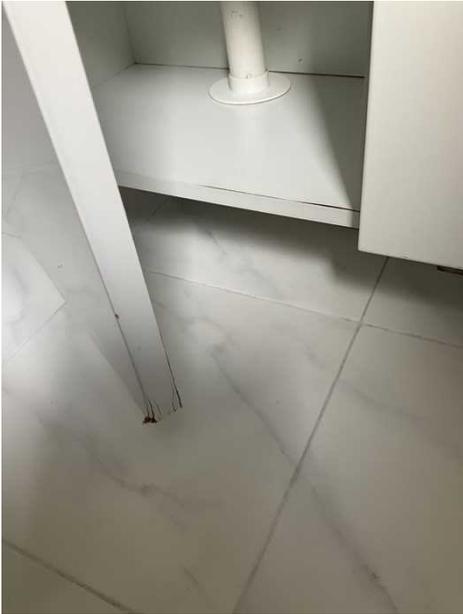
Water damage to vanity, recommend carpenter to repair/replace to prevent further deterioration., + Moisture damage to bathroom/laundry vanity.

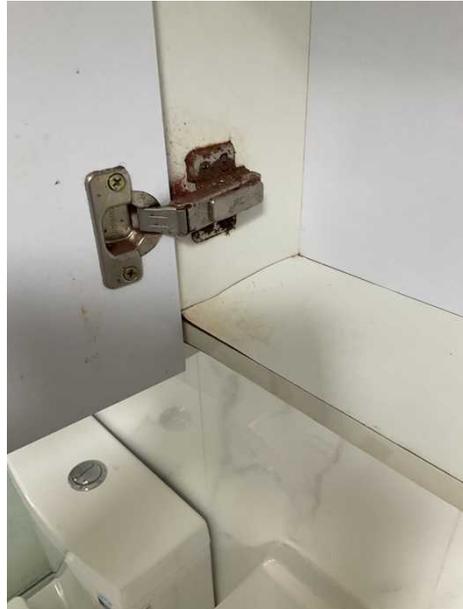
+ Moisture damage to shaving cabinet in bathroom/laundry.

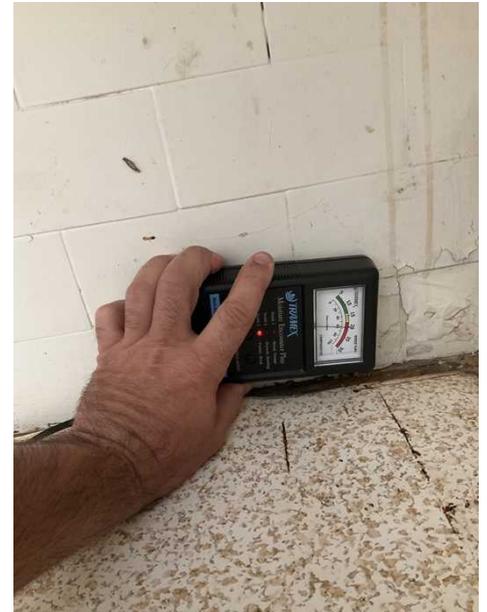
High moisture readings to areas. Recommend engaging a builder for invasive inspection to determine moisture source., + High moisture readings to Laundry/bathroom shower walls.

May be due to failed waterproofing or rising damp.

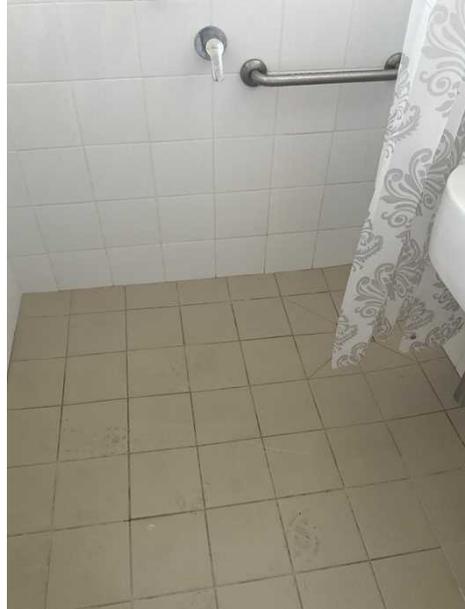
+ Main bathroom shower rags no shower screen, Water from shower is not contained in shower. Requires shower screen to control water. Waterproofing is undetermined. This bathroom should have waterproofing to entire floor. Requires subfloor access for further advice.

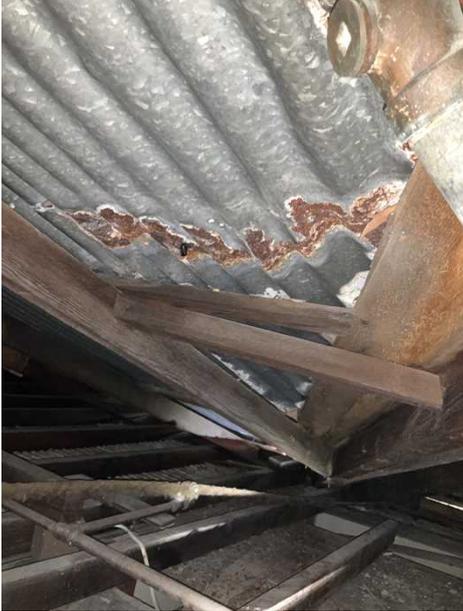
+ Rusted corrugated sheets above kitchen , bedroom 2 and Laundry.
Undetermined if any water ingress during rain.
Engage roofer for water testing. Likely to require replacement in the near future.

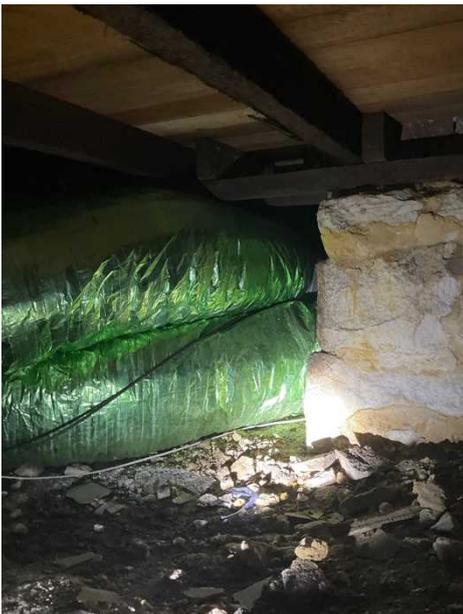
+ No access due to AC ducting blocking access hole. On partial inspection under living room.
Property & Timber Pest Report.

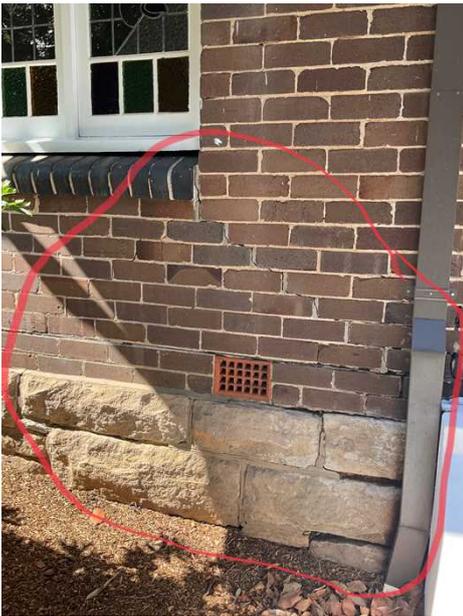
+ Movement cracks to external brickwork and sandstone wall outside bedroom 2.
Engage engineer for advice to control and prevent further deterioration.

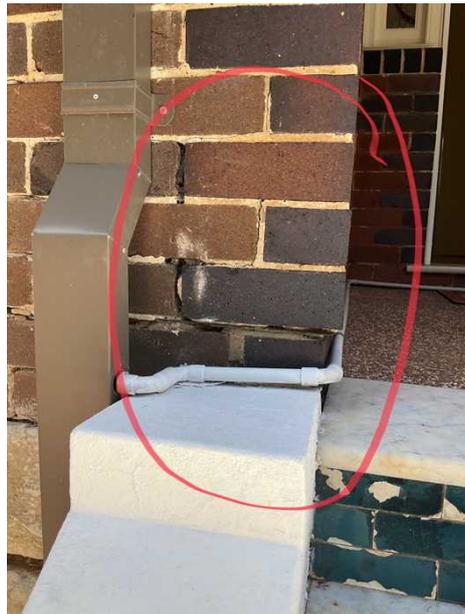
+ Example of movement cracks and brick overhang outside bedroom 2.

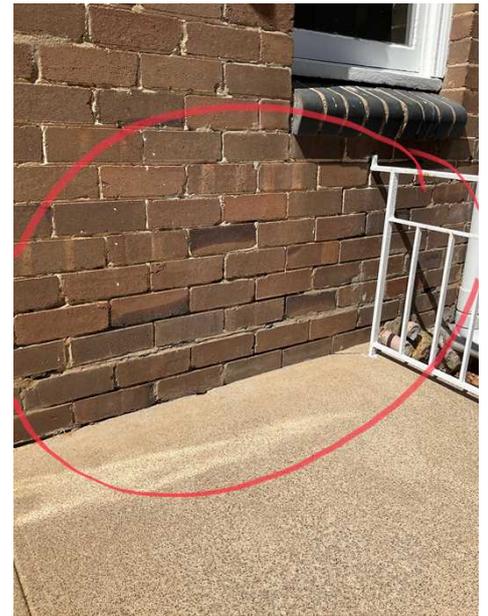
+ Mortar breakdown outside laundry external walls.
Engage bricklayer for repointing to prevent further deterioration.

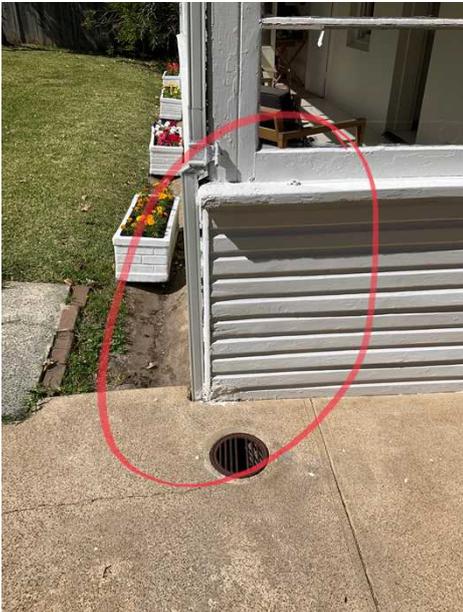
Weathered timbers to areas. Recommend a carpenter to repair or replace as required to prevent further deterioration., + Has been poorly patched by the painter.

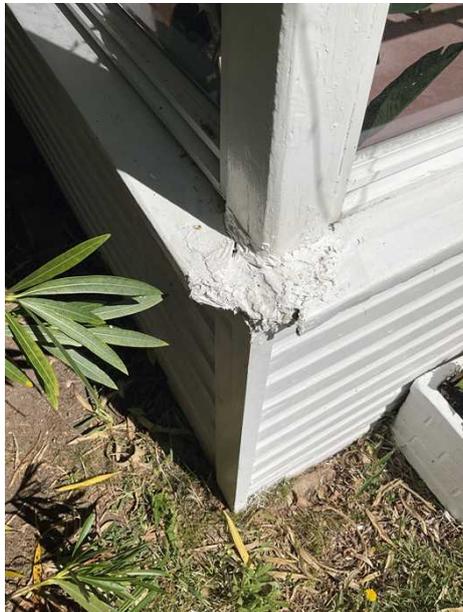
+ Example of more wood decay to sunroom walls. Engage carpenter for repairs to prevent further deterioration.

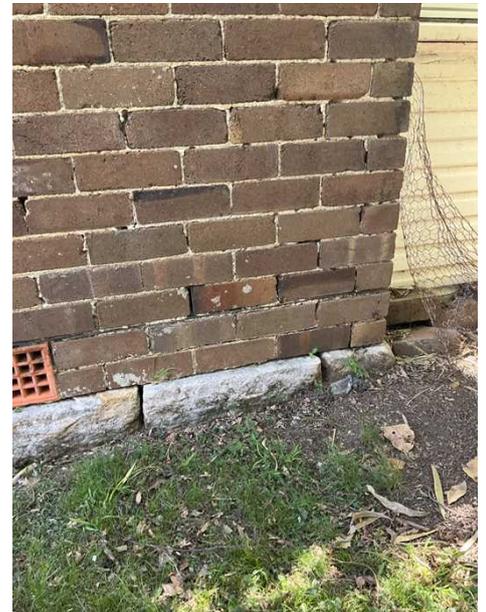
+ Mortar breakdown outside of bedroom 3. Engage bricklayer for repointing to prevent further deterioration.

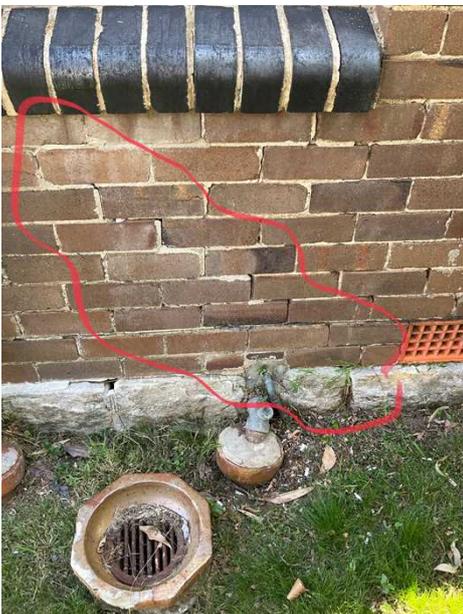
+ Cracking to outside window of bedroom 2. Engage engineer for advice to prevent further deterioration.

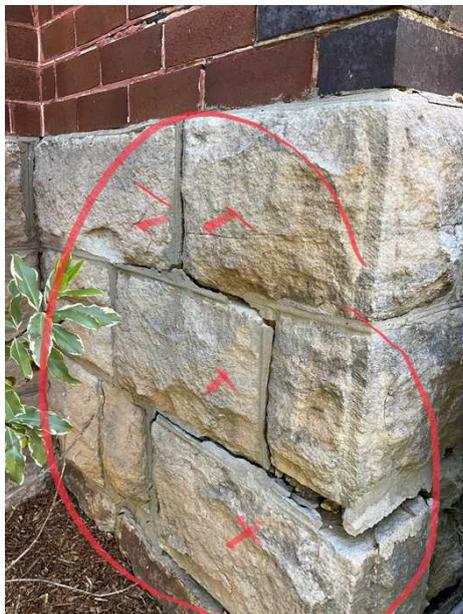
+ Cracking to sandstone foundation walls. Engage engineer for advice to repair and prevent further deterioration.

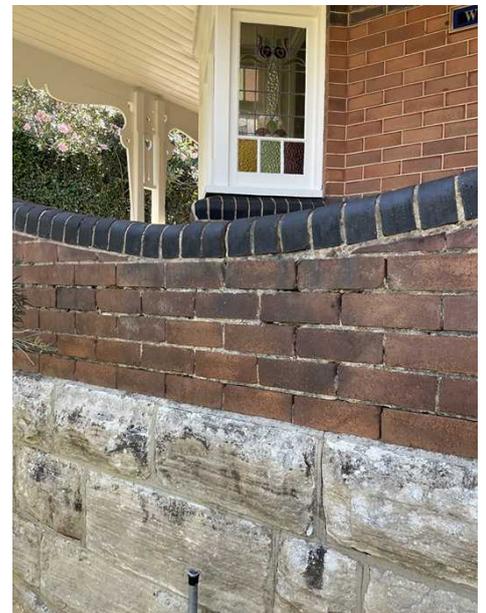
+ Cracking and mortar breakdown to front porch brickwork. Engage bricklayer for repointing to prevent further deterioration.

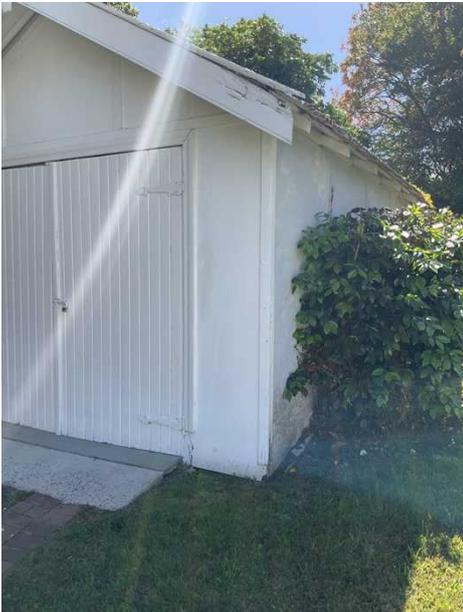
+ Walks to garage are likely asbestos based. Ensure testing of lining is completed prior to any work or removal of sheets. Asbestos is life threatening and all care should be taken when working with this material.

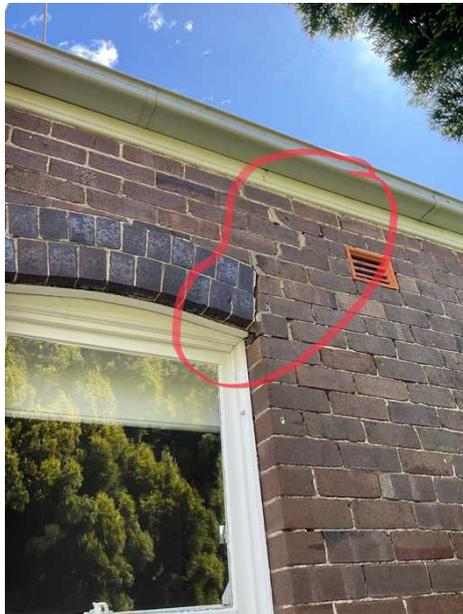
+ Example of large crack above window of bedroom 2

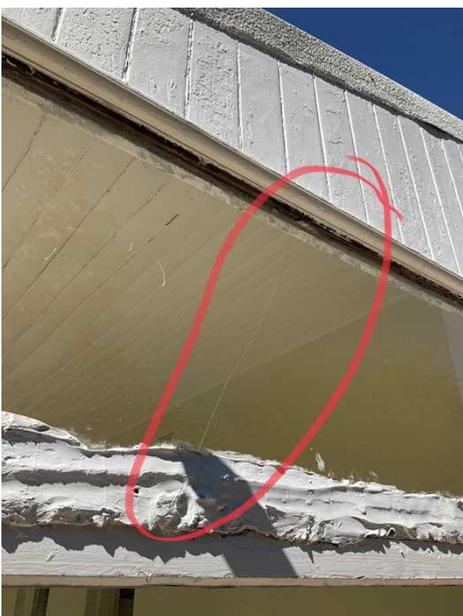
Broken window, recommend a glazier to replace the broken pane to prevent risk of personal injury and water penetration., + Sunroom location.

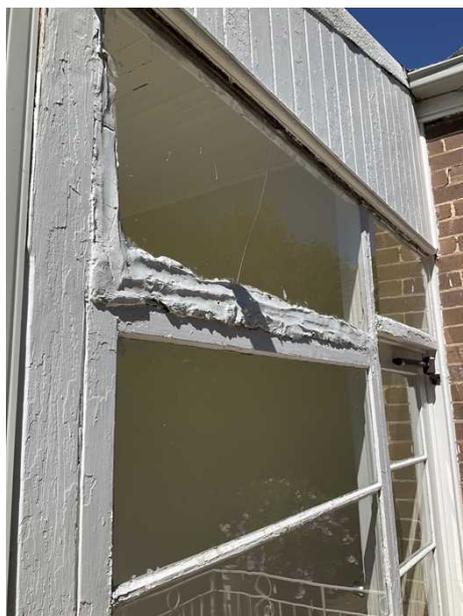
Weathered timbers to parts of the windows. Recommend a carpenter for repairs to prevent further deterioration., Cracked and missing putty to parts of the windows. Recommend a glazier to repair/replace to prevent further damage., + Sunroom location.

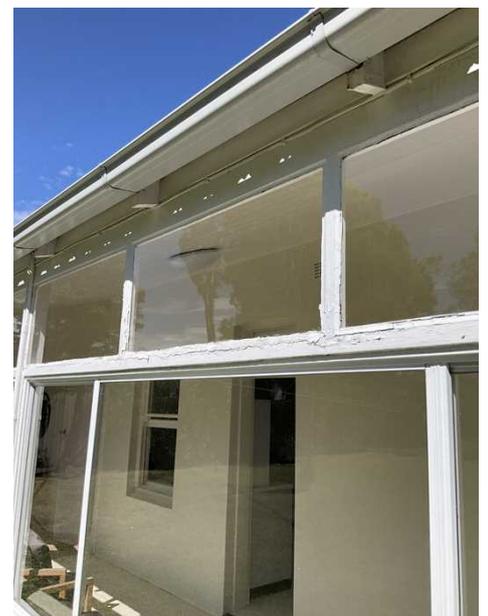
+ Example of weathered window frames to sunroom.

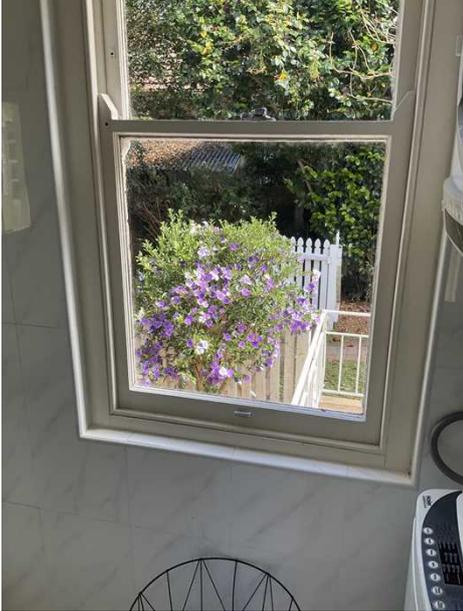
+ Example of some windows that do not open likely due to been glued with paint.

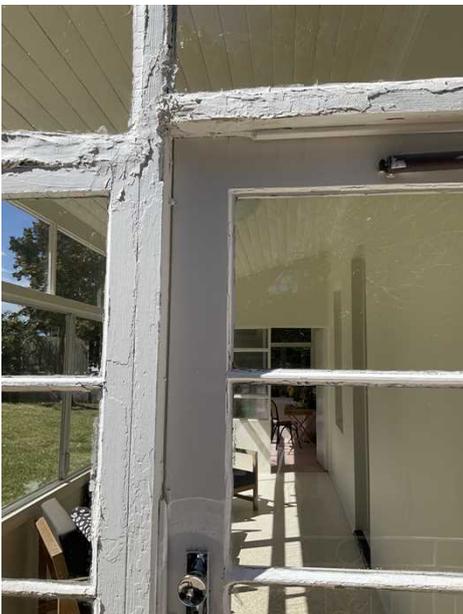
+ Rear sunroom door is weathered and deteriorated as is the door jamb. Extensive work required throughout to make good of sunroom.

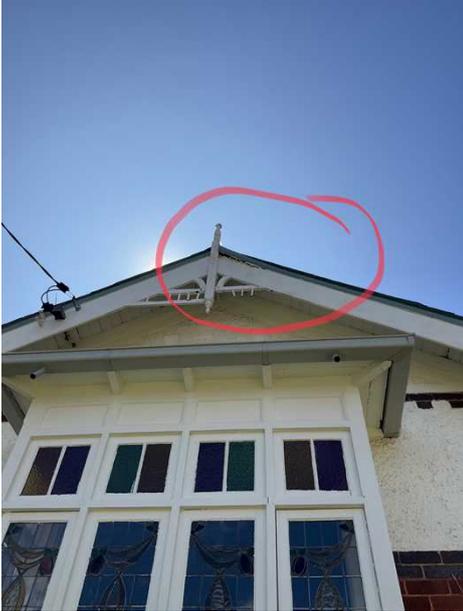
Aged and deteriorated fascia- Engage a carpenter to repair/replace to prevent further deterioration and damage.

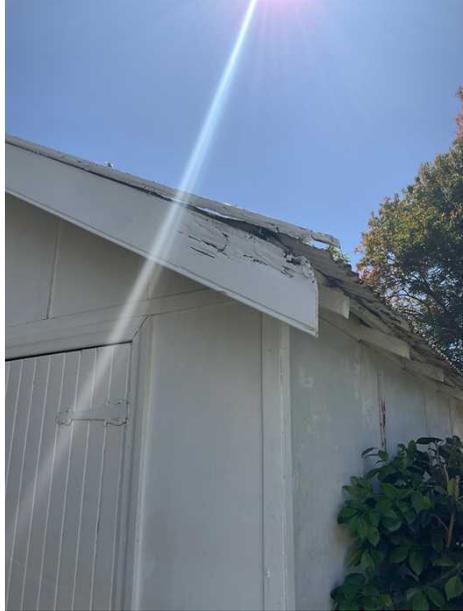
Aged and deteriorated fascia- Engage a carpenter to repair/replace to prevent further deterioration and damage., + Located at rear garage.

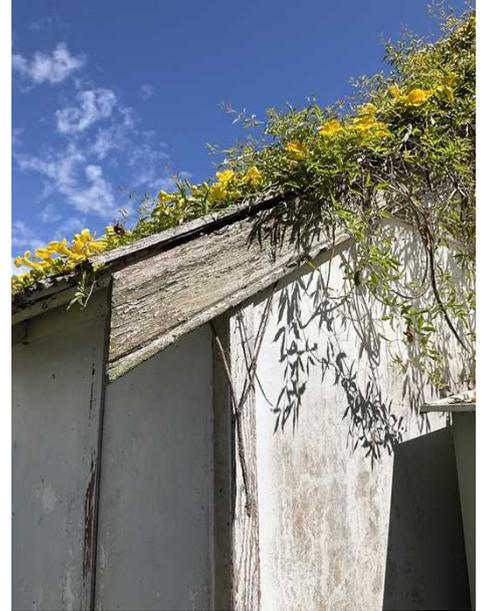
+ Example of weathered fascia.

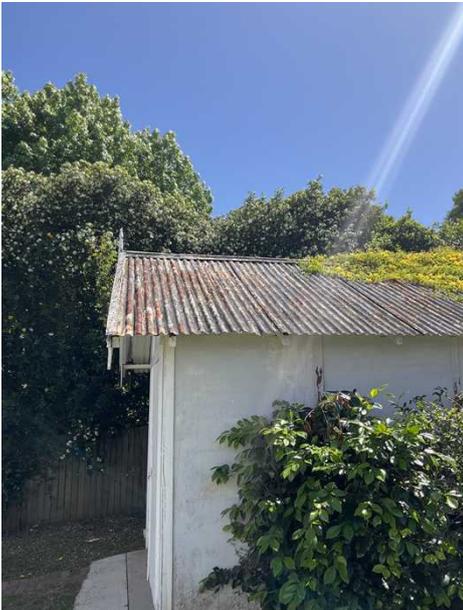
Rust to parts of the roof. Recommend engaging a roofer for repairs to prevent further deterioration and damage., + Rear garage location.

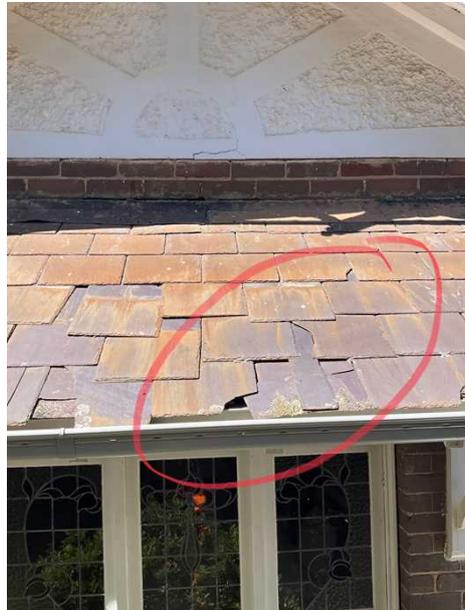
+ Slate tiles have slid down and not providing protection in areas of the roof. Engage specialised roofer for repairs to prevent water ingress.

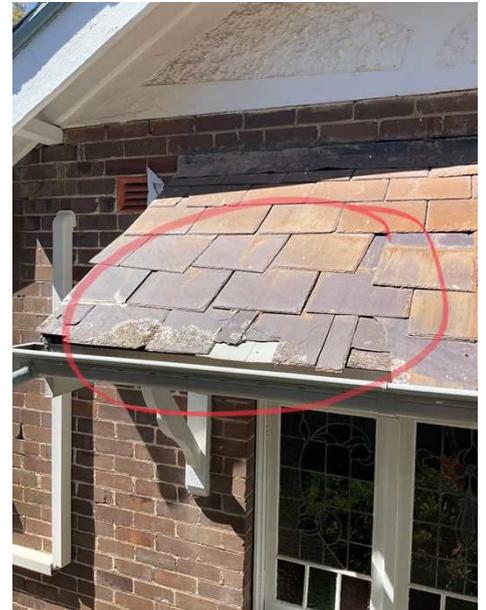
+ Example of broken and missing slate tiles. Some tiles have been siliconed together,

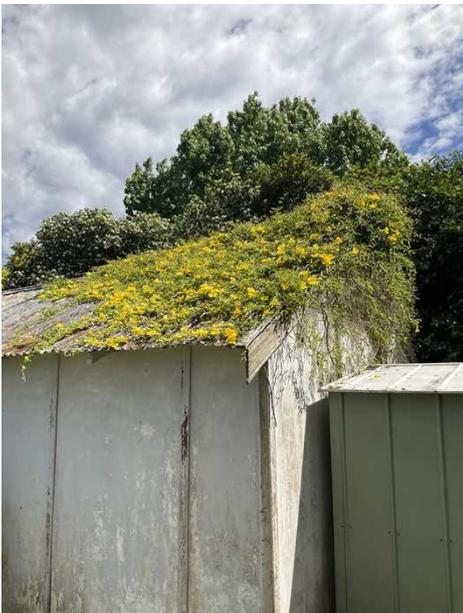
+ Vegetation to roof on garage. Engage roofer to clean and remove to prevent further deterioration of garage roof.

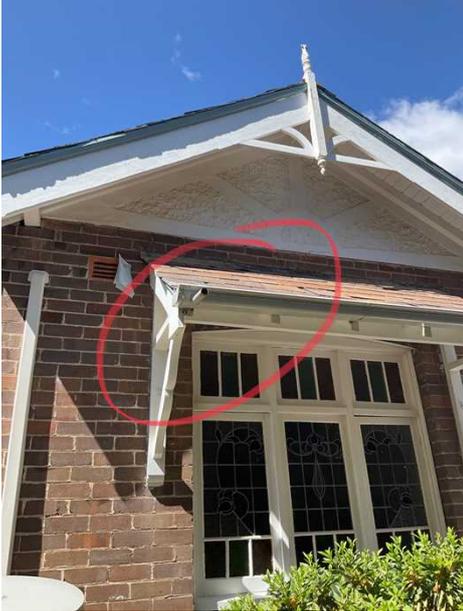
Parts of the gutters are missing downpipes. Recommend a plumber to rectify to reduce the risk of moisture issues., + Excess water to the property causes subsidence to footings, pavers and is generally the cause of sinking piers and cracking walls.

All down pipes should be connected to stormwater.

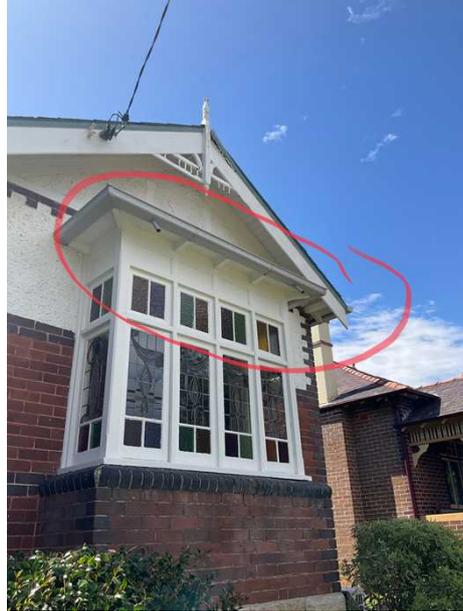
+ Example of no down pipes.

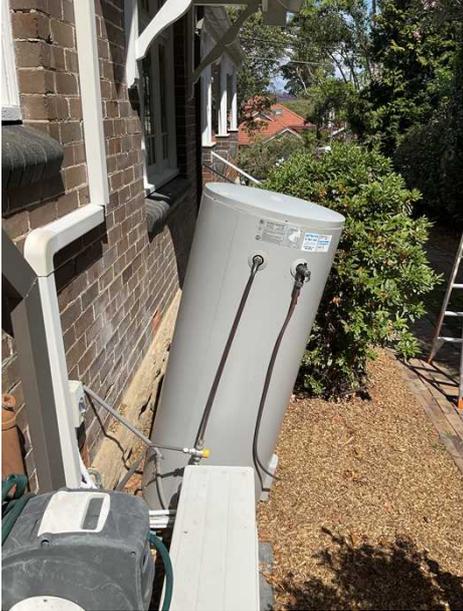
+ Subsiding water heater.
Engage plumber to remove and install suitable base for water heater to prevent subsidence and leaning.

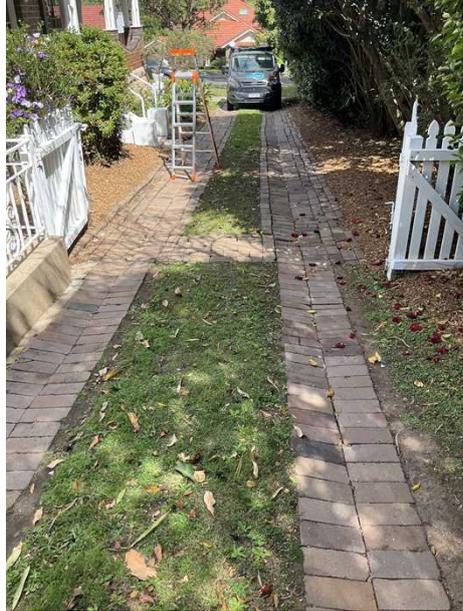
Poor surface drainage-recommend engaging a plumber to rectify ground water issues which can lead to foundation movement., Unevenness of the pavers. Recommend a landscaper for repairs as required to prevent personal injury to footing.

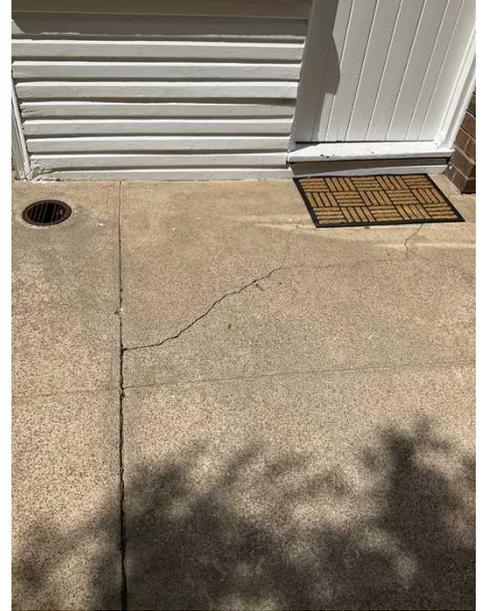
Cracked and uneven concrete. Engage concreter for repair/replacing to prevent further deterioration.

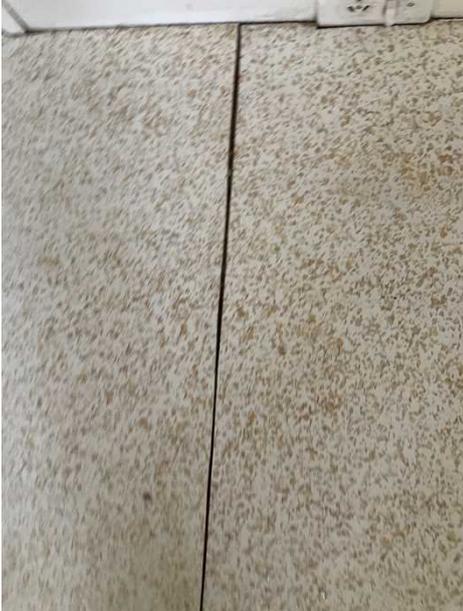
Example of peeling vinyl flooring.

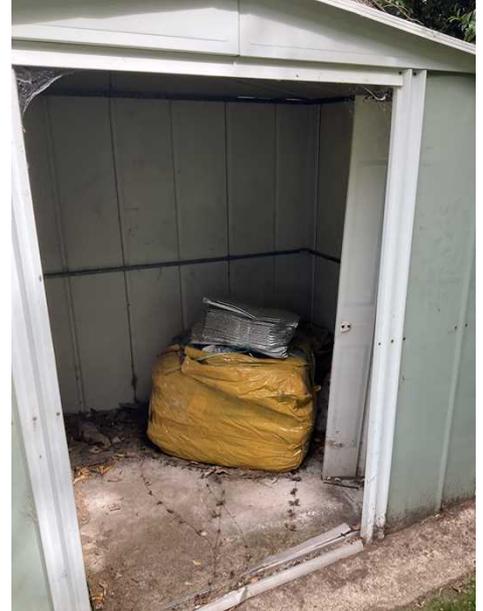
Example of missing doors to outbuilding.

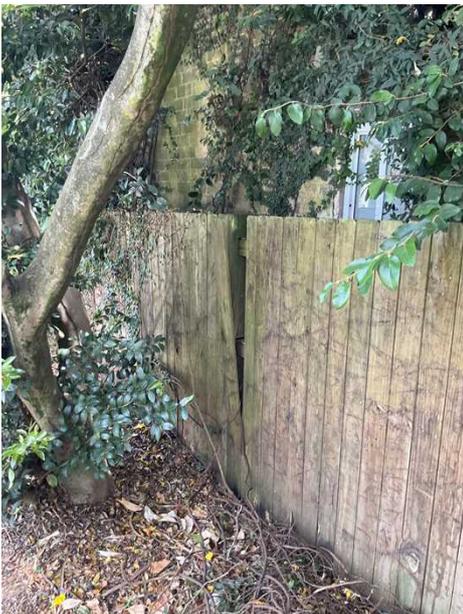
Example of missing palings to fence.

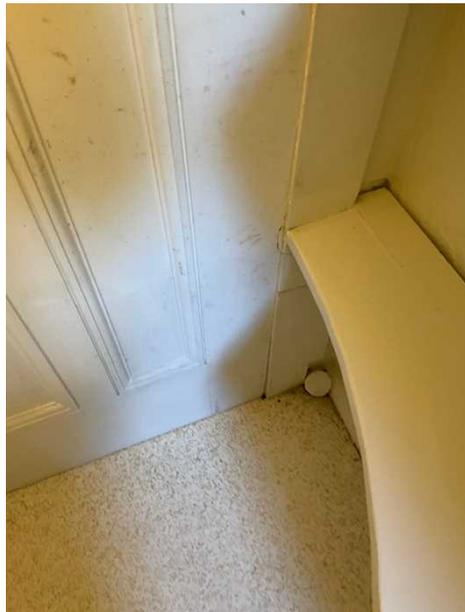
Example of stains and scuff marks to walls, floors and doors.

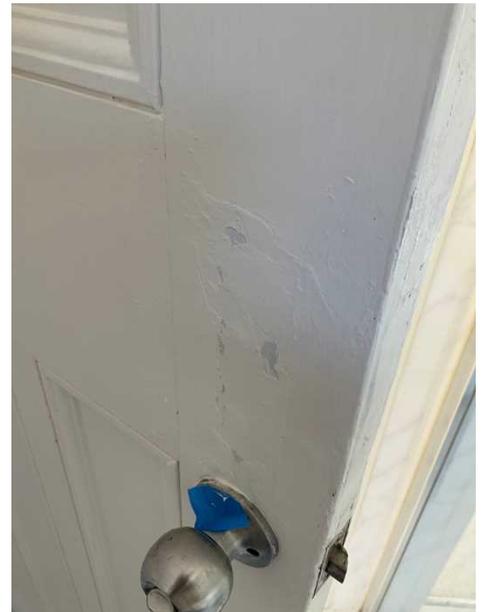
Example of poorly repaired and painted surfaces.

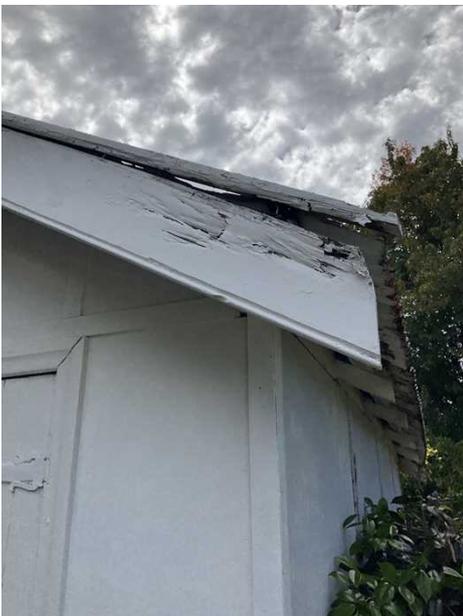
Example of wood rot to fascia boards.

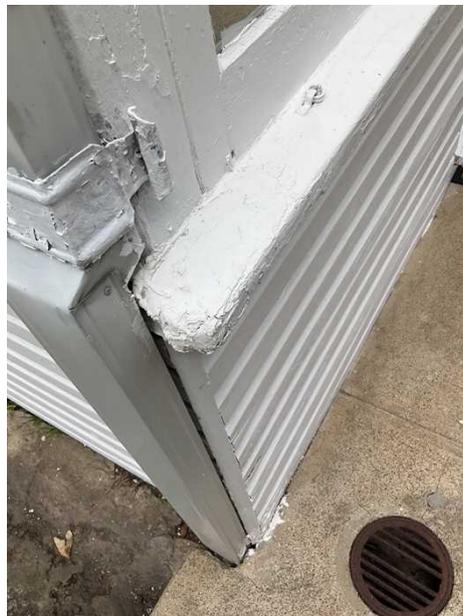
Example of wood rot to window frames.

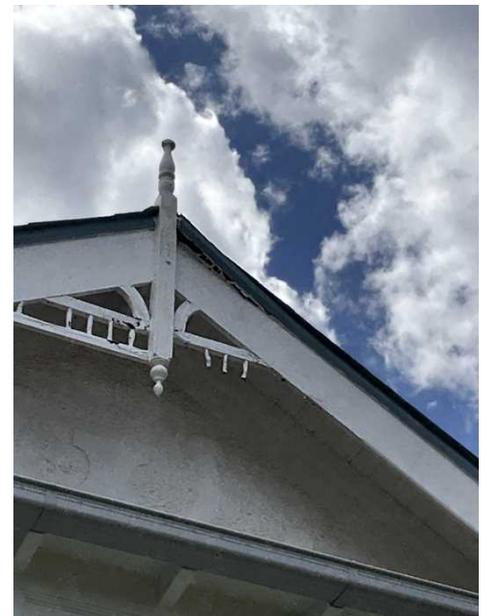
Example of wood decay to gable end.

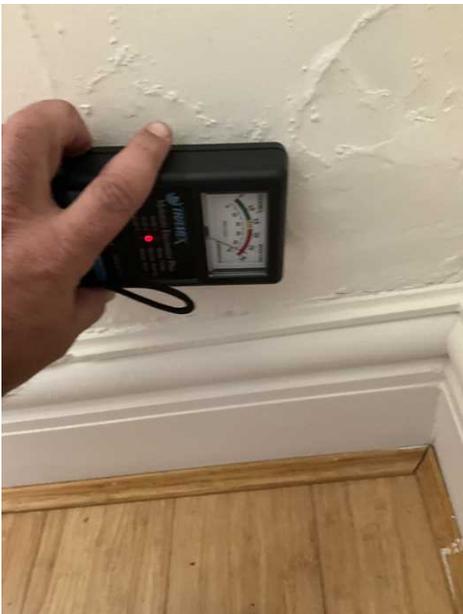
Example of high moisture reading to main bathroom walls,

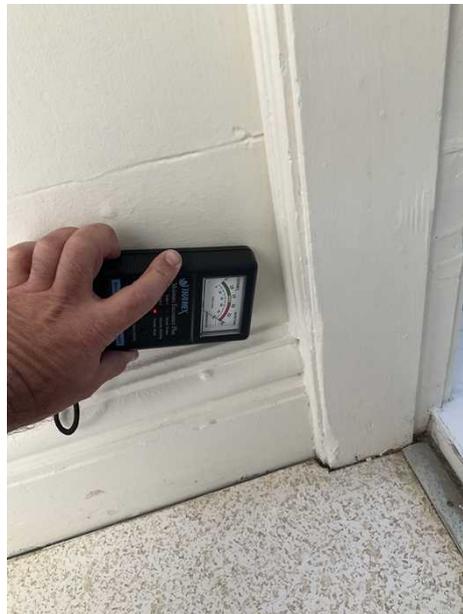
Example of high moisture reading to laundry/ bathroom shower walls.

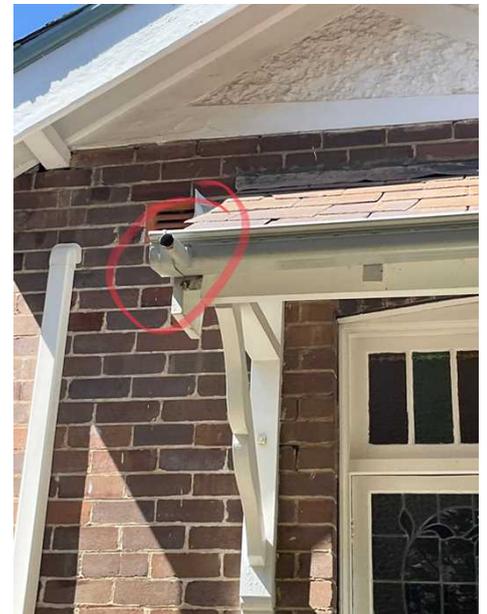
Example of no down pipes connected. Moisture is conducive to termites. It's important to prevent excess moisture around the property not to attract termites.

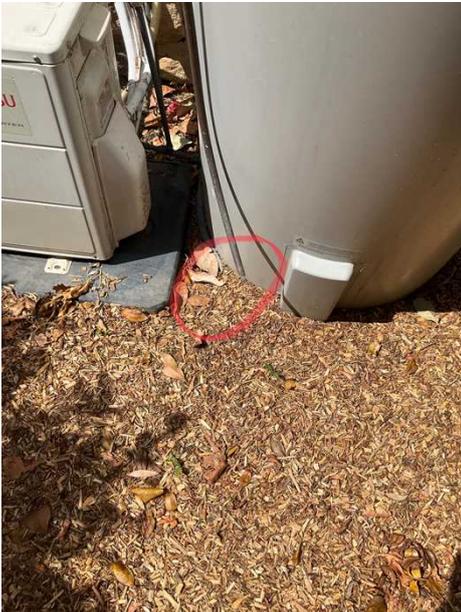
Example of hot water overflow.
