NEW CONSTRUCTION STAGE PROPERTY INSPECTION REPORT

AS4349.0-2007

New Construction Stage Inspection Report.

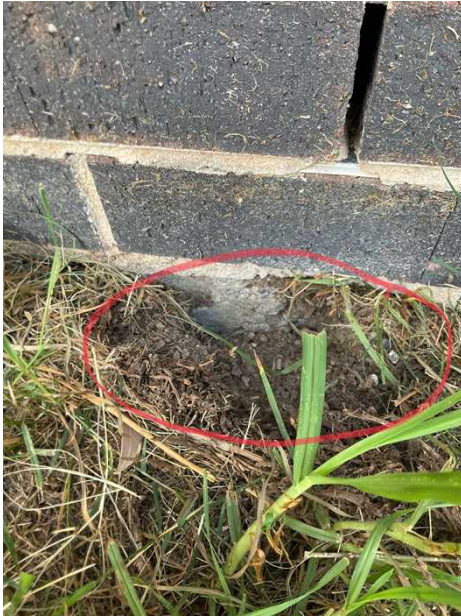
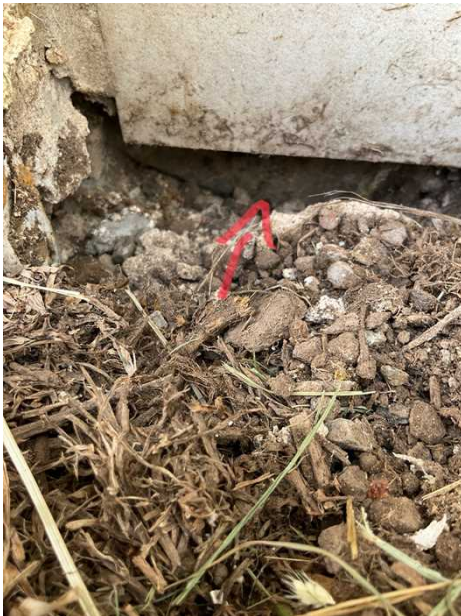
Location: Slab edge to entire perimeter of home.

Details: Numerous spots have been excavated to expose the slab edge.

Vapour barrier is required to prevent moisture penetration to the slab perimeters as it does for the underside.

VAPOUR BARRIER must be placed beneath the slab so that the bottom surface of the slab is entirely underlaid and extends under edge beams to finish at ground level. Refer figure 3.2.2.3 in NCC or figure 4.2.8 in NCC 2022

Recommendation: Entire slab edge will need to be exposed and excavated and be treated with a suitable membrane recommended by the acting engineers.

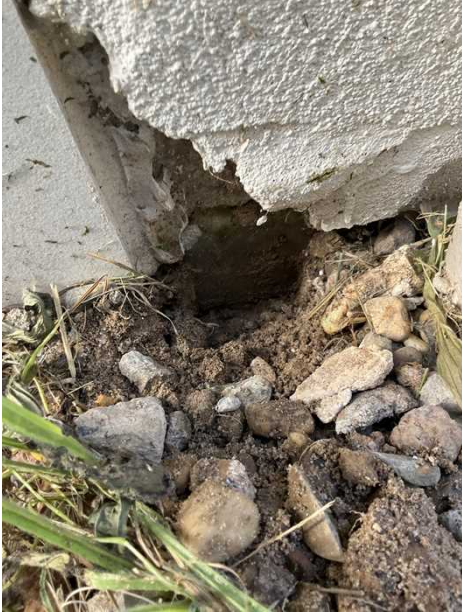
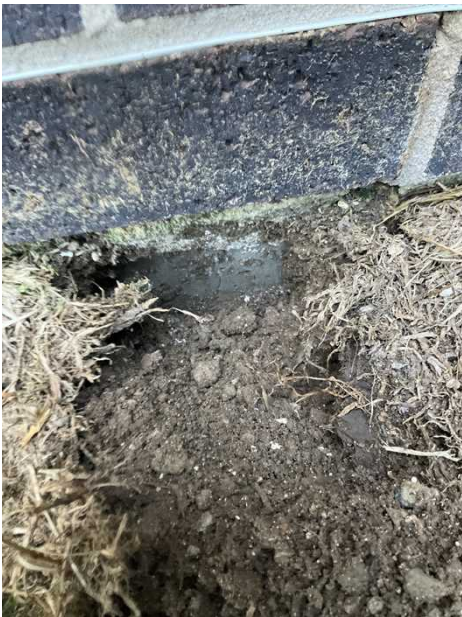
Location: Slab edge perimeters.

Details: More examples of no vapour barrier.

Recommendation: As per previous.

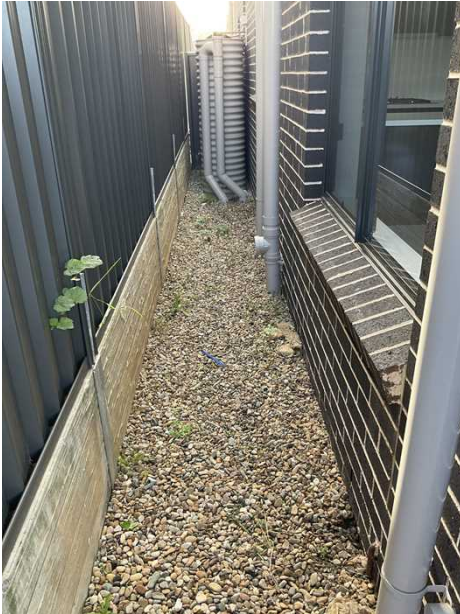
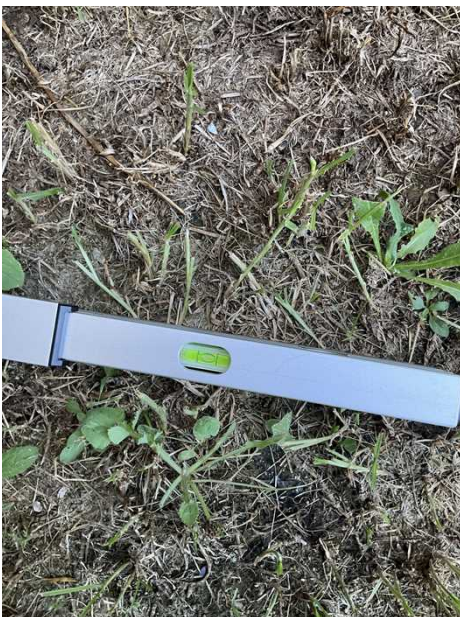
Location: Side and rear of home.

Details: Finished ground level is level.

50mm over 1m in any other case.

Recommendation: Landscaping to be re-completed ensuring compliance with falls is achieved and be directed to the drainage allocated at the rear of the property.

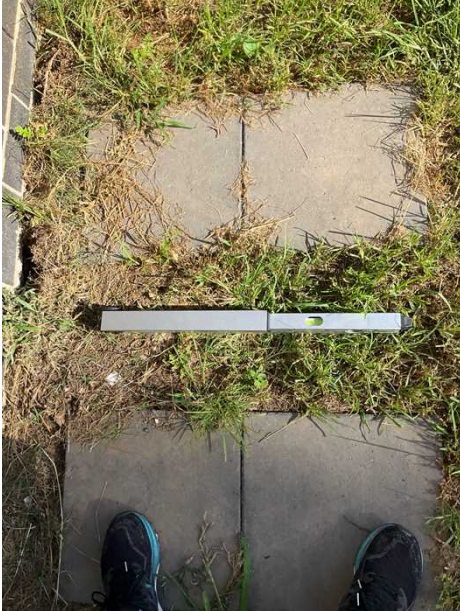
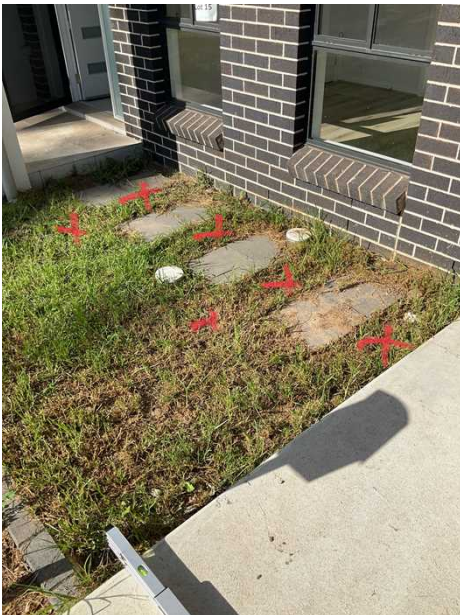
Location: Front of property

Details: Finished ground level is level.

Also detailed in engineers.

Recommendation: Landscapers to redesign contours to suit regulations.

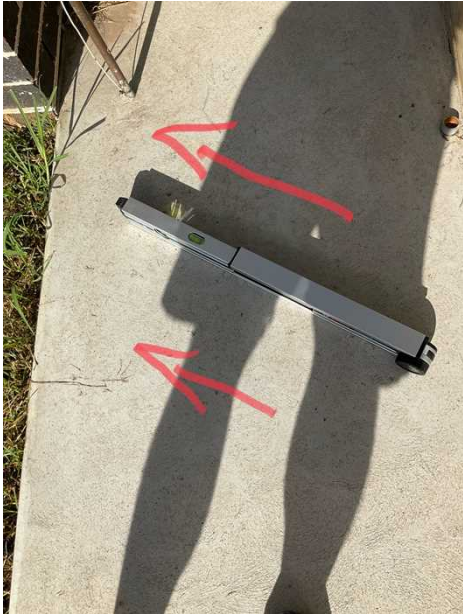
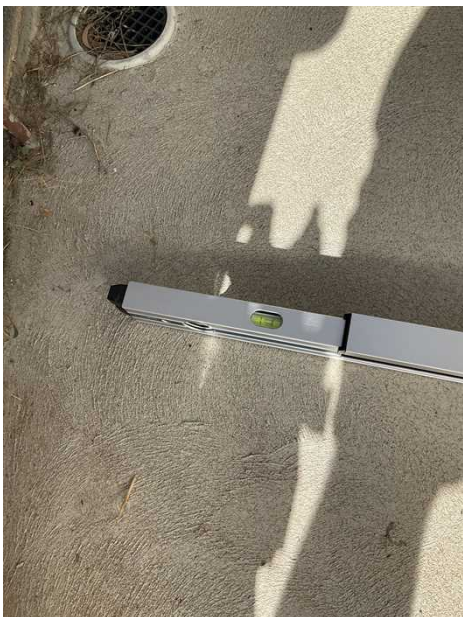
Location: Pavement as side of property.

Details: Entire concrete path is diverting water towards the house and its footings.

50mm over 1m in any other case.

Recommendation: Concrete to be removed and recompleted with suitable falls.

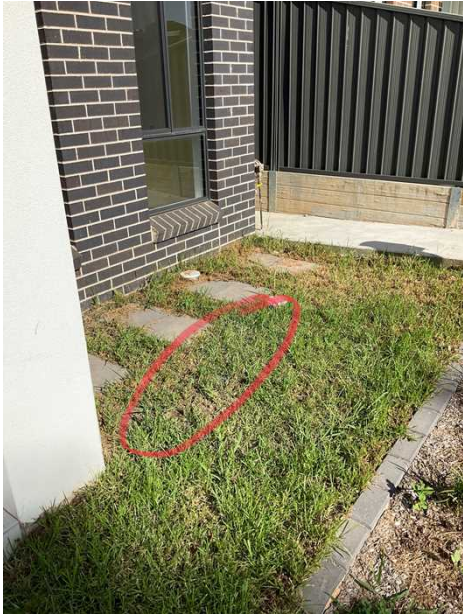
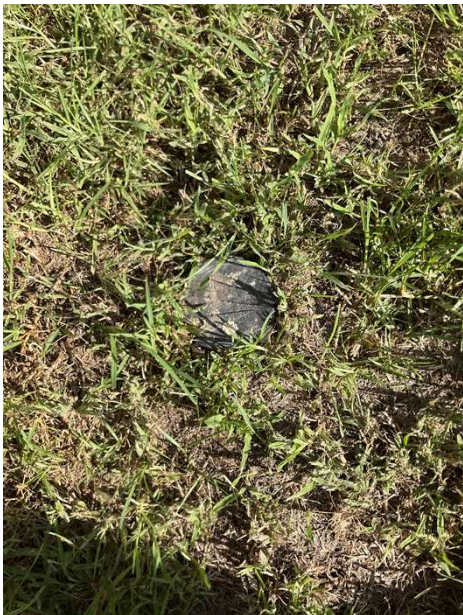
Location: Front yard drainage.

Details: Incomplete. No drainage out. Just plastic cap.

Recommendation: Drainage put to be installed with relevant falls to pit prior to handover.

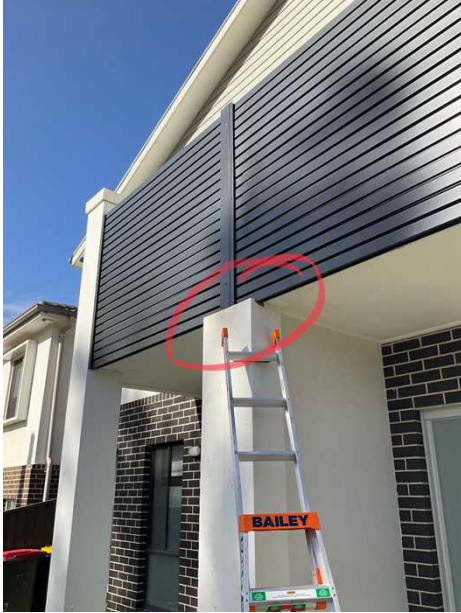
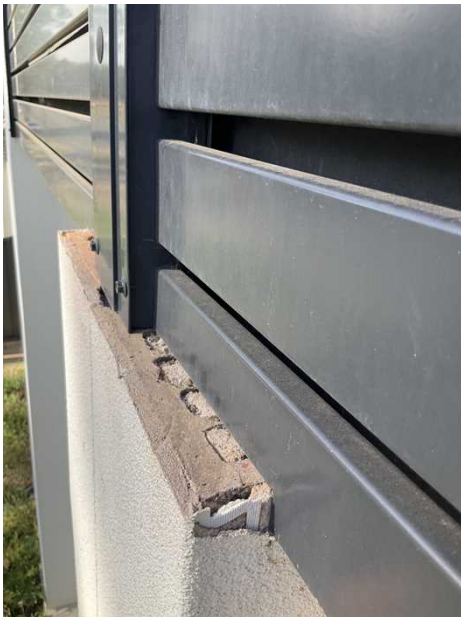
Location: Top of front wall/column.

Details: The top has not been sealed or has any type of capping.

This will cause render to deteriorate and paint to peel and bubble overtime.

Recommendation: A simple flashing design would be suitable to prevent water penetration.

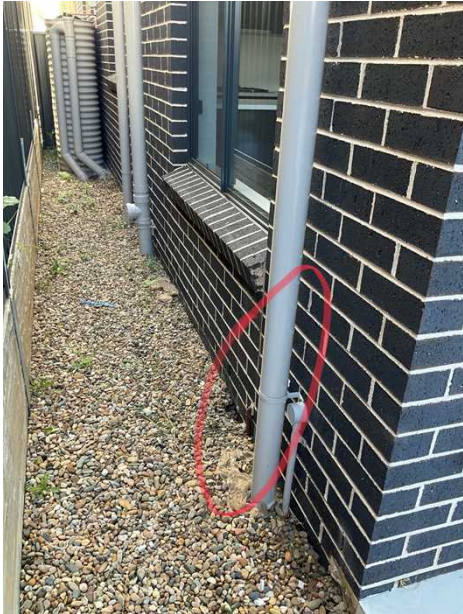
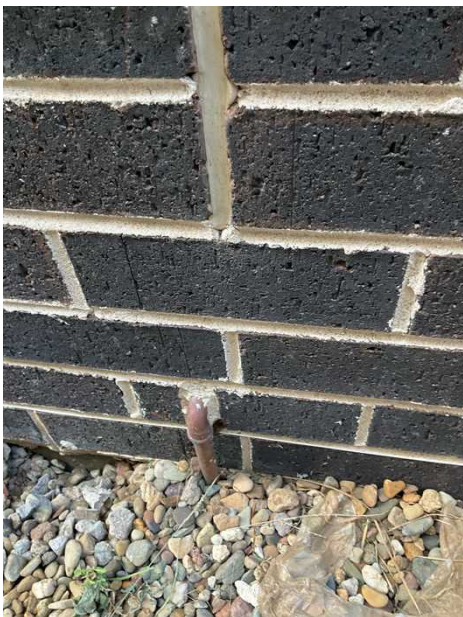
Location: Rear side of property.

Details: Articulation joint is incomplete.

Articulation joints between masonry elements must have a width not less than 10mm.

Recommendation: Articulation joint to be completed and cut in.

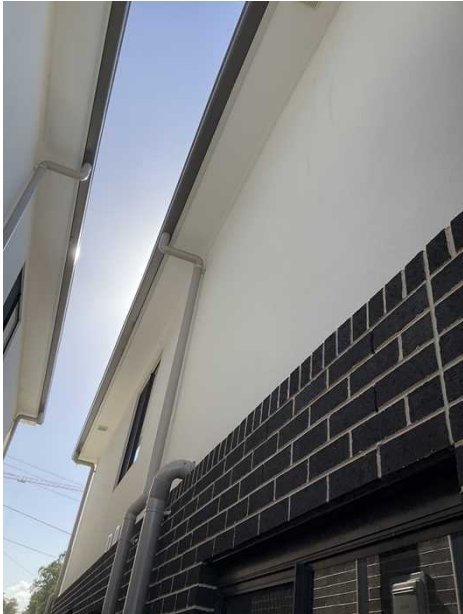
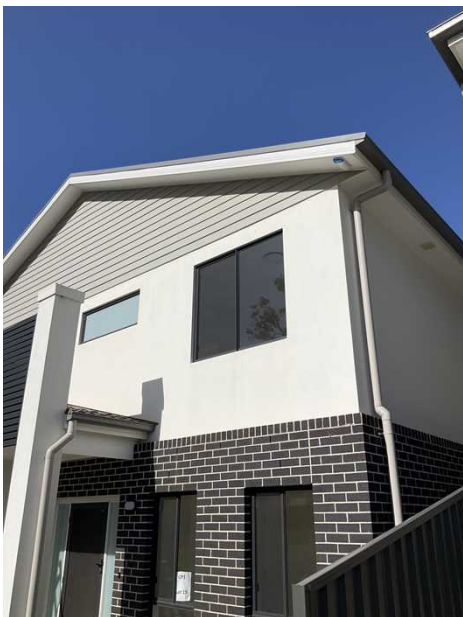
Location: Exterior cladding.

Details: Cladding is a polystyrene product.

This product will crack and have vertical and horizontal separation without articulation joints in place.

Recommendation: Builder to add articulation joints as required.

Builder to provide client with information on what product was used to be able to criss check AJ in the right locations.

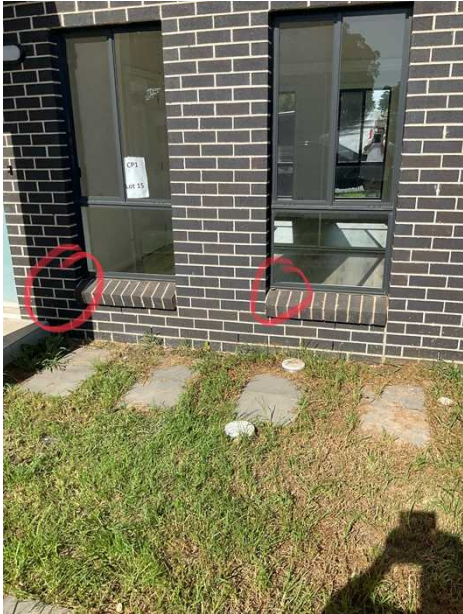
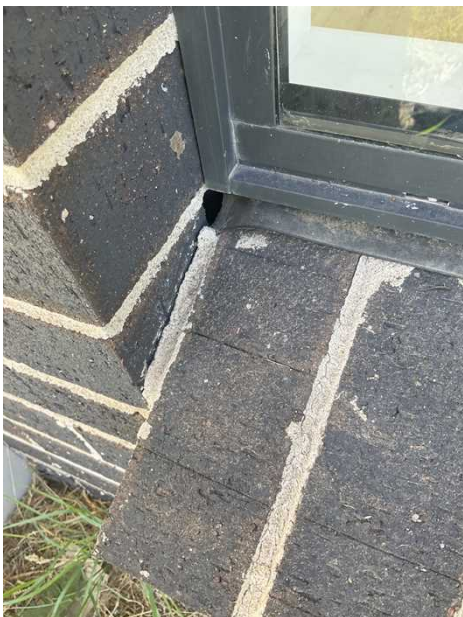
Location: Front window sill rubbers.

Details: Gaps and voids into the wall cavity from window sill due to brick which has been cut short and has insufficient depth.

The other sill needs sill rubber repaired

Recommendation: Builder will to repair rubber and brick work to ensure no water ingress during rain.

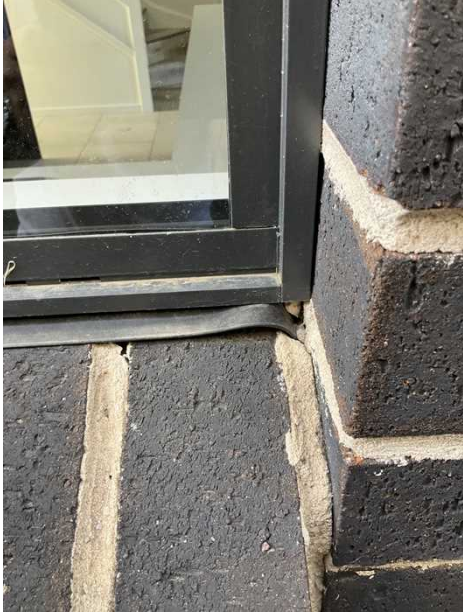
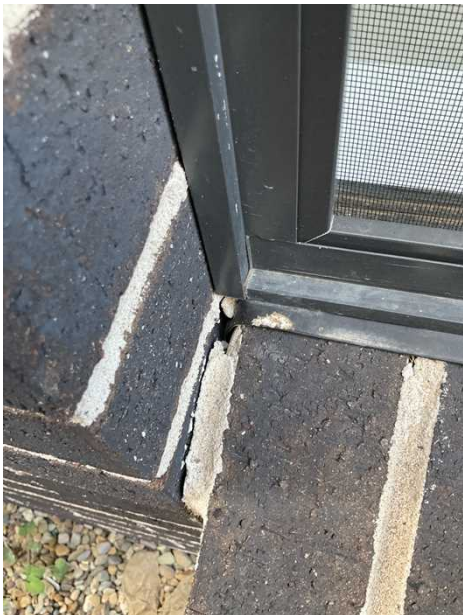
Location: Lower windows at side of house.

Details: Sill rubbers are in bedded in the mortar and AJ.
Water ingress to cavity likely.

Recommendation: Sill rubber to be repaired to all windows
to ensure no water ingress into property.

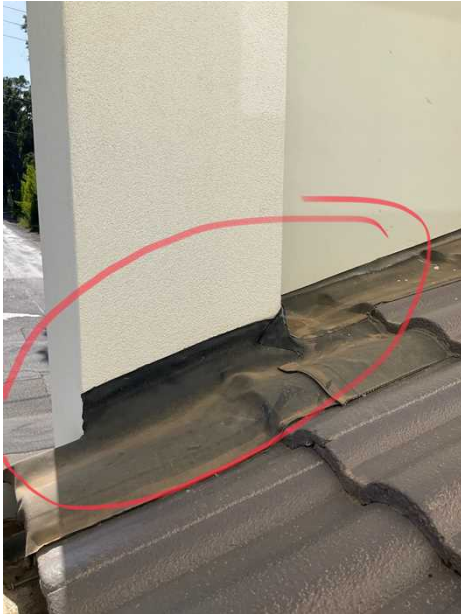
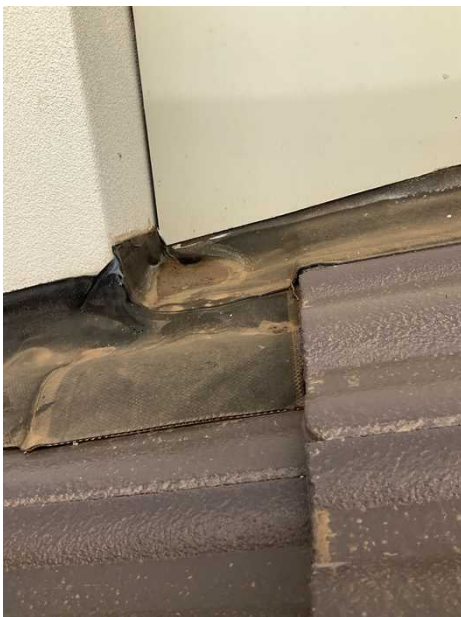
Location: Front lower roof.

Details: Flashing is siliconed to masonry to provide seal and prevent water ingress.

Recommendation: Flashing to be recompleted to comply with NCC.

Silicon should never be the primary source of preventing water ingress.

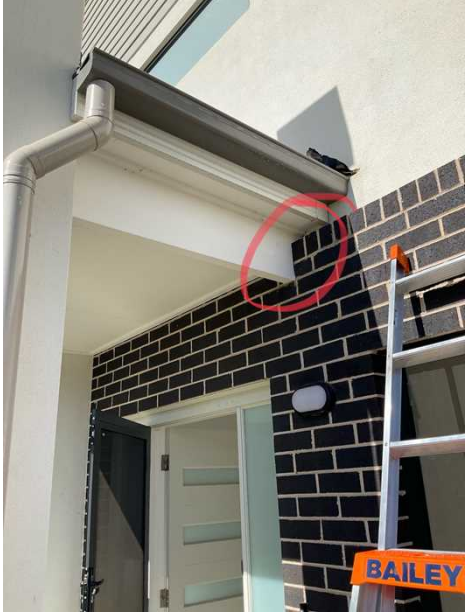
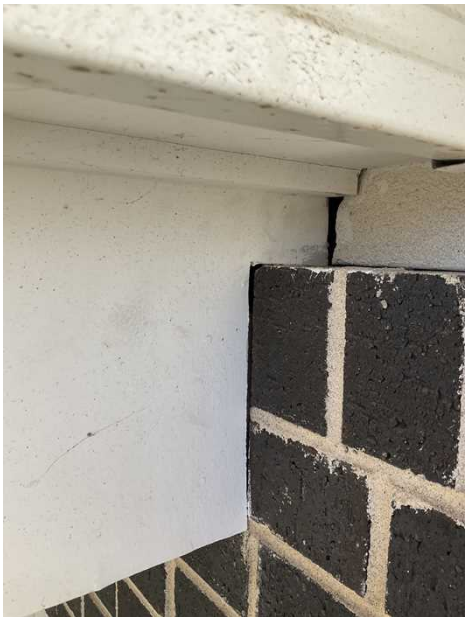
Location: Front eaves and wall junction.

Details: Gaps inbetween cladding and eaves.

All exterior surrounding should be sealed with no gaps.

Recommendation: Builder to caulk or install timber trims etc.

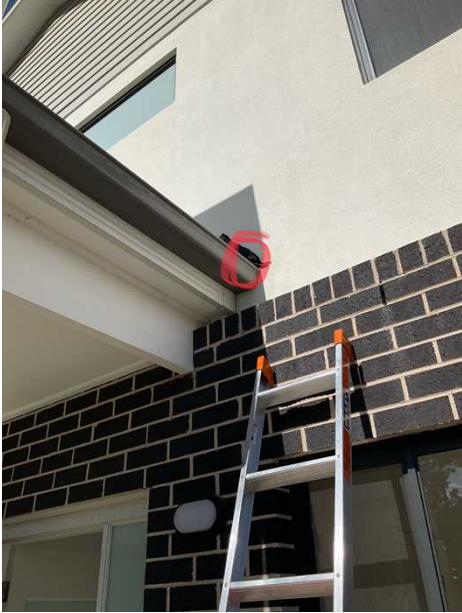
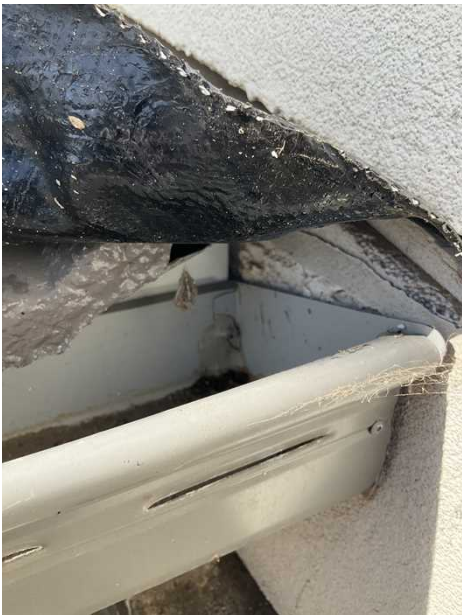
Location: Front lower roof gutter

Details: Gutter is loose. Missing bracket at stop end.

i) supported by brackets securely fixed at stop ends and at no more than 1.2m centres.

Recommendation: Install additional brackets as required.

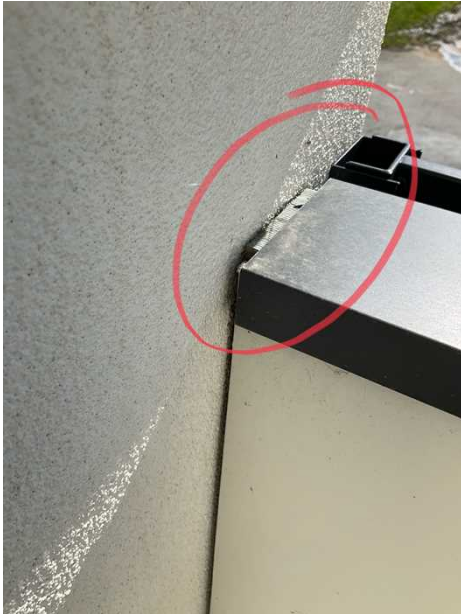
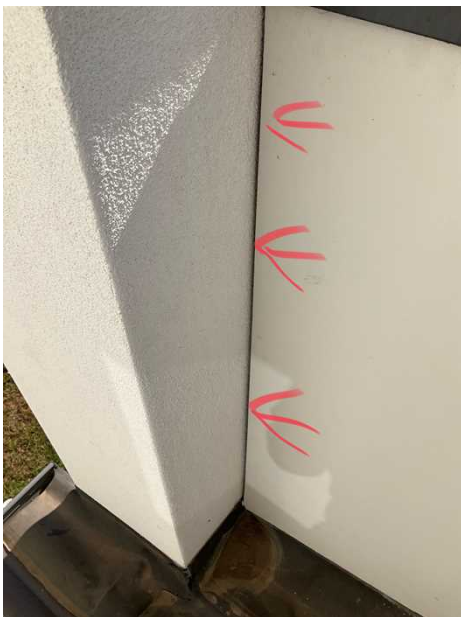
Location: Front parapet wall.

Details: Exposed open gaps. Timber frame is visible.

V) wall and step flashing must be fastened into masonry walls with galvanised or zinc/aluminium sheet metal wedges at each end of each length and at intermediate intervals of not more than 500mm and must overlap by not less than 75mm in the direction of flow.

Recommendation: Overflashing to be installed at capping and masonry junction to prevent water ingress into the wall framing and roof below.

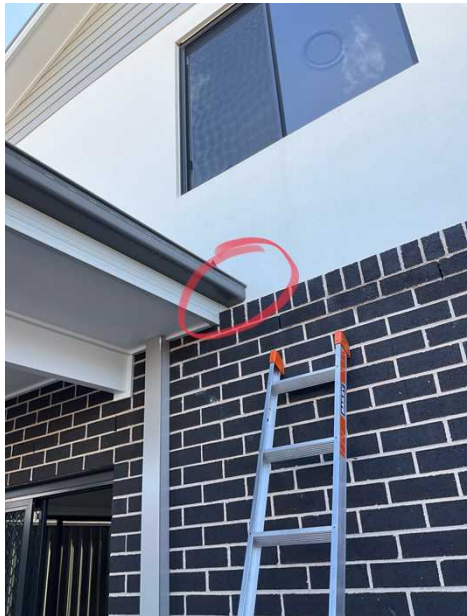
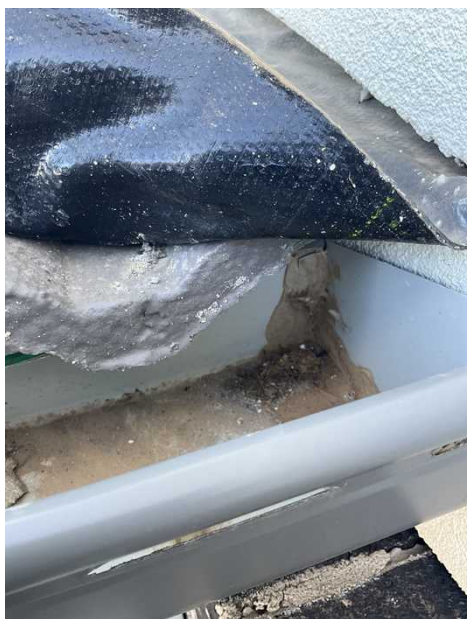
Location: Rear roof to alfresco.

Details: Missing gutter bracket at stop end.

Recommendation: Install additional gutter brackets.

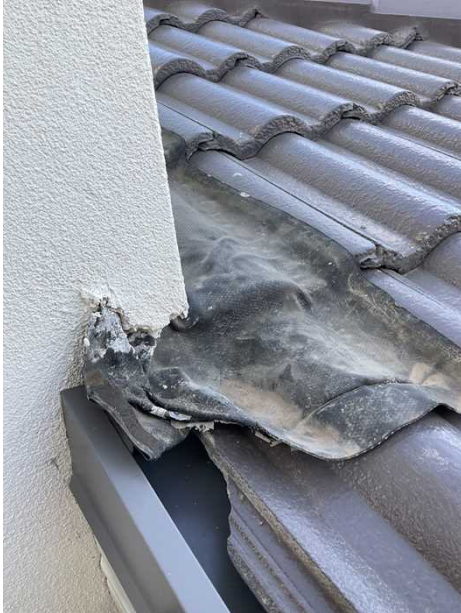
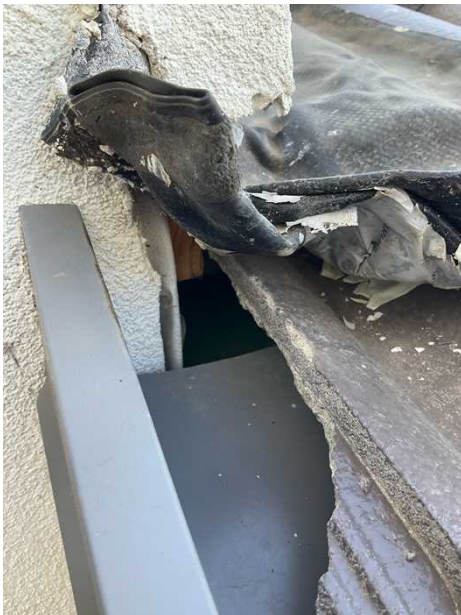
Location: Left rear lower roof tile and wall junction.

Details: Flashing is insufficient in this location.

A) follow the roof line allowing not less than 75mm upturn to the wall and a minimum of 150mm in width and moulded into the tiles and

C) have joints overlap the one below by not less than 75mm in the direction of flow.

Recommendation: Fix flashing junction.

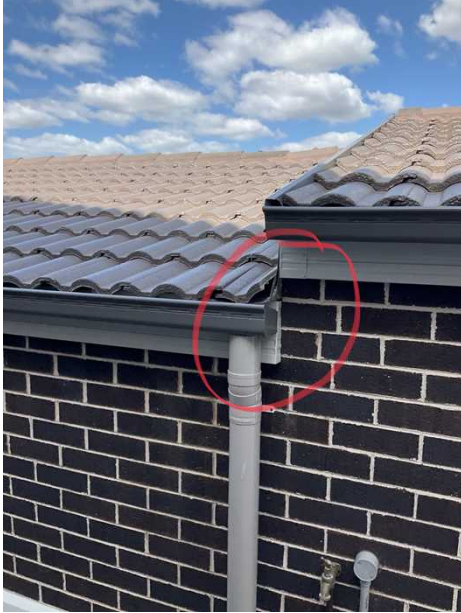
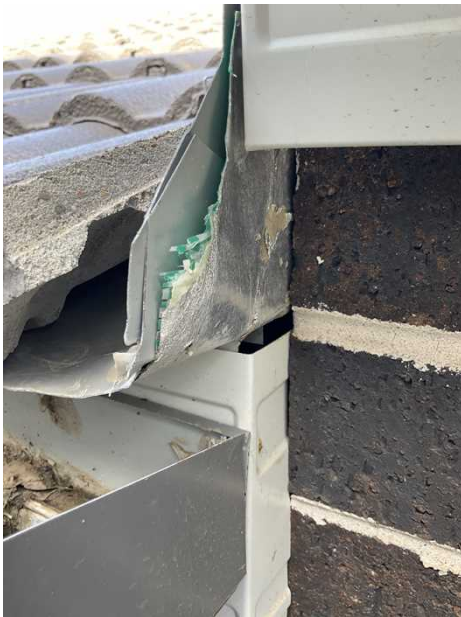
Location: Junction between both garages.

Details: Flashing requires attention to prevent water ingress. Open gaps. Visibly see framing below.

Recommendation: Builder to address flashing to ensure water seal and no water ingress.

Complying with flashing principles , overlapping and fixings etc.

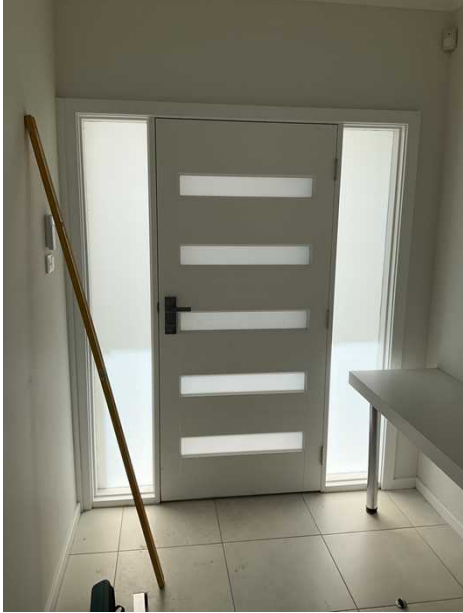
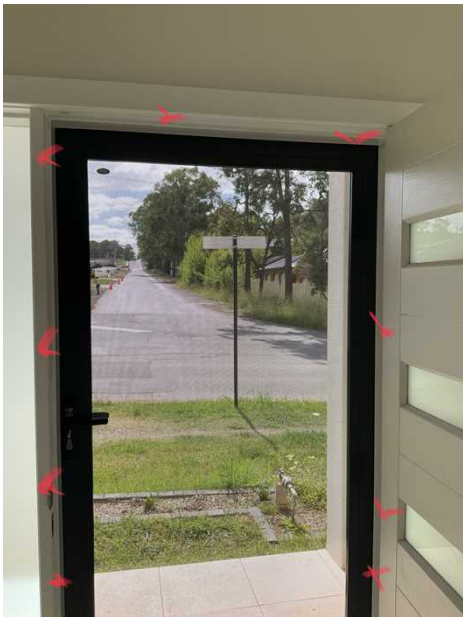
Location: Front door.

Details: Not sealed as per NCC requirements.

B) a seal to restrict air infiltration-

i) for the bottom edge of a door, must be a draft protection device and

ii) for the other edges of a door or the edges of an openable window or other such openings , may be a foam or rubber compressible strip, fibrous seal or the like.

Recommendation: Door to be sealed prior to hand over.

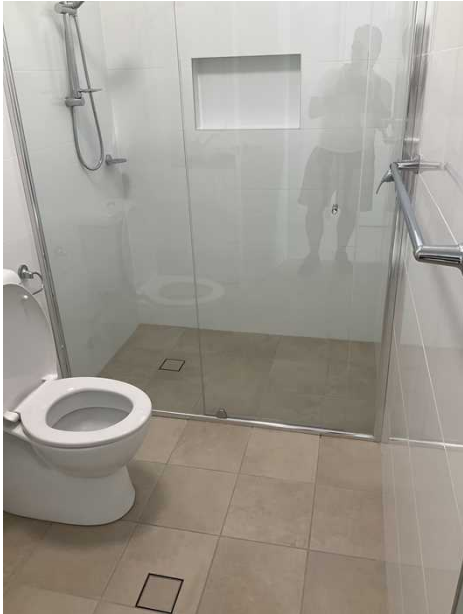
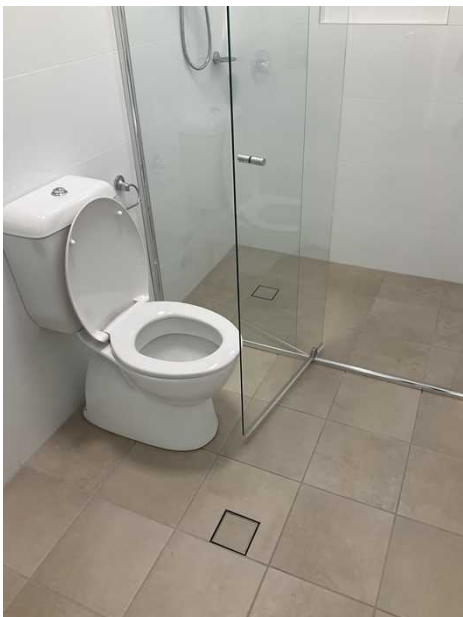
Location: Ground floor bathroom and laundry.

Details: Shower door requiring a door stop for safety reasons.

Recommendation: Builder to address door issue.

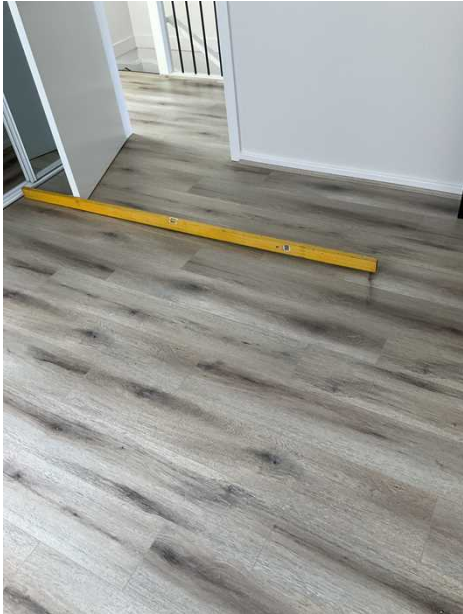
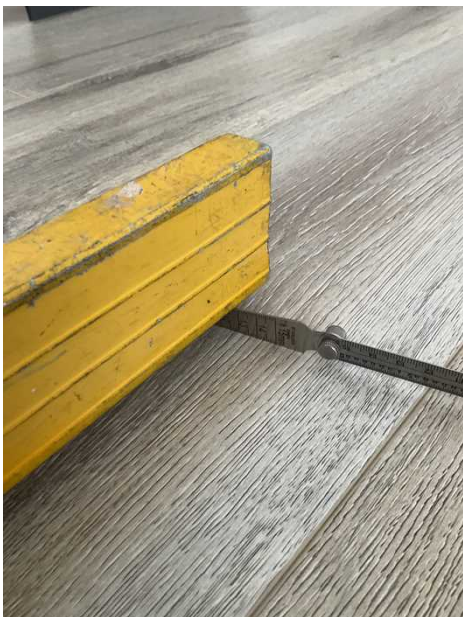
Location: Bedroom 2

Details: Floor is bulging.

The guides and tolerances provides a fair assessment and tolerance guidelines.

Recommendation: Builder to address issue and have repaired
Builder to repair within guide and tolerances guidelines.

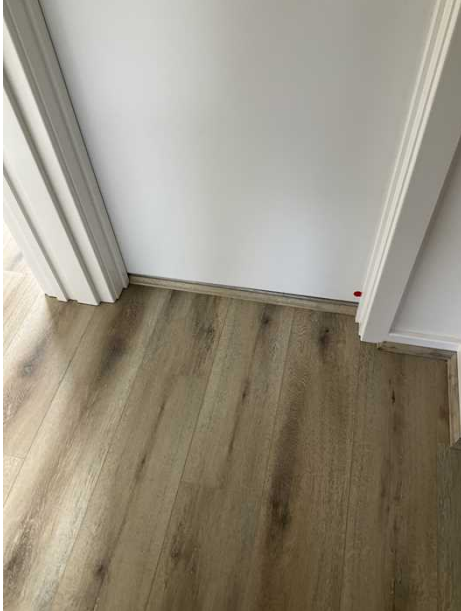
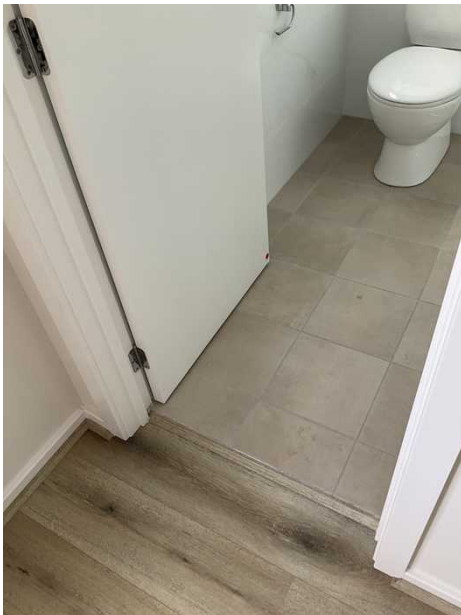
Location: Wet area doors.

Details: Underside of wet area doors have not been painted. They will swell from moisture damage over time.

Recommendation: Builder to paint underside of all wet area doors.

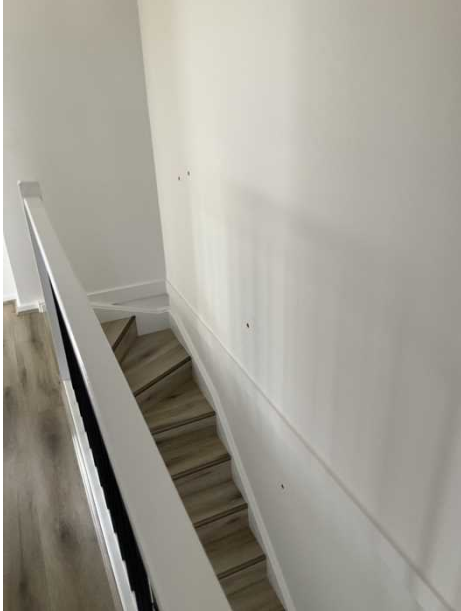
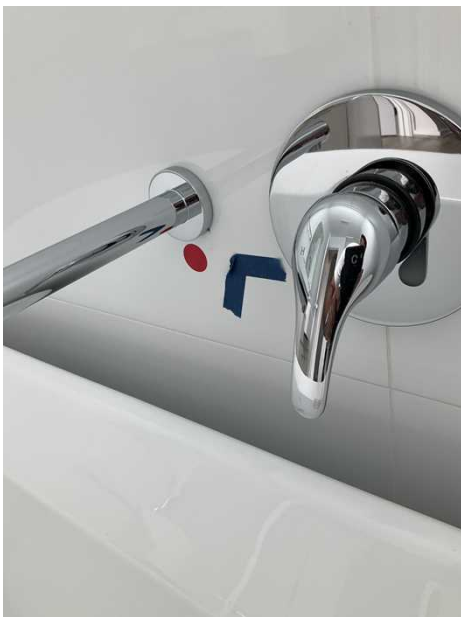
Location: Red stickers throughout the property indicate defects.

Few sample images added but not all cosmetic defects added to report.

Details: Defects are either cosmetic, paint and plasterboard joints and cleaning.

Recommendation: All red sticker defects should be attended to as per below for painting.

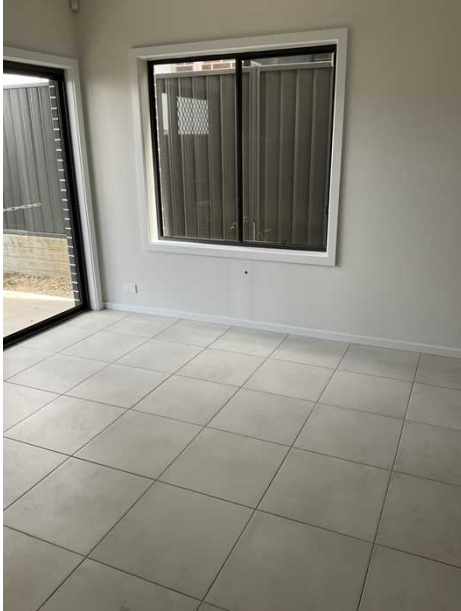
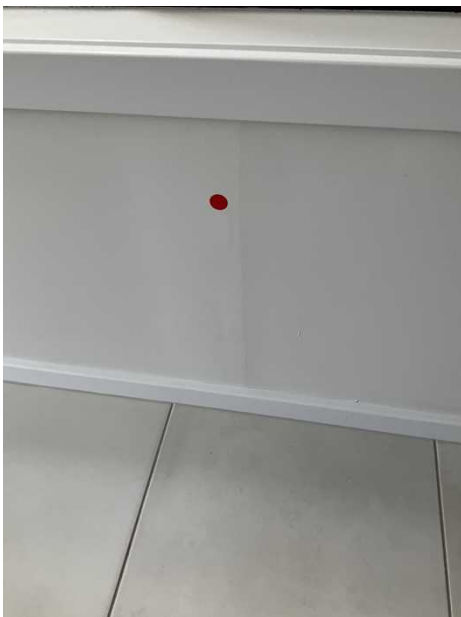
Location: Red sticker example of defects.

Details: Joint is very noticeable.

Should be repaired as per below.

Recommendation: Repair as required.

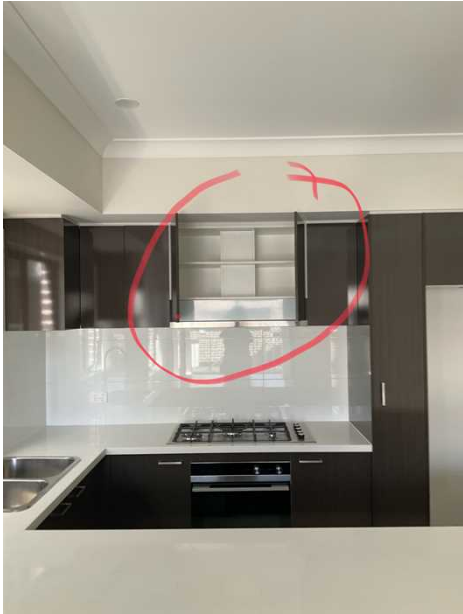
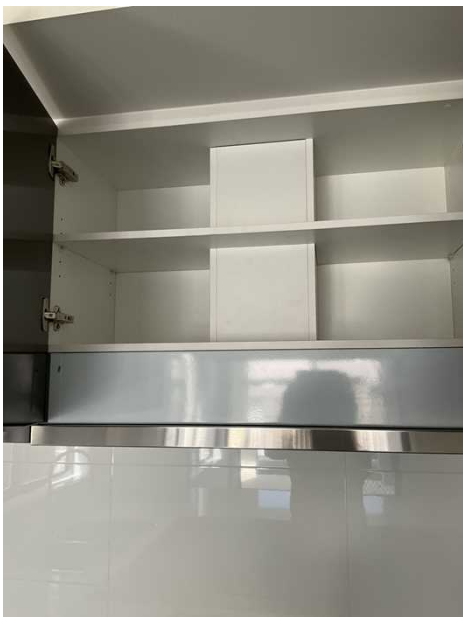
Location: Kitchen doors above range hood.

Details: No push catches. Was very difficult to open.

Recommendation: Push catches to be added.

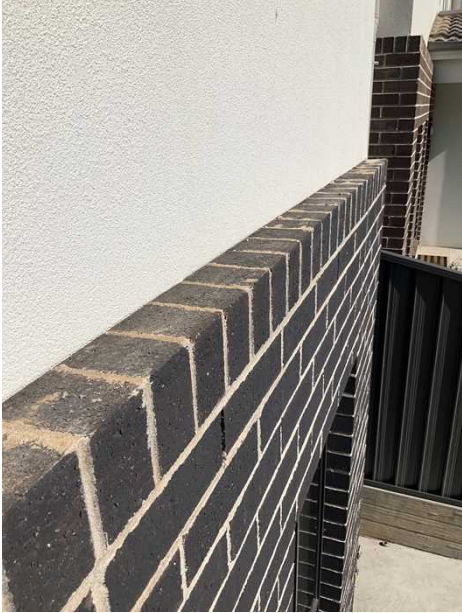
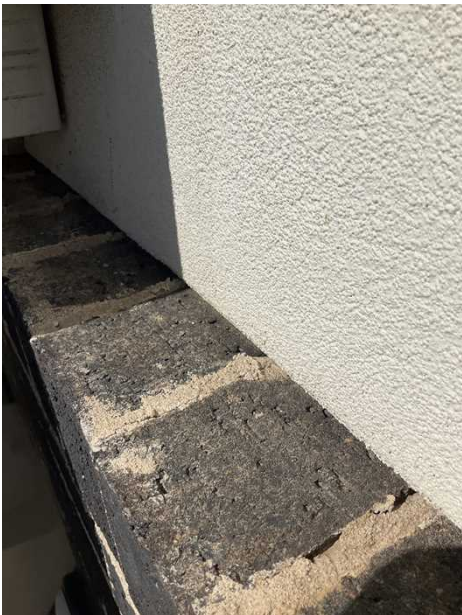
Location: Masonry at cladding and brick junction.

Details: Mortar stains.

Requires cleaning.

Recommendation: Builder to clean all bricks of paint and mortar stains to exterior surrounds.

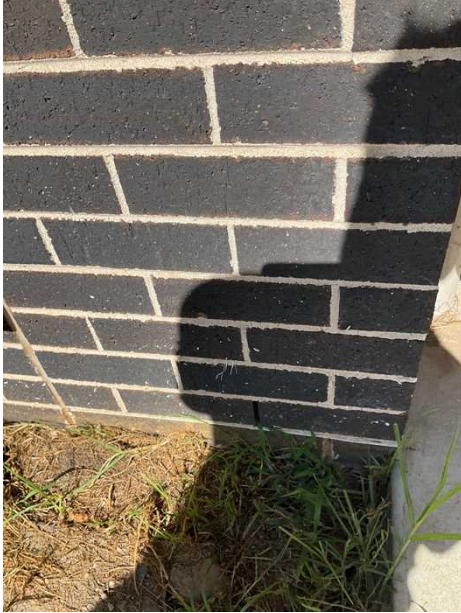
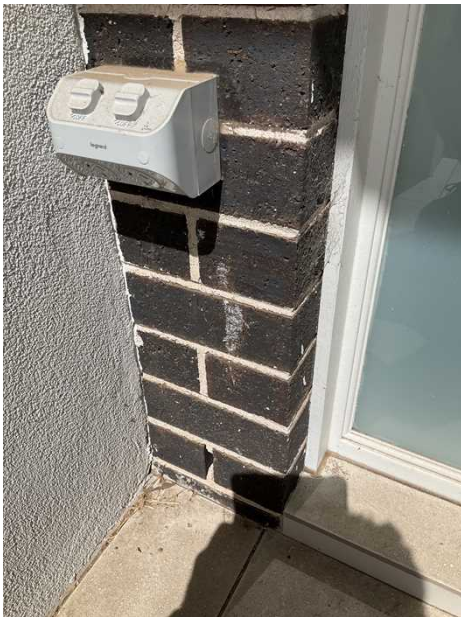
Location: Exterior surrounding.

Details: Example of typical staining to masonry surrounds.

Recommendation: All staining, wall and floor surfaces to be cleaned prior to hand over.
