## NEW CONSTRUCTION STAGE PROPERTY INSPECTION REPORT AS4349.0-2007

Type of Inspection Completed	Pre-lining Inspection
Have Architectural and/or Structural Engineering Plans been provided for this inspection:	Yes
<p>It is the responsibility of you (the client) to provide us (the inspector) with a full set of construction and engineering drawings for us to compare the construction drawings to what is being built on site.          Without these drawing we can Not comment on incorrect home and room dimensions, specified levels, engineer specifications and any relevant Australian Standards that has been referenced for the project.</p>	
Prevailing weather conditions at the time of inspection:	Dry
In respect of significant items:	
Was there any MAJOR DEFECTS evident from this inspection?	Yes
Was there any MINOR DEFECTS evident from this inspection?	Yes

New Construction Stage Inspection Report.

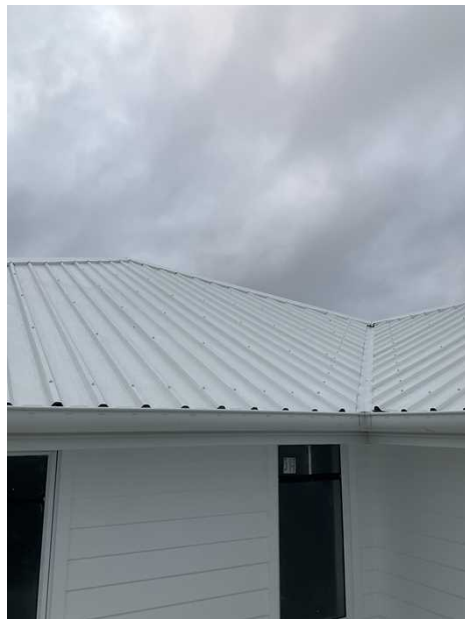
+ Example of roof covering

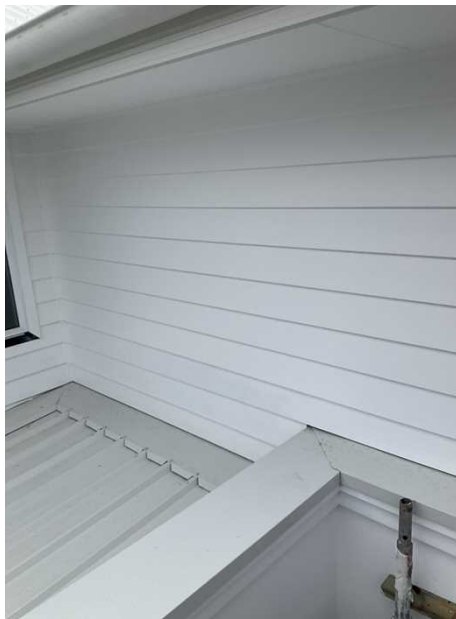
+ Example of cladding

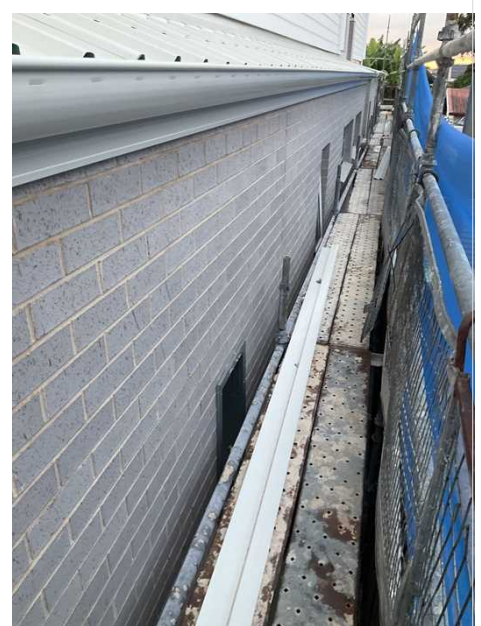
Showing example of Brickwork completed

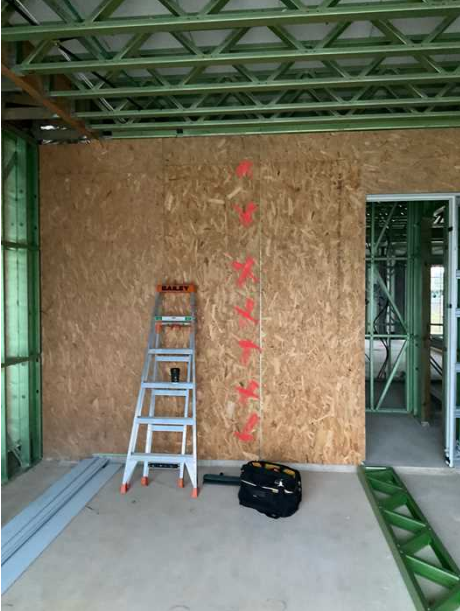
**Location:** Garage panel bracing.

**Details:** Panel bracing , panel 2 not fixed into position.

One side is missing fixings.

**Recommendation:** Fixings required at minimum 150mm spacings to edges of boards.

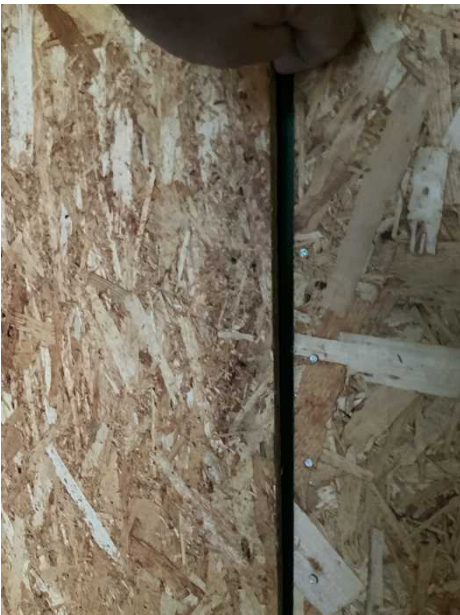
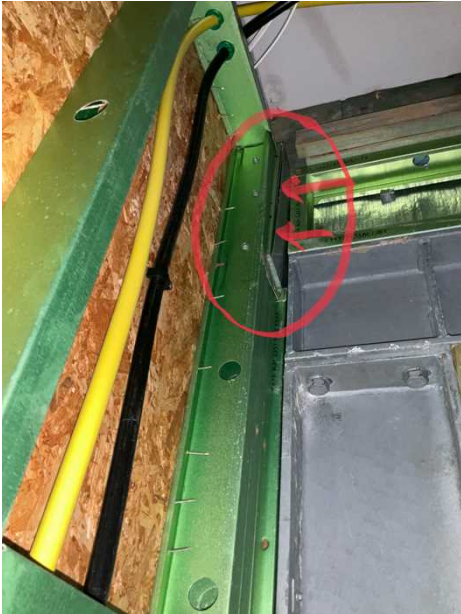
**Location:** Family room

**Details:** The family room far corner adjoining the alfresco.

This will cause plasterboard to be pushed out and be out of plumb.

**Recommendation:** Alfresco beam to be adjusted by at least 10mm further out.

This will allow sheeting to be fixed straight and plumb.

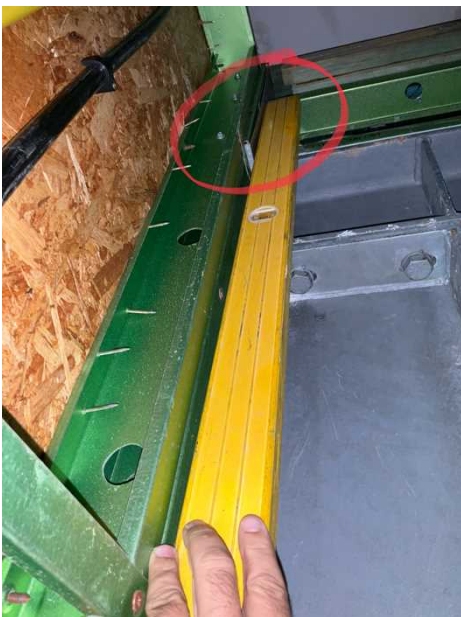
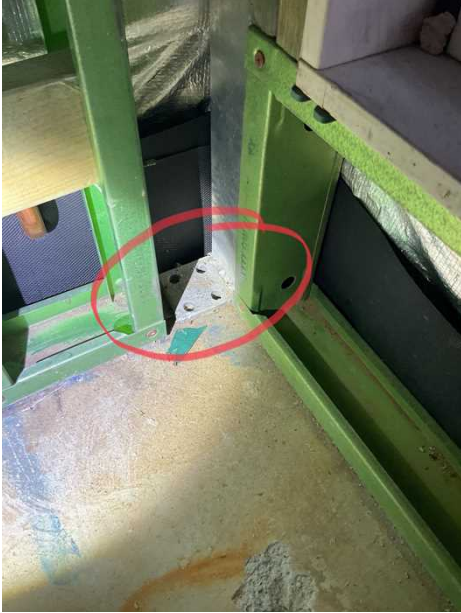
**Location:** Guest room ground floor.

**Details:** Structural post is missing tie down bolts.

As per engineers it requires 2 m12 bolts with 75mm embedment.

**Recommendation:** Builder to address prior to lining.

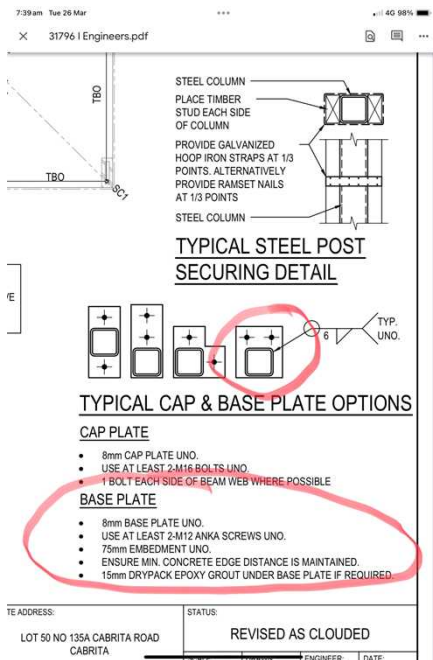
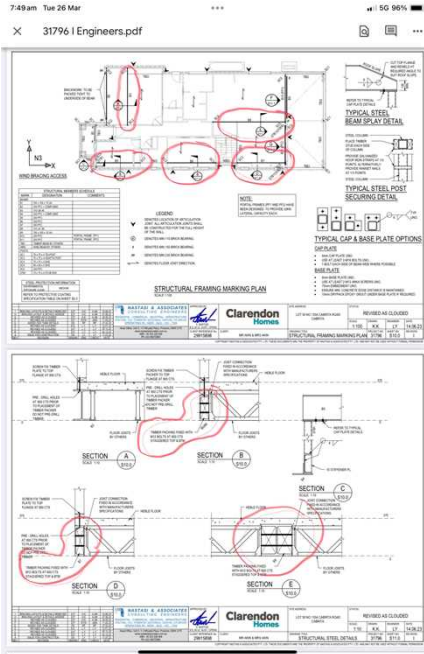
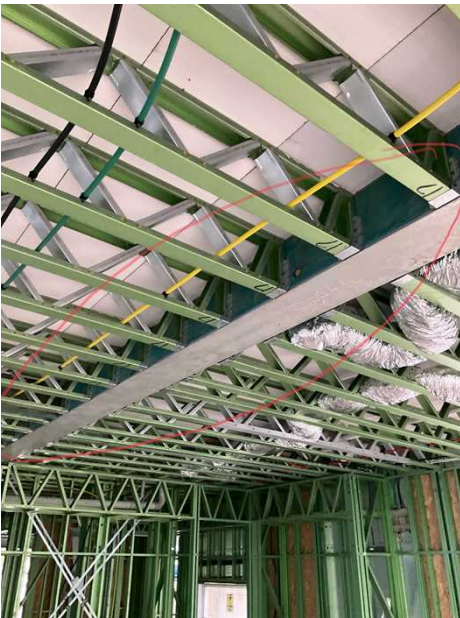
**Location:** Timber packers to structural beams to ground floor.  
Marked on architectural in red for locations.

**Details:** Timber infills/packers are required to have m12 bolts at 600mm centres staggered top and bottom throughout all beams, as detailed in the engineers drawings.

**Recommendation:** This bolts must all be installed prior to any sheeting.

Evidence of each beam and fixings to be provided.

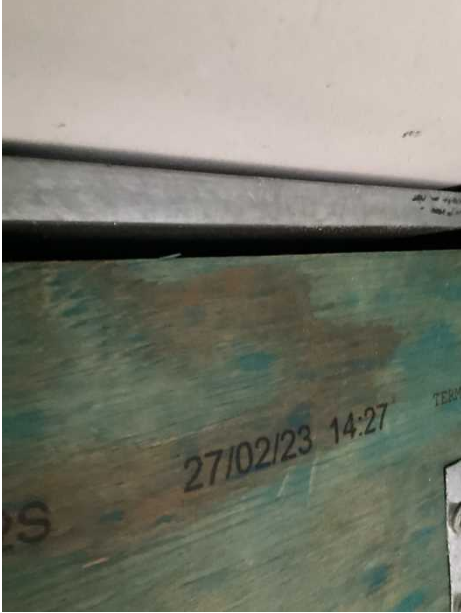
**Location:** Top frame tie down to lower structural beams.

**Details:** Refer to engineering detail.

On inspection there is no fixings which fix into the steel member.

**Recommendation:** Pre-drill holes and add screw fixings at 900mm centres as per engineers design.

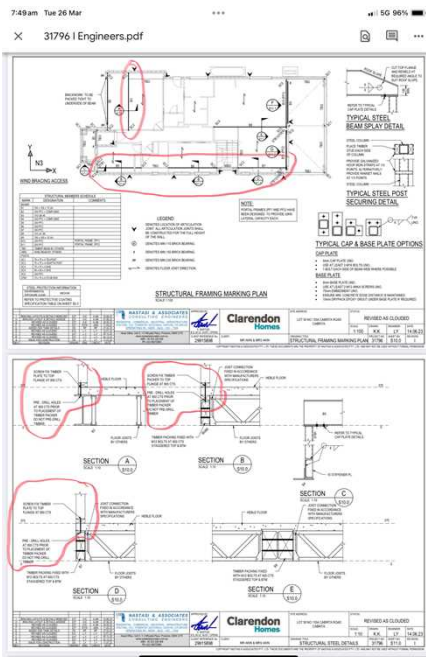
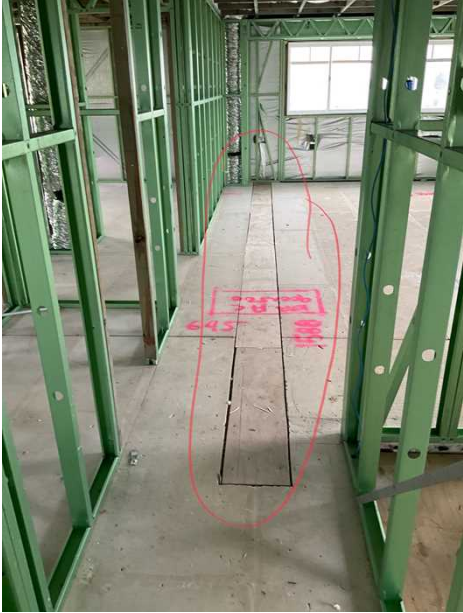
**Location:** First floor flooring.

**Details:** Timber infill used for flooring above beam b8.

The Hebel can be easily sanded, plained back.

**Recommendation:** Remove timber infill and install Hebel as per design.

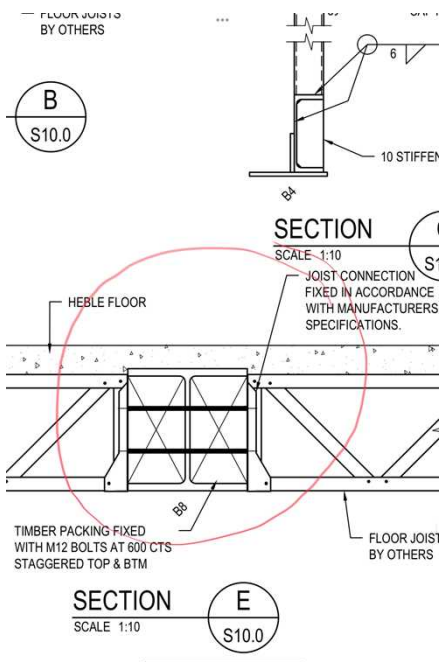
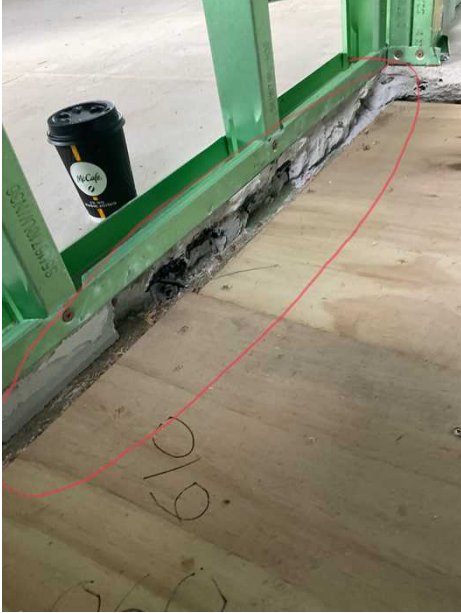
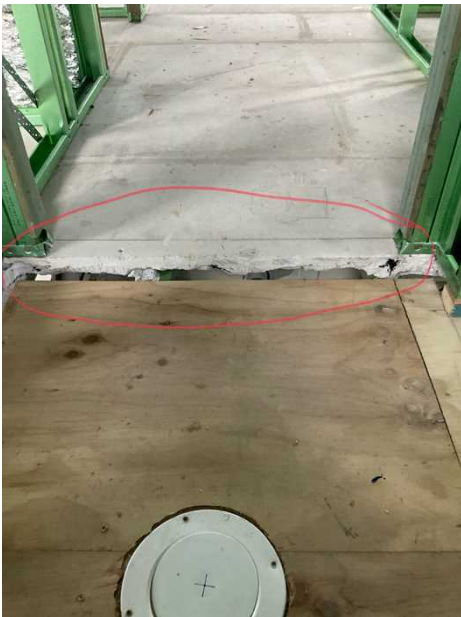
**Location:** WC first floor.

**Details:** Hebel has been poorly cut and has minimal bearing on joist.

**Recommendation:** We are not engineers but have concerns.

We would like confirmation from the acting site engineers that the Hebel in this location is structurally sound. If not the engineer should detail required repairs.

Written response from engineers should be supplied to the client.

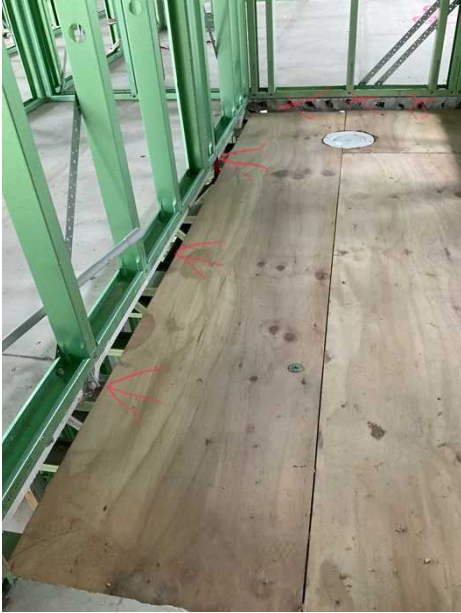
**Location:** Main bathroom

**Details:** Bottom plate has hardly any support.  
70mm plate with 35mm support.

**Recommendation:** Engineer to respond with advice to client.

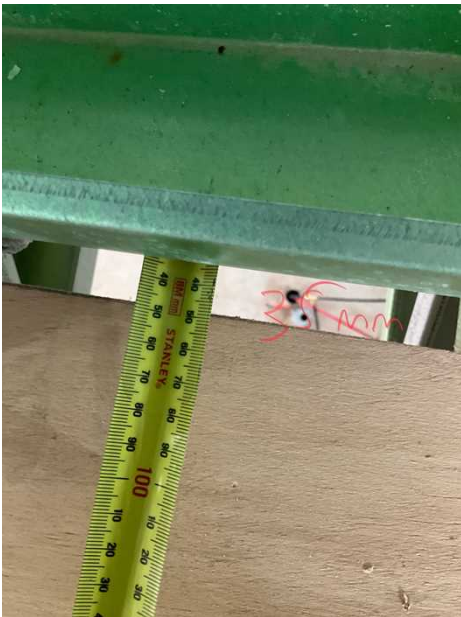
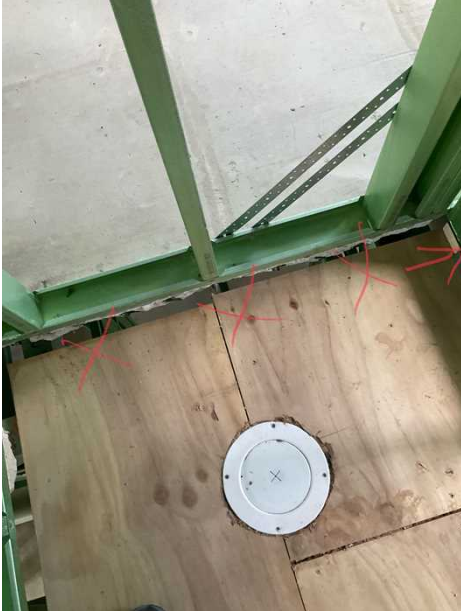
**Location:** Main bathroom on first floor.

**Details:** Flooring on bathtub side has no support.

Requires trimmers throughout to support bathroom floor and bedroom 3 wall which also has no support under the Hebel.

**Recommendation:** Engineer to detail rectification and sign off on repairs.

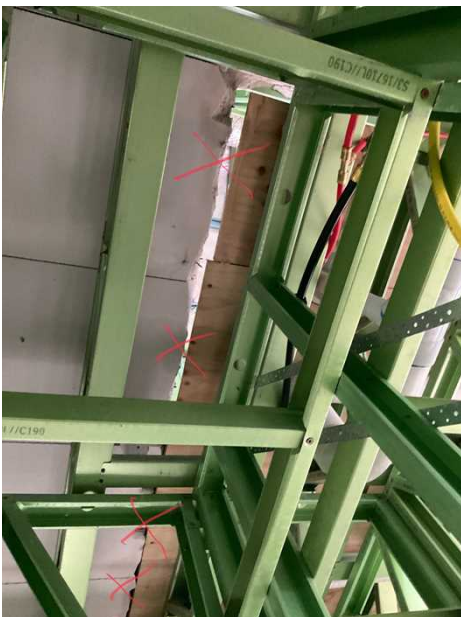
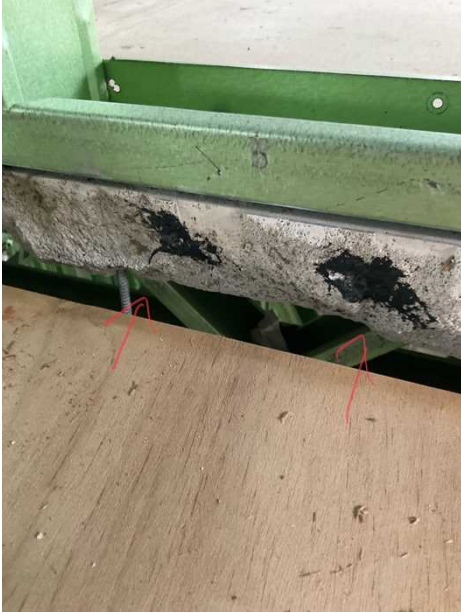
**Location:** Bed 3 and bathroom

**Details:** Example of no support under bedroom 3 flooring and wall.

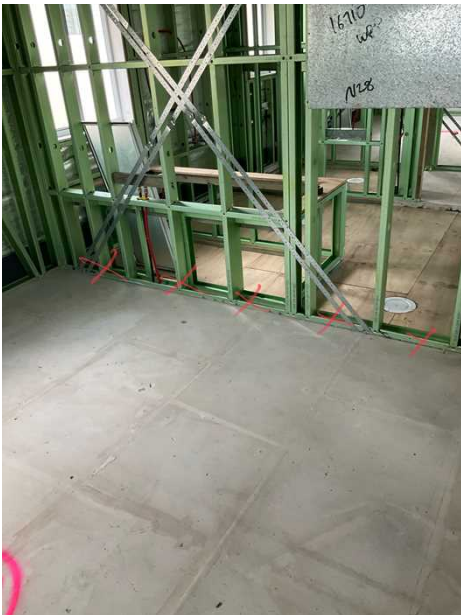
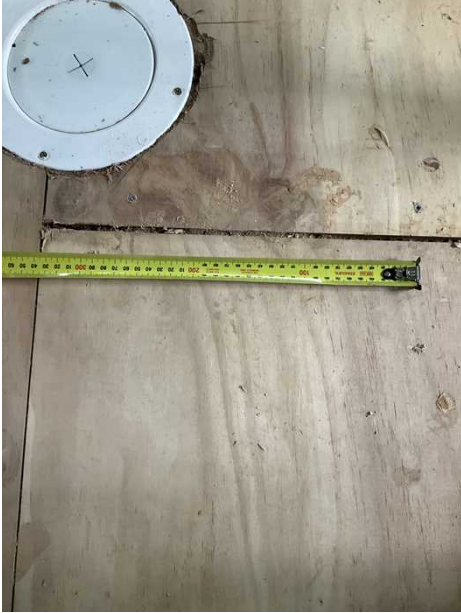
**Location:** Flooring to bathrooms, ensuite.

**Details:** Plywood requires fixings as would particle board flooring.

Refer plywood engineer detail for flooring installation

**Recommendation:** All plywood flooring to have fixings added.

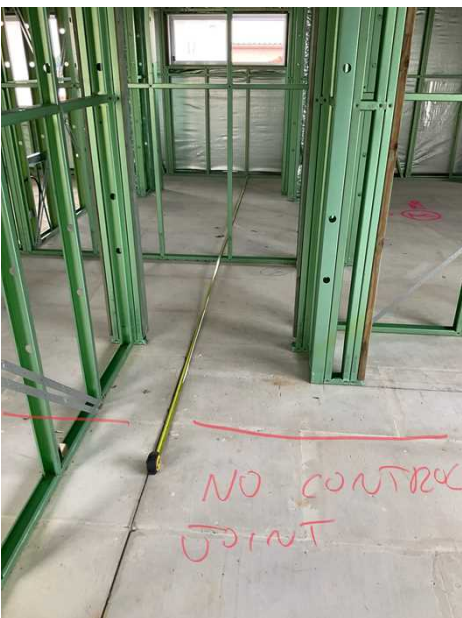
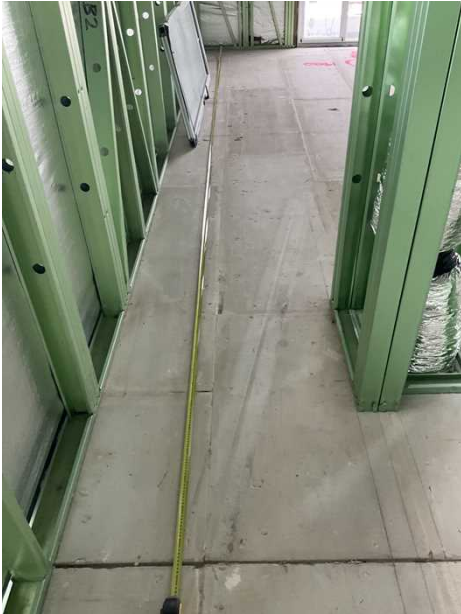
**Location:** Hebel flooring.

**Details:** Expansion joint to its lengths is past the 6m recommendation.

This may be ok but does require engineer sign off.

**Recommendation:** Builder to provide engineer sign off or complete required repairs.

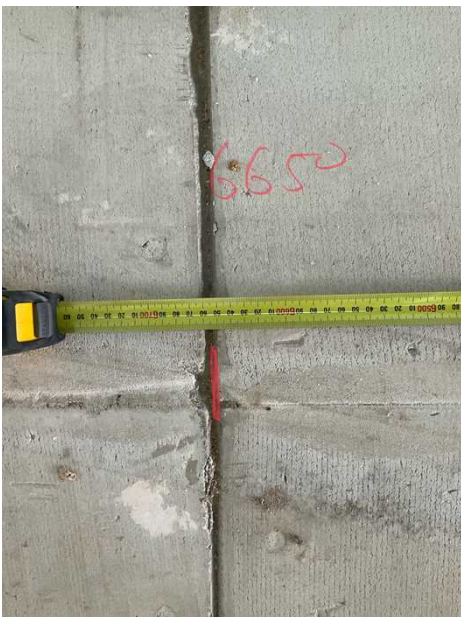
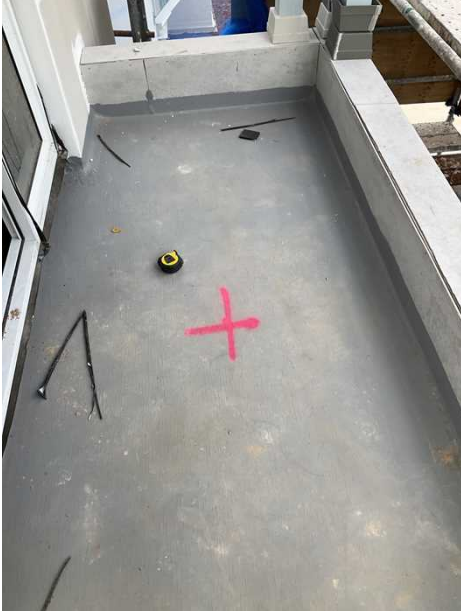
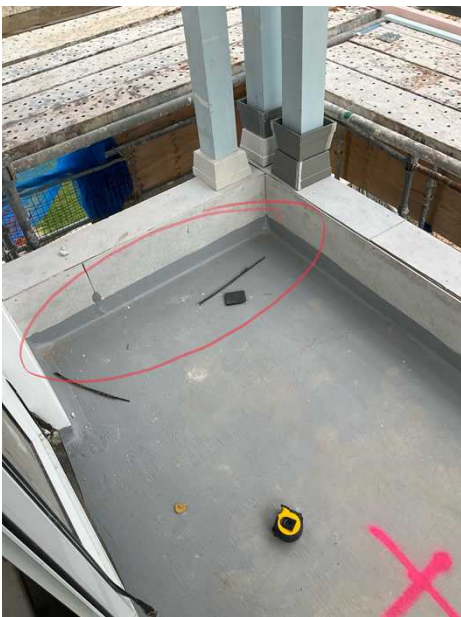
**Location:** Balcony

**Details:** No floor waste installed. Is detailed in drawings and is a legal requirement. It does seem to be likely to be installed from the markings.

Surface water drainage systems shall be designed to provide protection against potential losses caused by any overflows including damage to buildings and their contents and injury and nuisance to persons.

**Recommendation:** Install drainage and over flow must comply with AS3500.3-2021

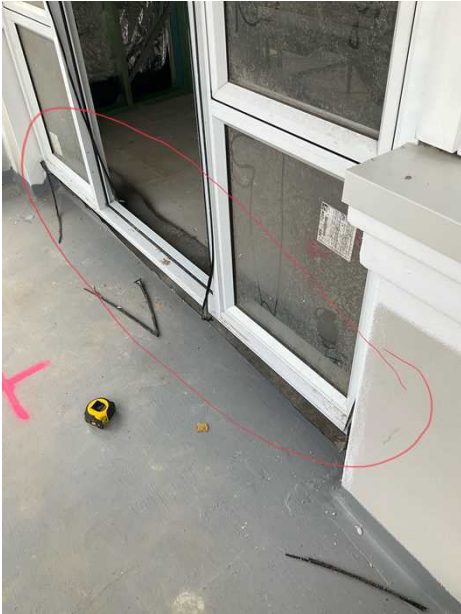
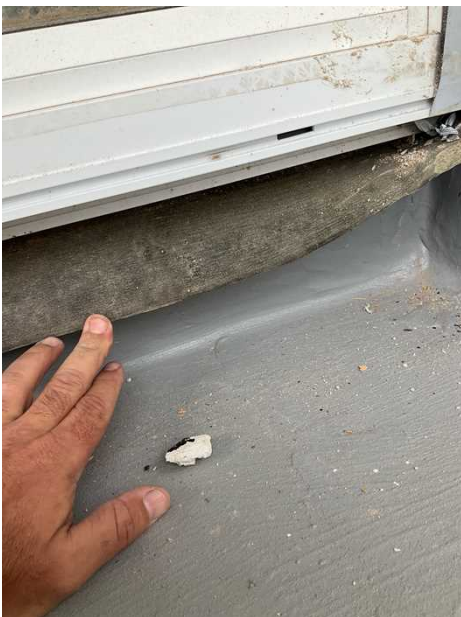
**Location:** Balcony door, window.

**Details:** The detail completed onsite will be difficult to make compliant with External waterproofing AS4654.2-2012

**Recommendation:** Clause 2.8.3 Doors and windows onto external waterproof areas.

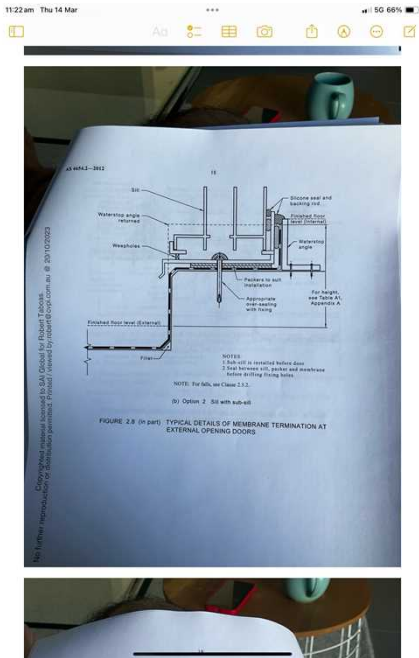
**Location:** Balcony.

**Details:** Example of waterproofing details from External waterproofing AS4654.2-2012

**Recommendation:** Builder to provide further information on design and finish to door and balcony junction.

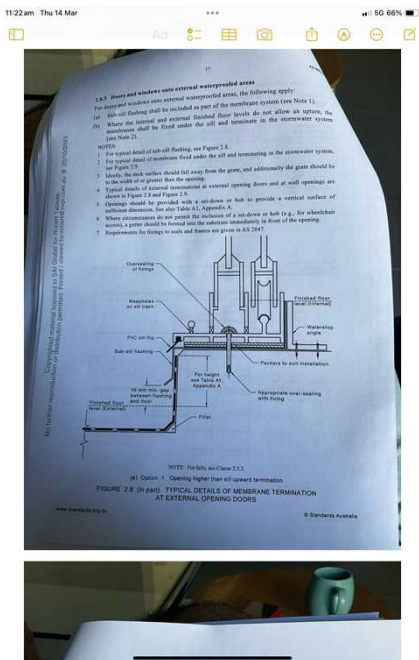
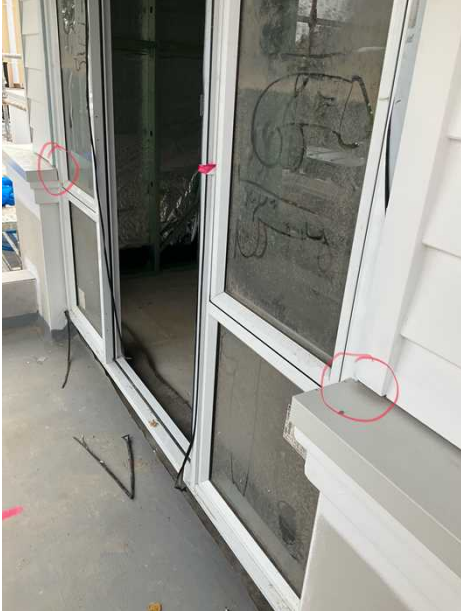
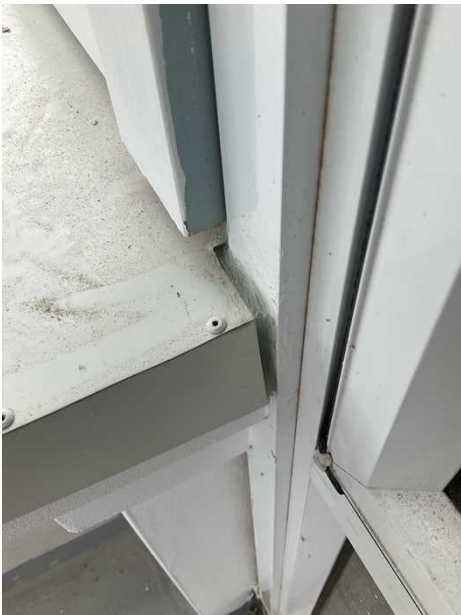
**Location:** Balcony cladding and flashing detail.

**Details:** Flashing junction poorly finished with silicon.

I understand this is a difficult junction but perhaps engage a professional joint sealer to seal with sikaflex or similar rather than blobs of silicon.

**Recommendation:** Builder to address junction prior to completion of job.

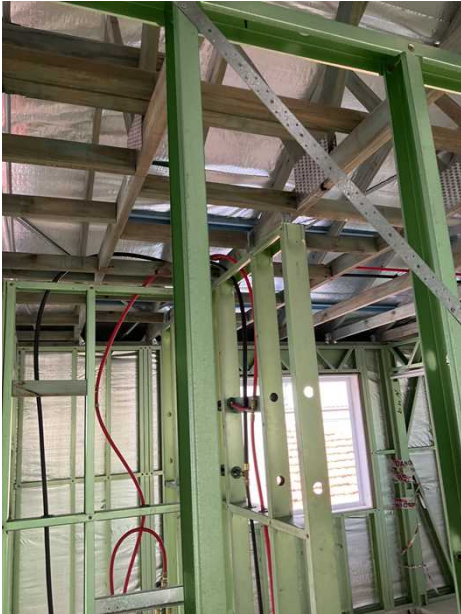
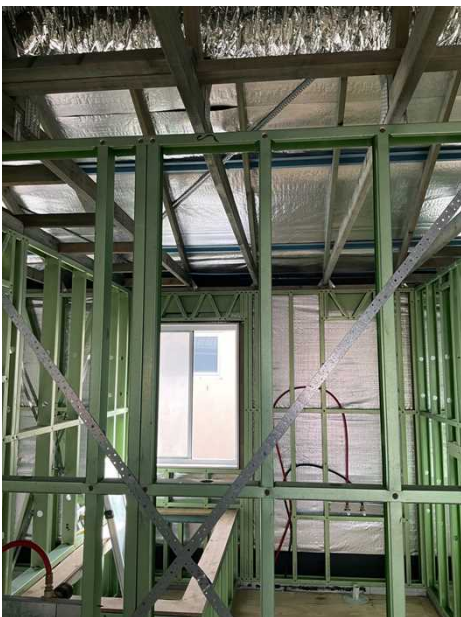
**Location:** All bathrooms, ensuite, WCs

**Details:** Ensure all mechanical exhaust is roughed in and ducted to outside air.

**Recommendation:** 10.8.2 of NCC 2022 Exhaust systems.

- 1) An exhaust system installed in a kitchen, bathroom, sanitary compartment or laundry must have a minimum flow rate of
  - i) 25L/s for a bathroom or sanitary compartment and
  - ii) 40L/s for a kitchen or Laundry
- 2) Exhaust from a kitchen, kitchen range hood, bathroom, sanitary compartment, or laundry must be discharged directly or via a shaft or duct to outdoor air .
- (3) where a venting clothes dryer is installed it must discharge directly or via a shaft or duct to outdoor air

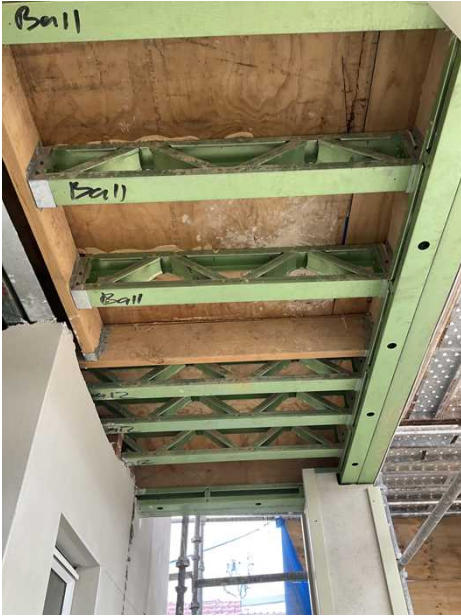
**Location:** Balcony

**Details:** No stormwater drain roughed in.

**Recommendation:** Builder to address this prior to sheeting.

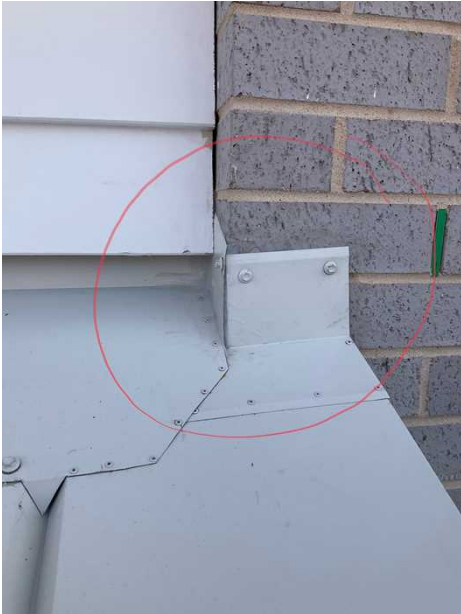
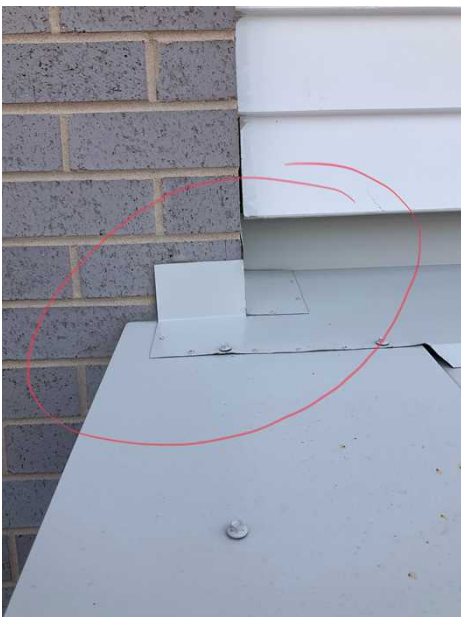
**Location:** Roof outside dining room.

**Details:** The overflashing needs to be re-completed.

**Recommendation:** Re-complete this area

This area needs to be detailed and encourage Clarendon to check all flashing and cladding junctions.

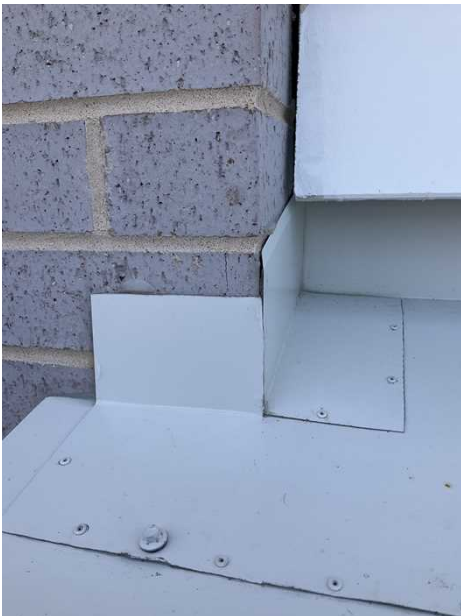
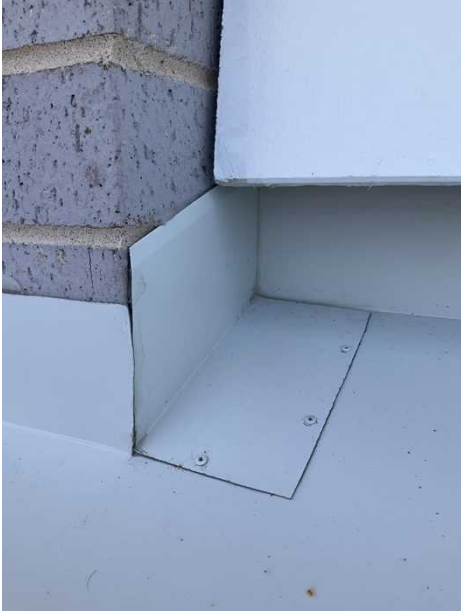
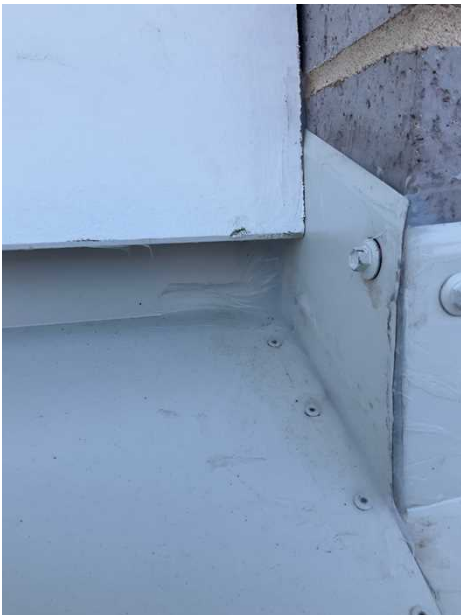
**Location:** As per previous location.

**Details:** Flashing must be lapped 75mm.

IV) joints in flashings and cappings must be not less than 75mm, lapped in the direction of the fall of the roof, and fastened at intervals not more than 40mm.

**Recommendation:** Flashings to be recompleted.

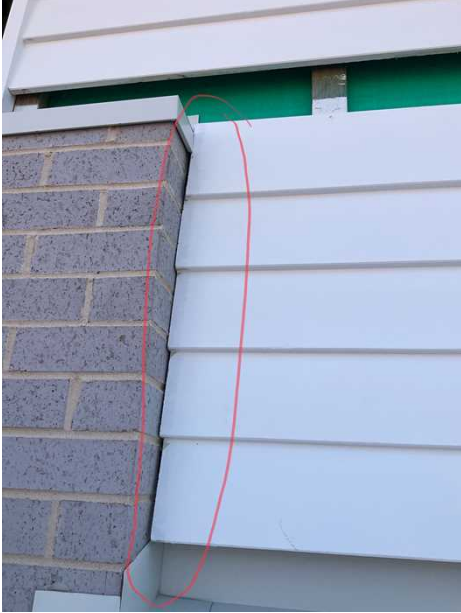
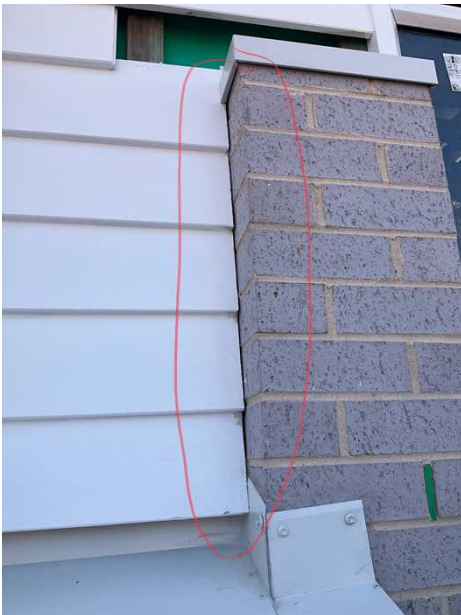
**Location:** As per previous, same location.

**Details:** Recommend Clarendon check with cladding manufacturer on cladding and brick junction requirements.

Sikaflex joint may be suitable.

**Recommendation:** Clarendon to review flashing in this location.

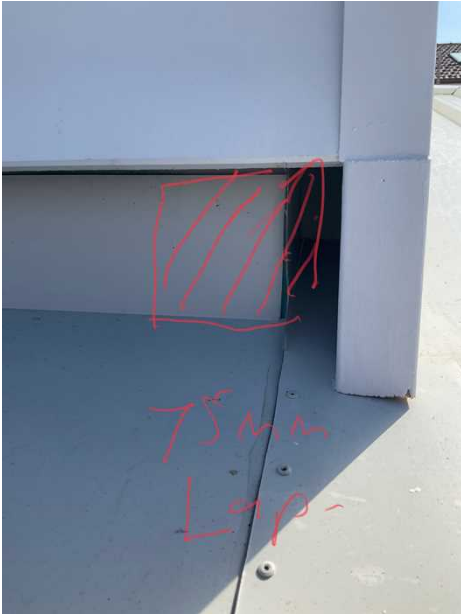
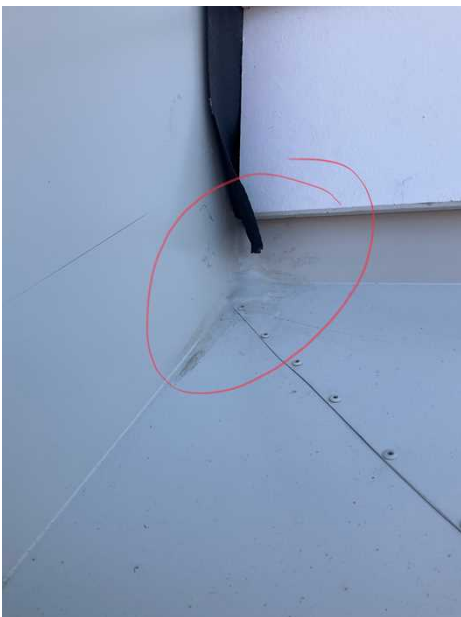
**Location:** Exterior roof junction at guest and dining room exteriors,

**Details:** Examples of flashing not lapped 75mm and but jointed, sealed with silicon.

**Recommendation:** Builder to review all flashings completed onsite.

The roof flashing work completed is not the usual Clarendon quality.

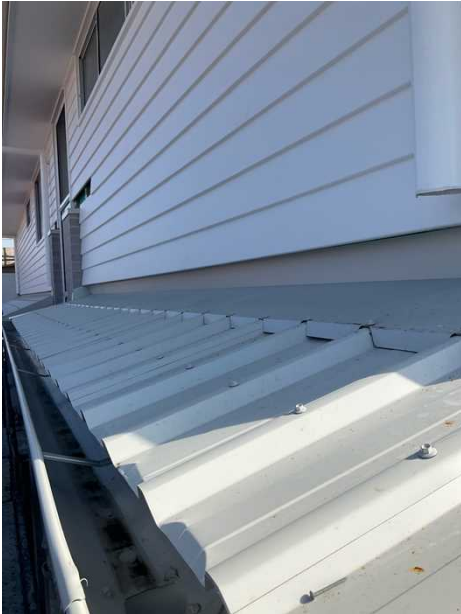
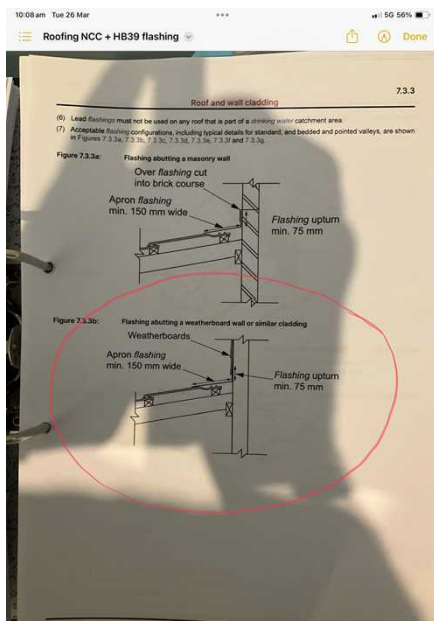
**Location:** Flashing and wall cladding detail to perimeters of building.

**Details:** Flashing does not upturn 75mm behind cladding.

Will require atleast one more board installed.

There is no battens installed to complete the addition boards without puncturing the installed flashing?

Clause 7.3.3 details requirements. Image attached.

**Recommendation:** Cladding and flashing detail requires attention to be water tight and comply with the 2022 NCC requirements.

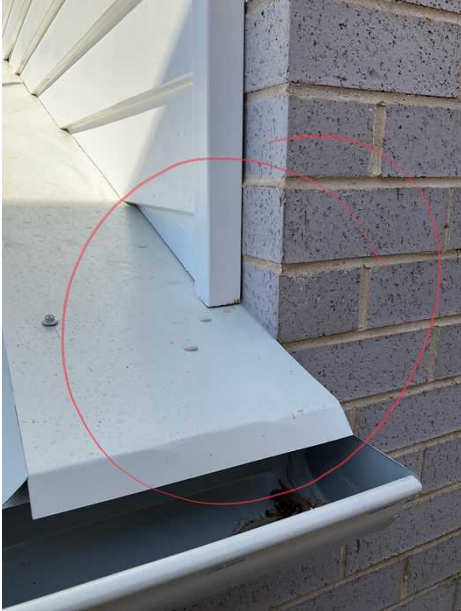
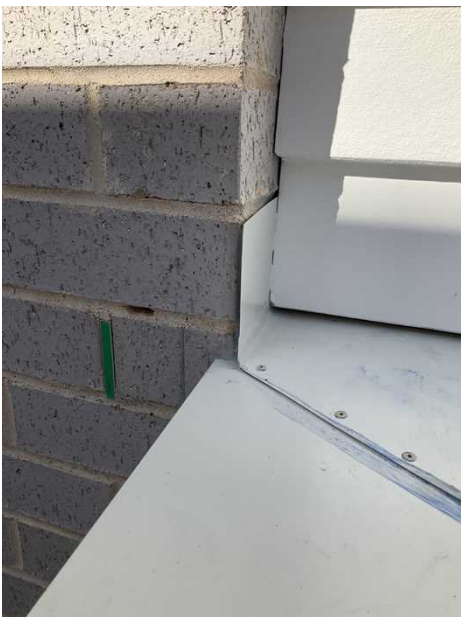
**Location:** Alfresco and garage roof junction to brick work.

**Details:** Further examples of non compliant work.

**Recommendation:** As per previous builder to address all flashing work for compliance and QA

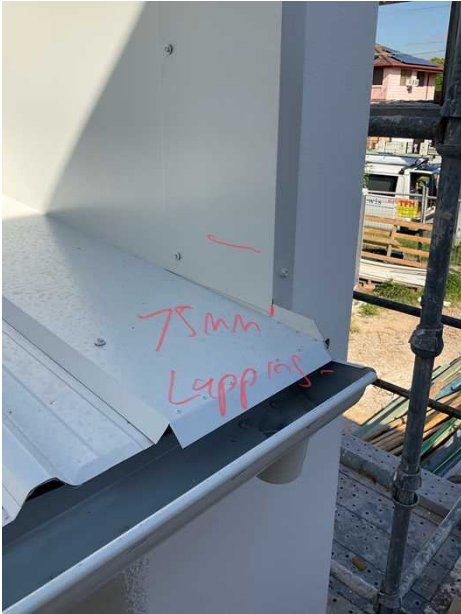
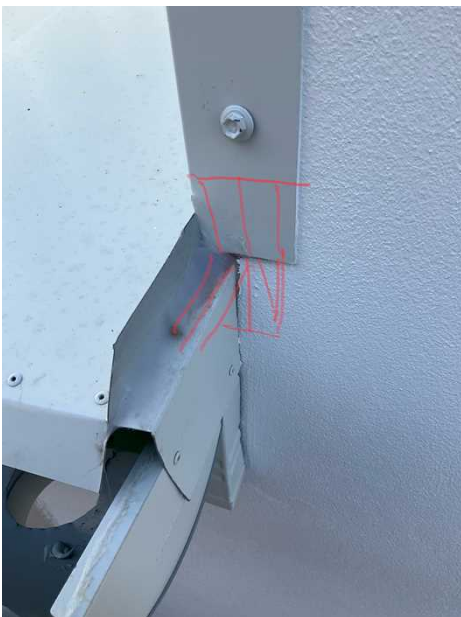
**Location:** Front garage parapet flashing.

**Details:** Non compliant and poorly completed.

Why doesn't apron flashing turn and be under the wall flashing instead of the bulk silicon detail finished?

**Recommendation:** As per previous allot of. The flashing/junctions need replacement and repairs.

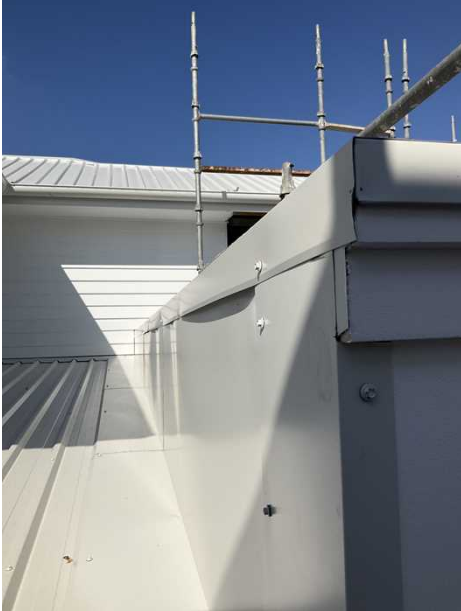
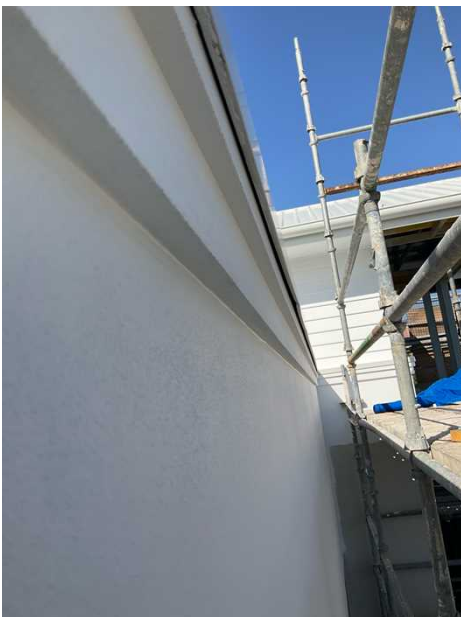
**Location:** Capping flashing at garage.

**Details:** Parapet capping have insufficient fixings. 500mm spacings max.

**Recommendation:** Builder to make suitable repairs as to comply with NCC and replace any damaged flashing.
