# NEW CONSTRUCTION STAGE PROPERTY INSPECTION REPORT AS4349.0-2007

Type of Inspection Completed	Frame Inspection
Have Architectural and/or Structural Engineering Plans been provided for this inspection:	Yes
It is the responsibility of you (the client) to provide us (the inspector) with a full set of construction and engineering drawings for us to compare the construction drawings to what is being built on site. Without these drawing we can Not comment on incorrect home and room dimensions, specified levels, engineer specifications and any relevant Australian Standards that has been referenced for the project.	
Prevailing weather conditions at the time of inspection:	Dry
In respect of significant items:	
Was there any MAJOR DEFECTS evident from this inspection?	Yes
Was there any MINOR DEFECTS evident from this inspection?	Yes

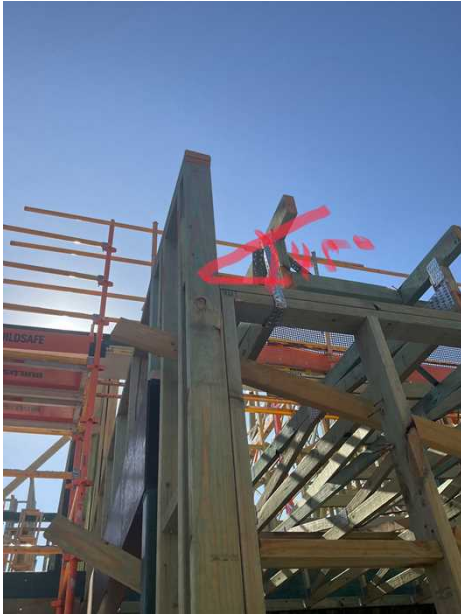
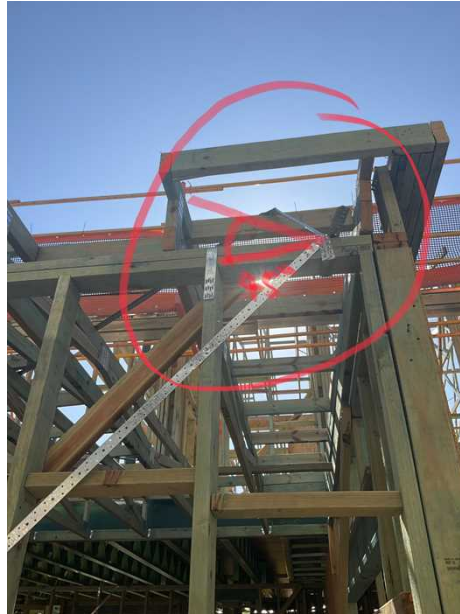
**Location:** Garage roof bracing and external garage wall.

**Details:** Brace from top plate and truss should be 45 degrees.

Insufficient tie down fixings to bracing.

**Recommendation:** As per roof bracing installation manual, the brace requires fixing with 2 nails to the side face and 3 nails to underside of top plate.

Due to the roof design I believe the 45 degree angle would be hard to achieve. Need to attempt to achieve as close as possible.

Cut speed brace to finish flush with the inside plate not return up the wall internally.

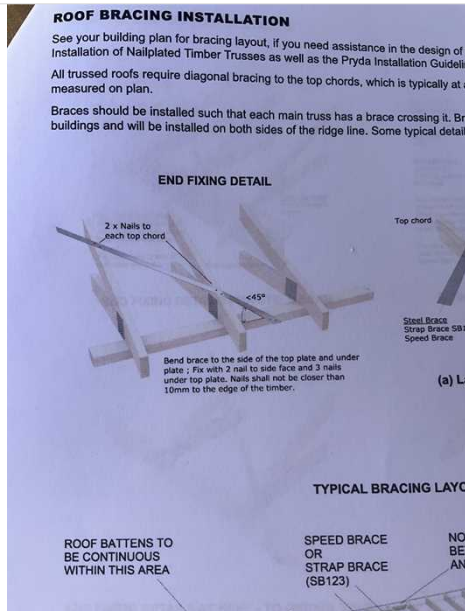
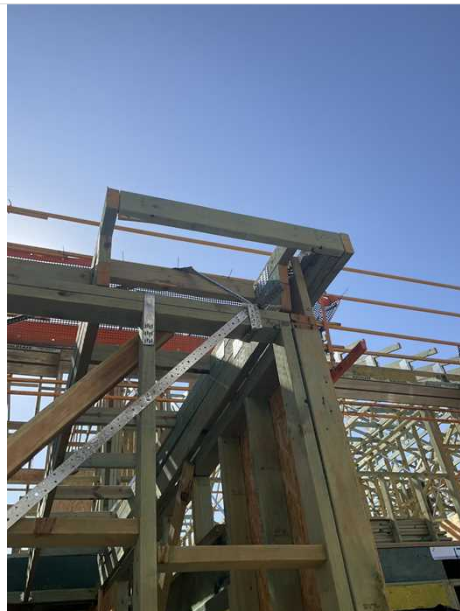
**Location:** Garage roof and wall junction

**Details:** Example of installation manual and what's onsite.

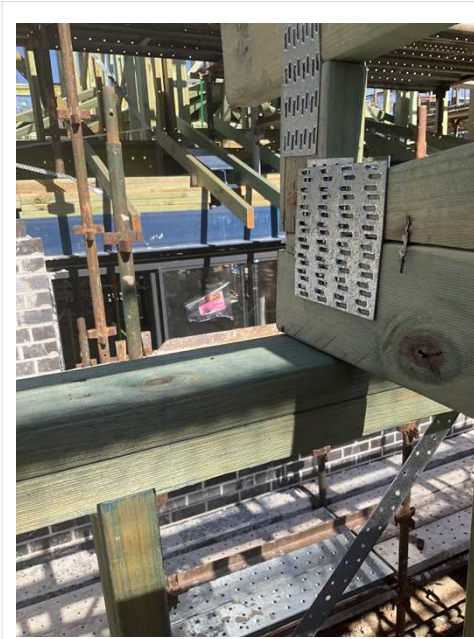
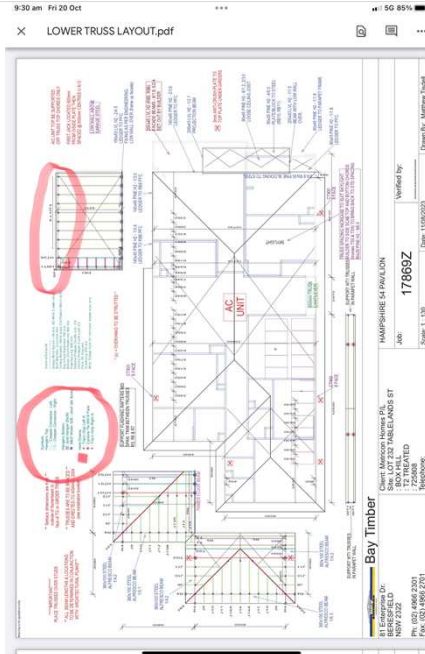
**Location:** Roof truss installation to garage.

**Details:** No triple L grips installed. All trusses skewed nailed.

This is not a conventional roof construction. Requires triple L grips tie downs as part of design.

**Recommendation:** Install triple L grips as per roofing design.

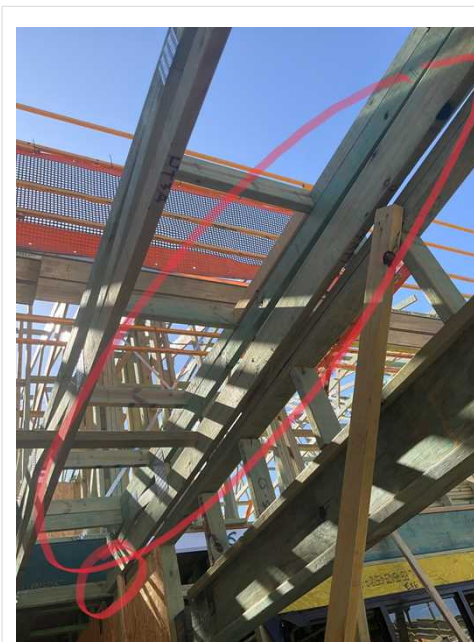
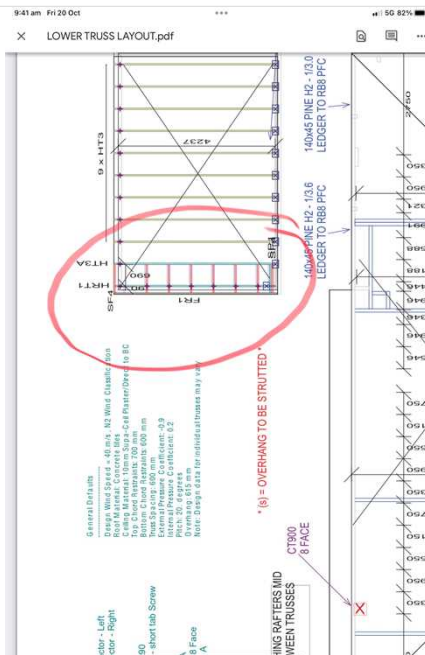
**Location:** Garage roof

**Details:** Rear detail not completed as per design.

Missing triple L grips and joist hanger as per design.

**Recommendation:** Finish roof as per design. Any changes need to be signed of by bay timber in writing.

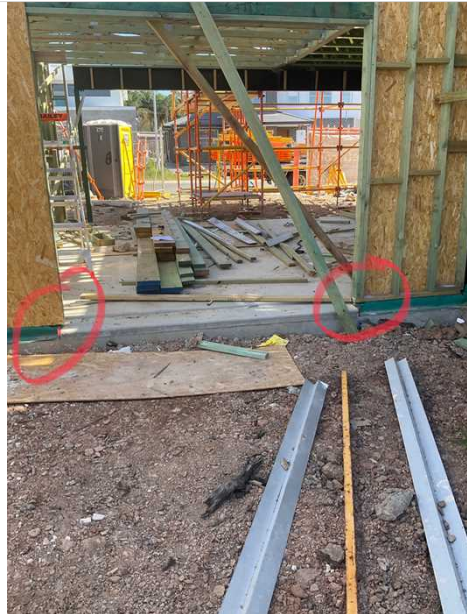
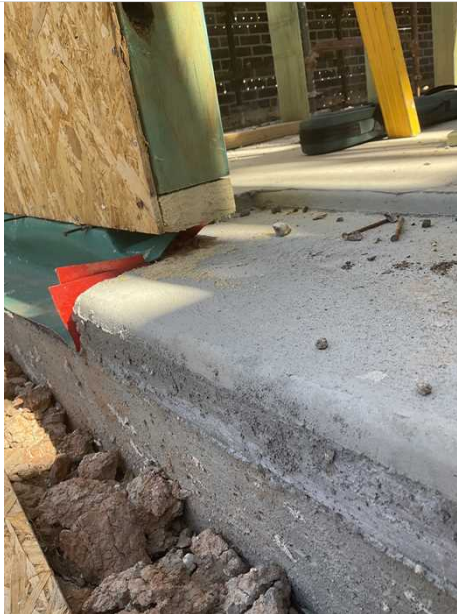
**Location:** Garage rear wall.

**Details:** No support to underside of frames. These wall carry load and must be supported throughout.

**Recommendation:** Install sufficient non shrink support to these areas.

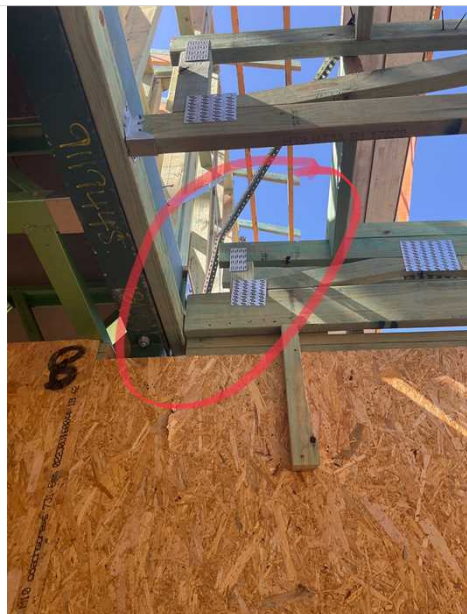
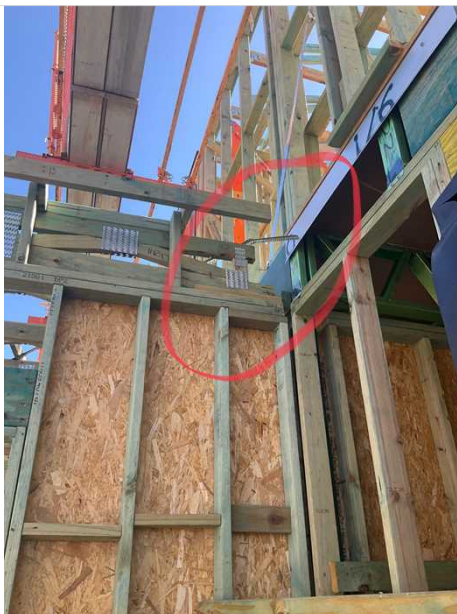
**Location:** Garage roof.

**Details:** Bracing incomplete.

**Recommendation:** Bracing to be double nailed to all cords and then returned down to top plate and nailed off.

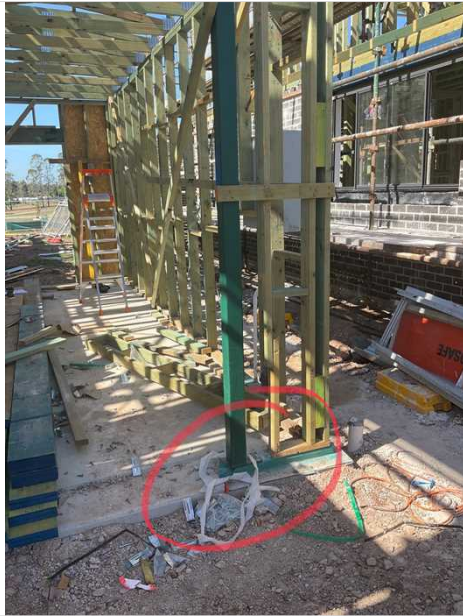
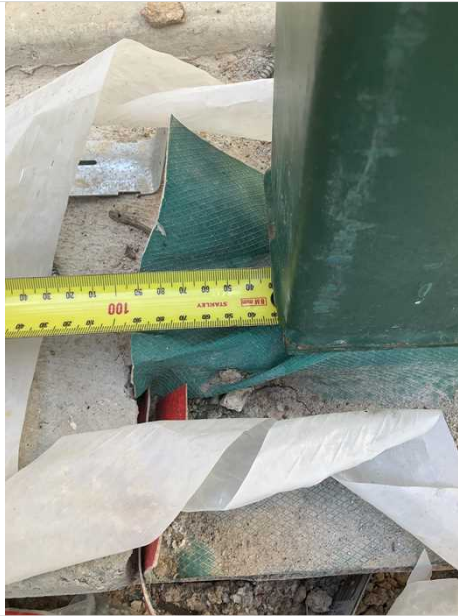
**Location:** Garage entrance structural post.

**Details:** Base of structural post has 30mm overhang with no support.

**Recommendation:** Engineer to sign off or provide rectification advice.

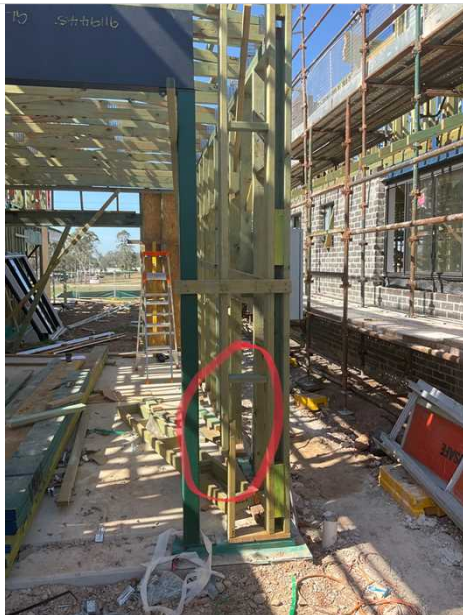
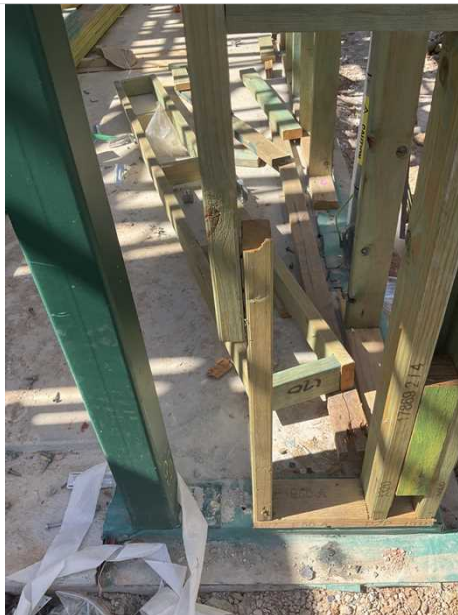
**Location:** Front garage facade.

**Details:** 4 inch Stud has been cut and joined with 3 inch stud.

This was designed with double studs from the manufacturer.

**Recommendation:** This whole wall needs to be replaced with new continuous studs.

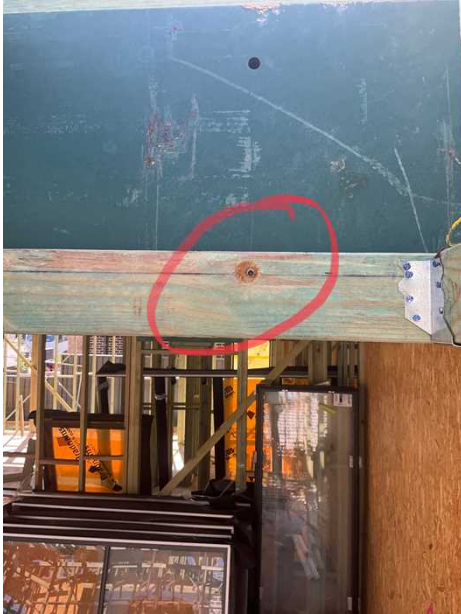
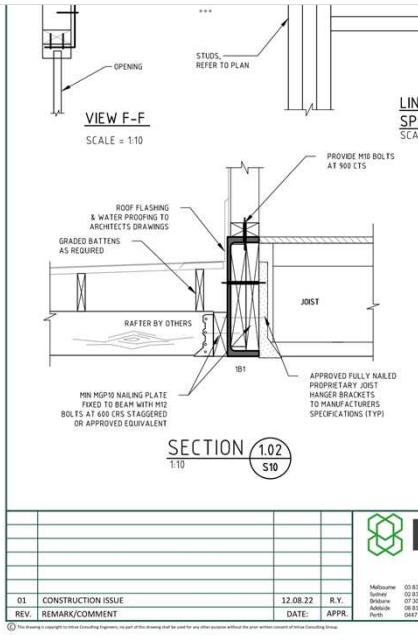
**Location:** Garage roof truss abutment.

**Details:** Garage truss nailing plate not completed as per design.

Regardless this is not as per design.

**Recommendation:** Carpenters to re complete this with m12 bolts as per engineer design.

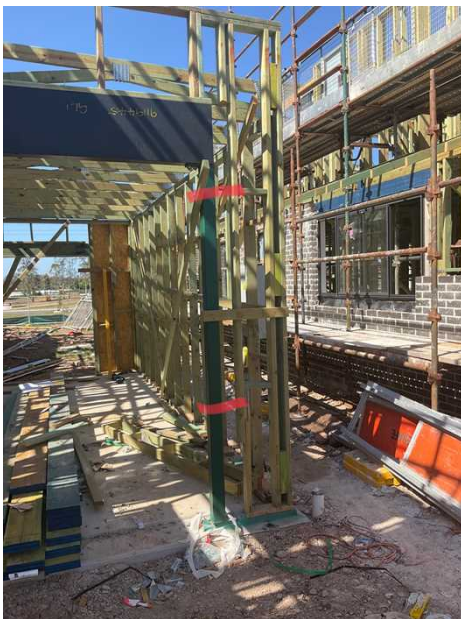
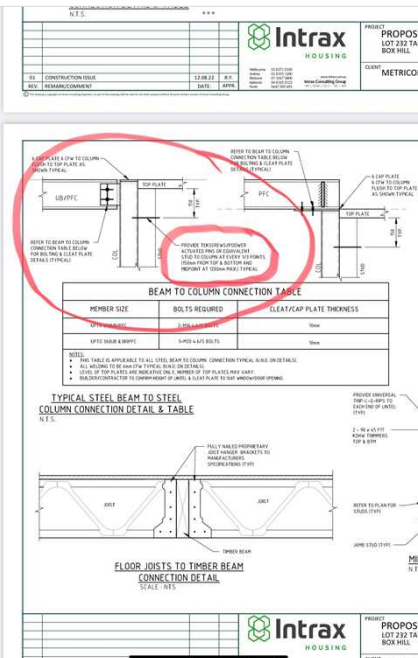
**Location:** Garage facade

**Details:** Structural steel column to stud frame ties to frame not completed.

**Recommendation:** Complete as per design.

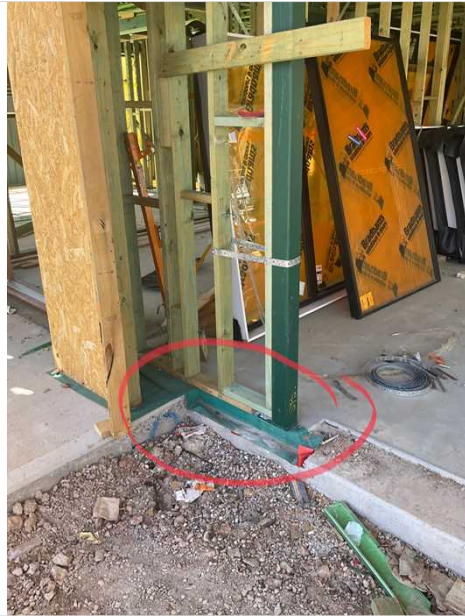
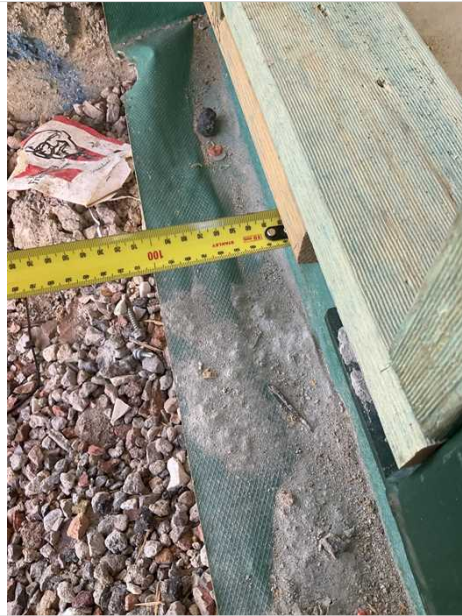
**Location:** Garage facade left side

**Details:** Frame overhang is 20mm

As with guidelines the engineer can sign off on this as is.

**Recommendation:** Engineer to sign off or provide repair method.

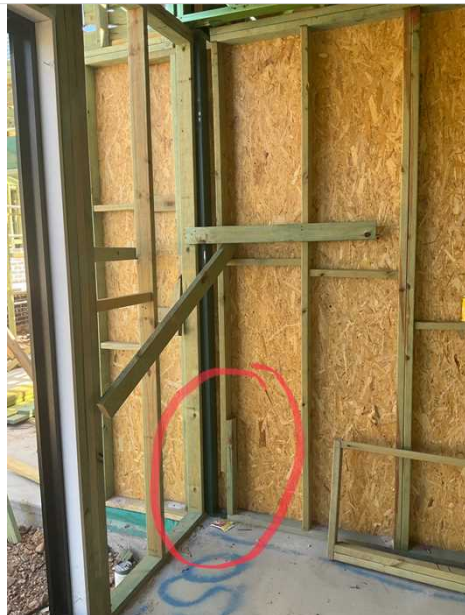
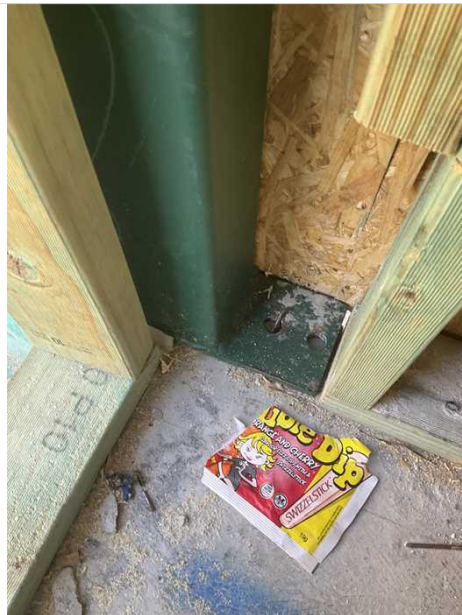
**Location:** Sitting room garage corner

**Details:** Structural post has not tie downs.

Stud has been cut and not spliced correctly.

**Recommendation:** Install tie downs to structural post as per design and replace stud in its entirety or splice to bay Timbers specifications.

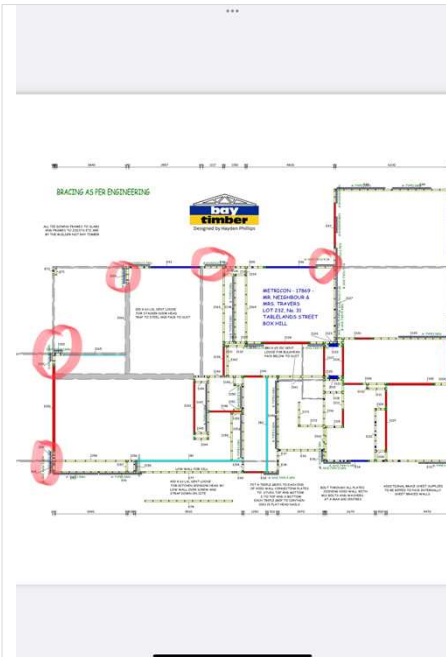
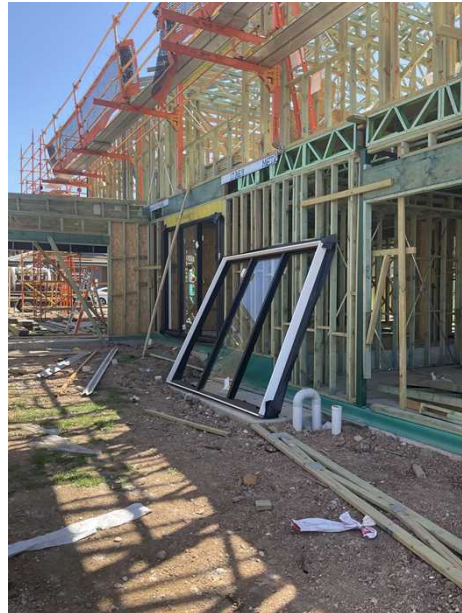
**Location:** External walls as per image.

**Details:** Sheet bracing not installed as per bay timber design.

**Recommendation:** Install sheet bracing as per design throughout.

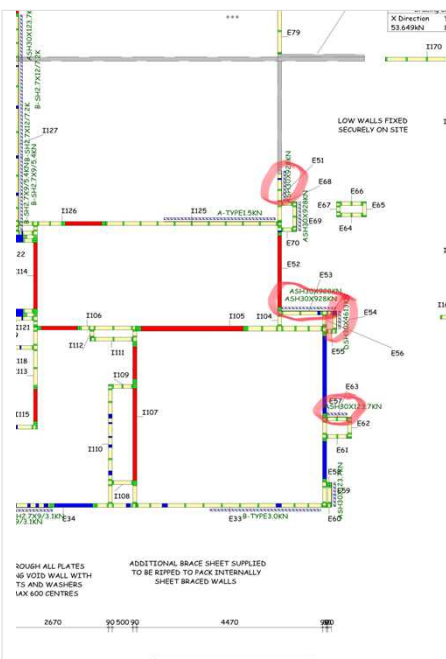
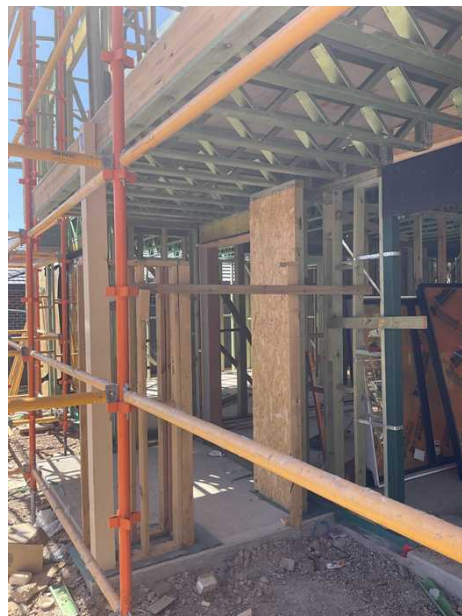
**Location:** Front facade area. As per image.

**Details:** Missing sheet bracing throughout.

**Recommendation:** Install sheet bracing as per bay timber design.

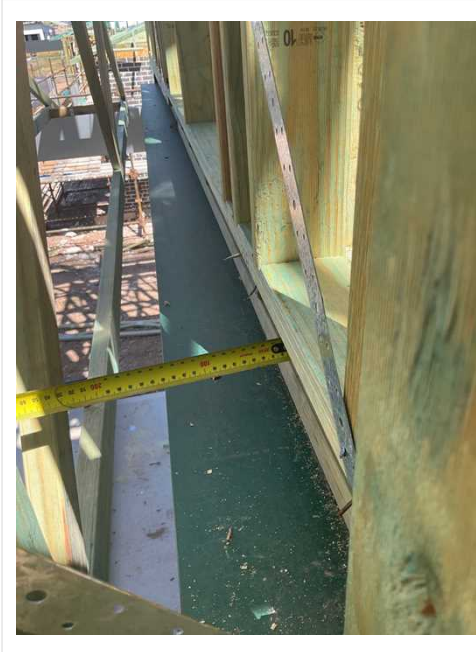
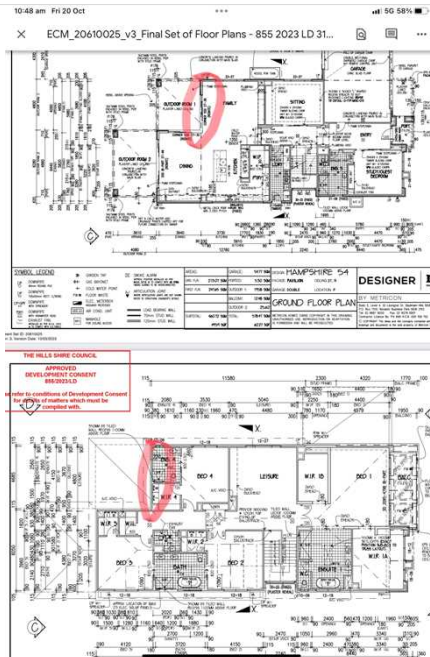
**Location:** As per mark out on plan

**Details:** Frame overhang excessive at second story level. About 30-40mm

Engineer to sign off or provide suitable repair solution.

**Recommendation:** Follow engineer instruction for repair.

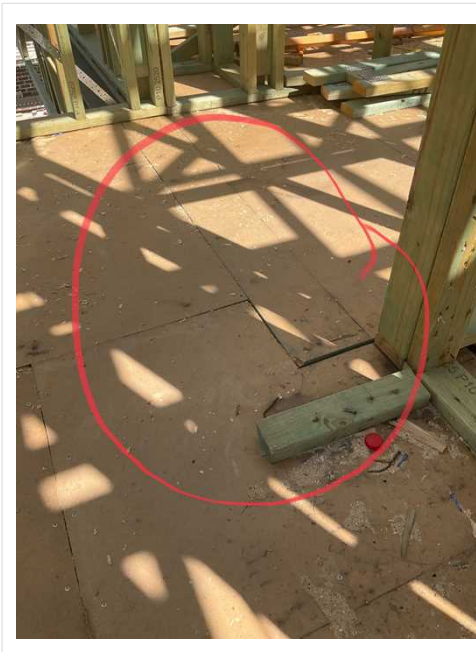
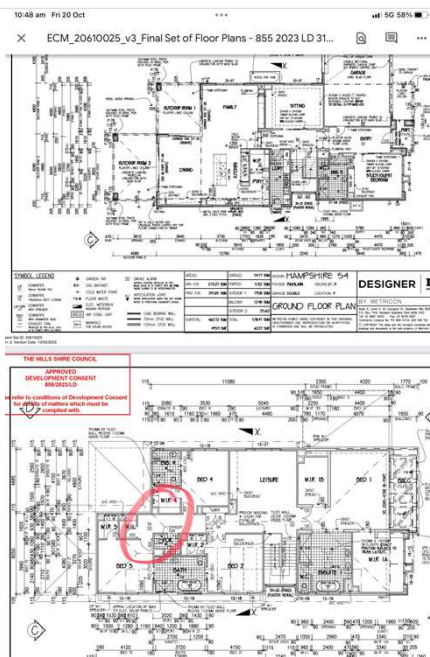
**Location:** As per plan markout

**Details:** Flooring in this area requires attention. Not level or even in any way.

There seems to be a gap under the floor which may allow it to be fixed down further.

**Recommendation:** Carpenters to address the floor in this area.

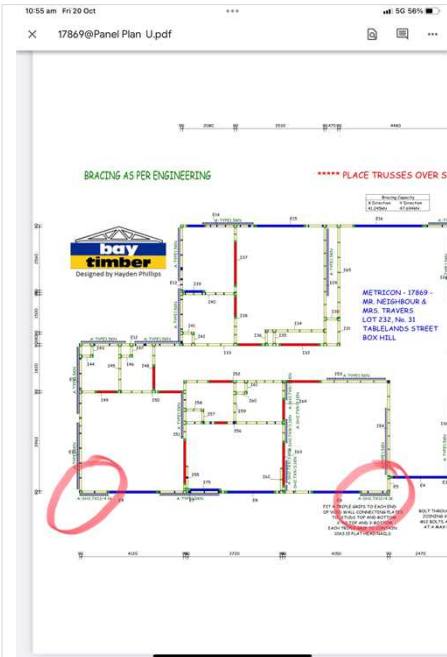
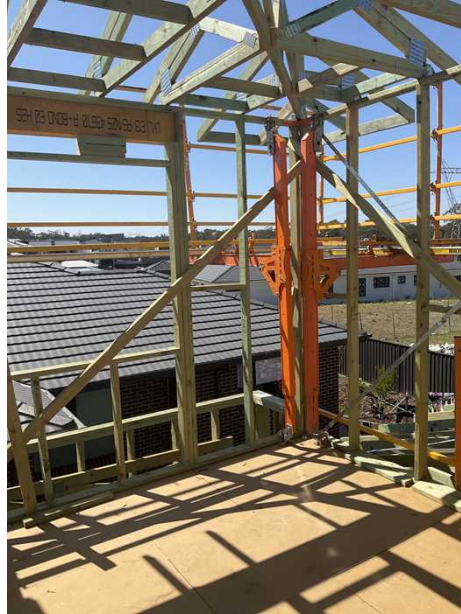
**Location:** Upper story as per marked out plan.  
**Details:** Missing sheet bracing.  
**Recommendation:** Install sheet bracing as per design

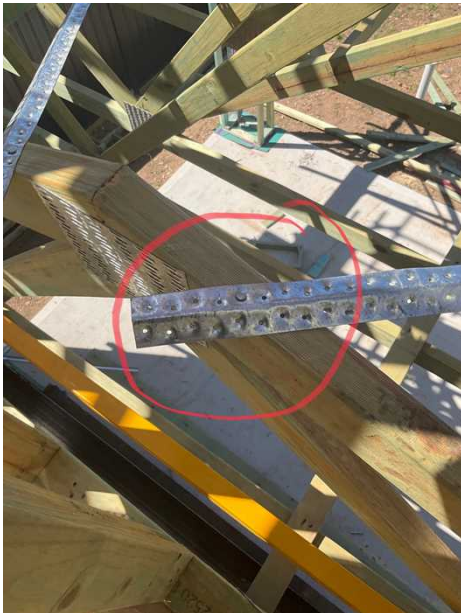
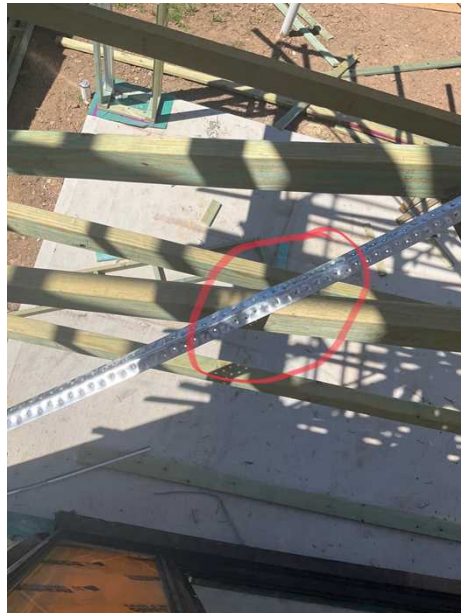
**Location:** Example of roof bracing throughout entire job.  
**Details:** Roof bracing installation requires 2 nails per cord/truss. Requires fixing to side of top plate and underside.  
At the top of the truss the speed bracing is not returned down the truss and has no fixings.  
**Recommendation:** Install additional fixings to all cords. Minimum 2 as per installation requirements.  
Speed brace at top of truss to be fixed at the top of the cord and return down the truss for side fixings.

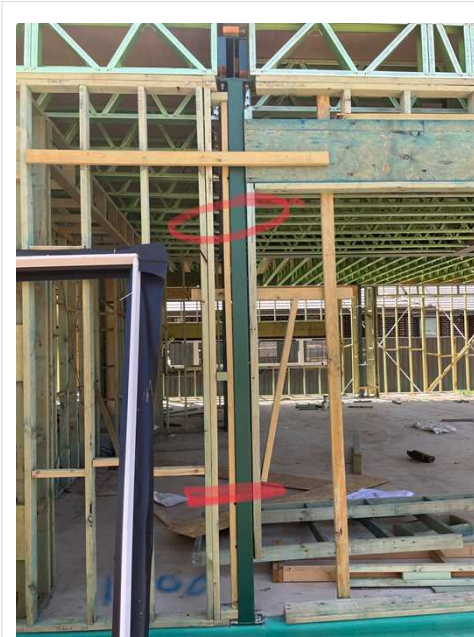
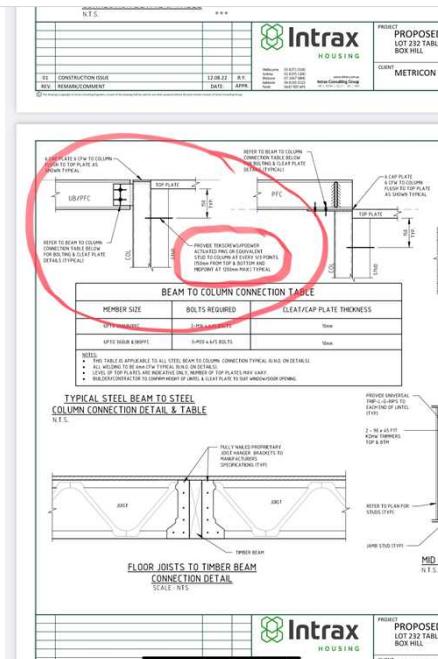
**Location:** Family room external wall

**Details:** Structural post to stud ties.

No ties installed as per engineers detail.

**Recommendation:** Install as per engineers drawings.

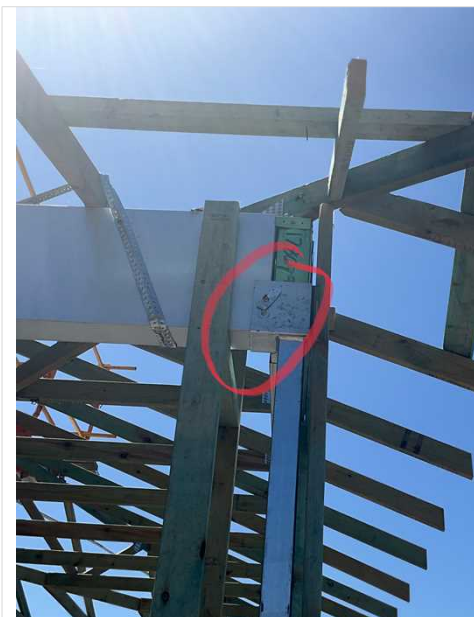
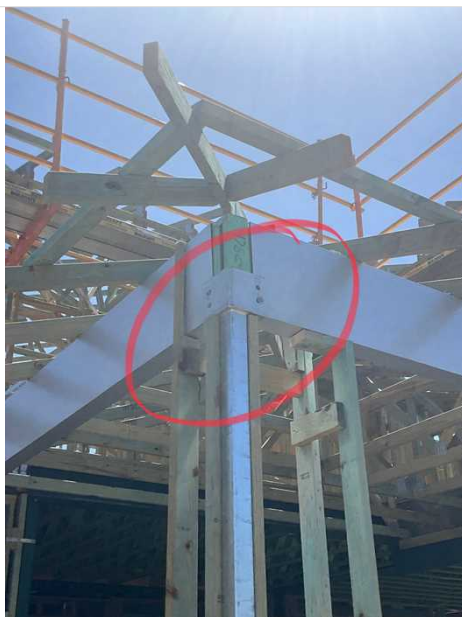
**Location:** Outdoor rooms

**Details:** Insufficient fixings to supporting beams.

In one location the carpenter has used metal strap as a washer?

**Recommendation:** Engineer to confirm fixing requirements from shs post to ribbed beam.

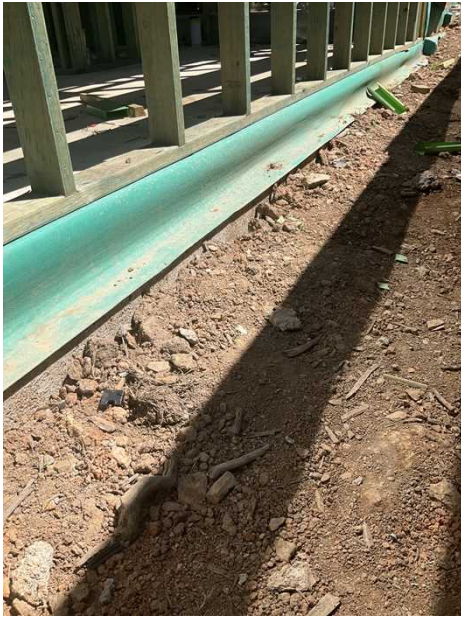
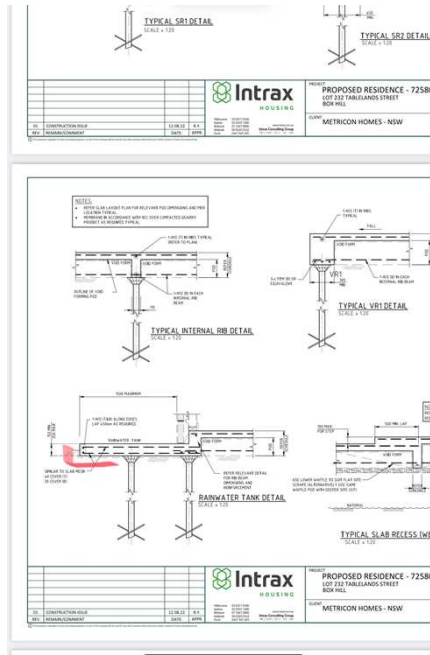
**Location:** Entire slab edge perimeter.

**Details:** Vapour barrier has not been returned up the slab edge to finish floor level.

**Recommendation:** Excavate entire perimeter exposing vapour barrier.
