NEW CONSTRUCTION STAGE PROPERTY INSPECTION REPORT AS4349.0-2007

Type of Inspection Completed	Pre-Slab Inspection
Have Architectural and/or Structural Engineering Plans been provided for this inspection:	Yes
It is the responsibility of you (the client) to provide us (the inspector) with a full set of construction and engineering drawings for us to compare the construction drawings to what is being built on site. Without these drawing we can Not comment on incorrect home and room dimensions, specified levels, engineer specifications and any relevant Australian Standards that has been referenced for the project.	
Prevailing weather conditions at the time of inspection:	Dry
In respect of significant items:	
Was there any MAJOR DEFECTS evident from this inspection?	Yes
Was there any MINOR DEFECTS evident from this inspection?	Yes

New Construction Stage Inspection Report.

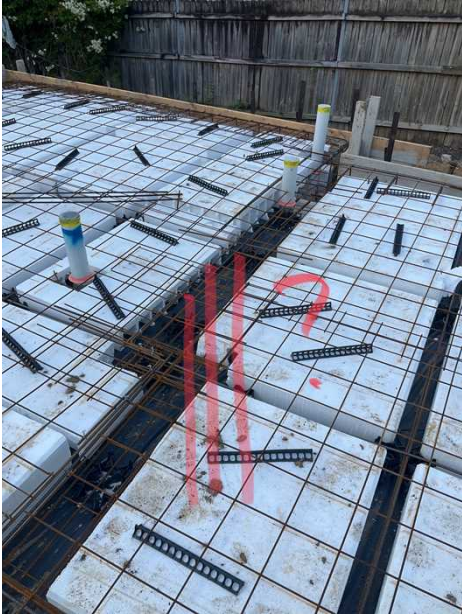
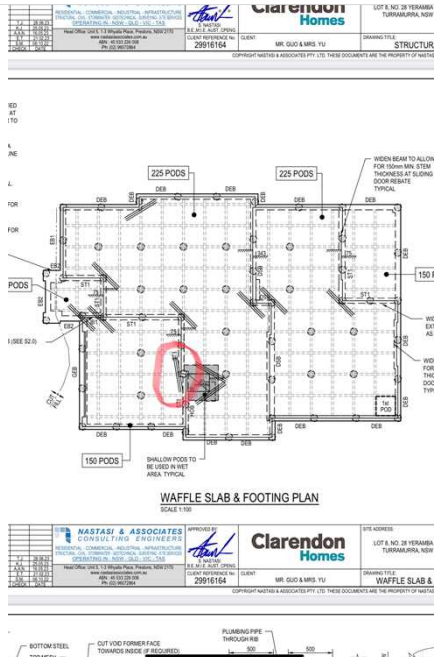
Location: As per image: Garage area abutting ensuite

Details: 2m long crack control bars have not been installed.

Recommendation: Install 3/n12 2m long to underside of mesh as per design.

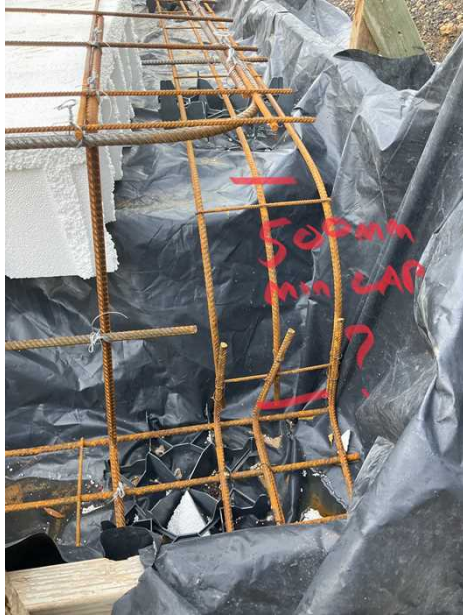
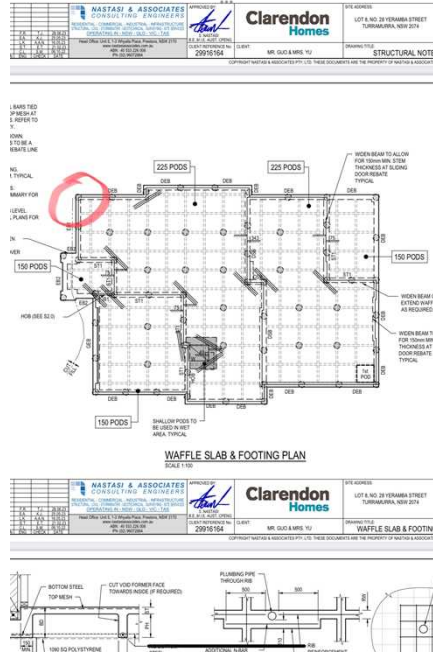
Location: As per mark out.

Details: Insufficient lapping of reinforcement.

Trench mesh 500 mm splice/lap minimum

Recommendation: 3 new bars installed with minimum 500mm lap.

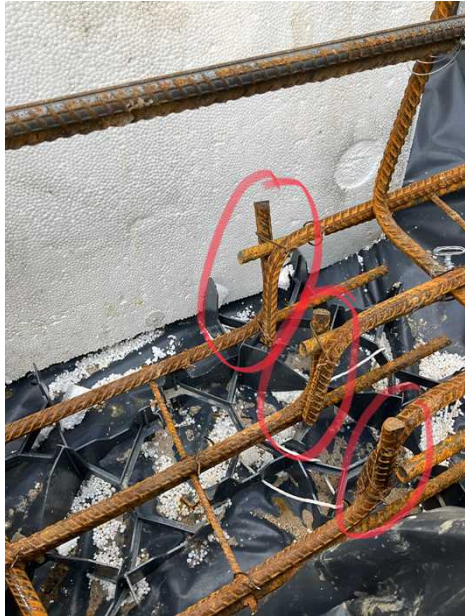
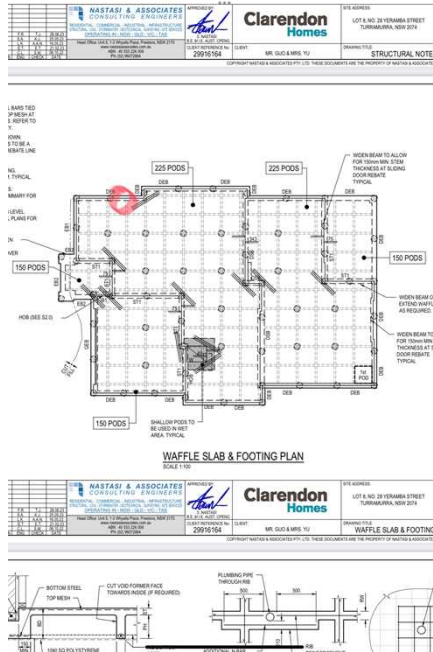
Location: As per mark out.
Details: Insufficient lapping.
Bars need to one and continuous.

As per section 3.2.3.2 of the NCC

Trench mesh 500 mm splice/lap minimum

Recommendation: Replace with 3 bars continuous bars with minimum lap of 500mm either side.

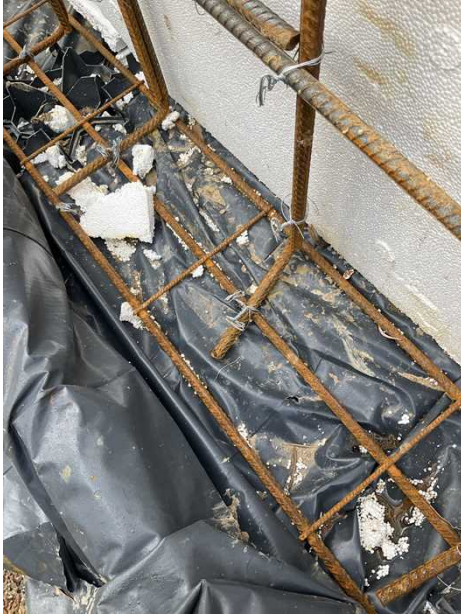
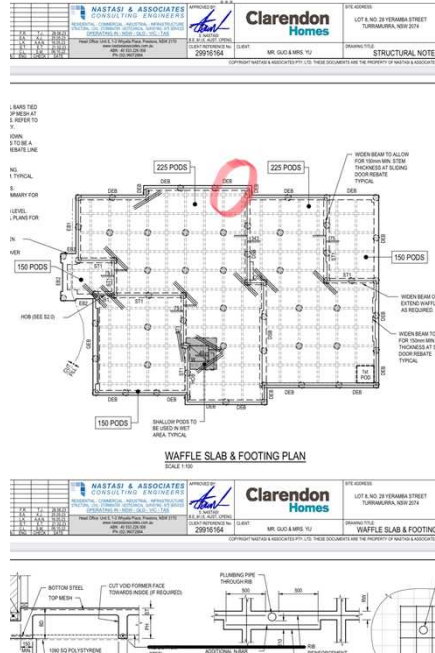
Location: As per mark out
Details: Trench mesh has no cover what's so ever.

As per section 3.2.3.2 of the NCC
 FOOTINGS AND SLABS REO COVER
 40 mm to unprotected ground
 30 mm to a membrane
 20 mm to an internal surface
 40 mm to external exposure

Recommendation: Add additional bar chairs ensuring sufficient cover to underside of reo.

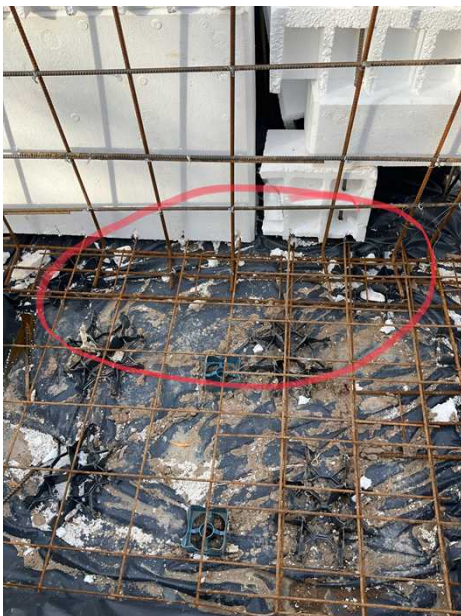
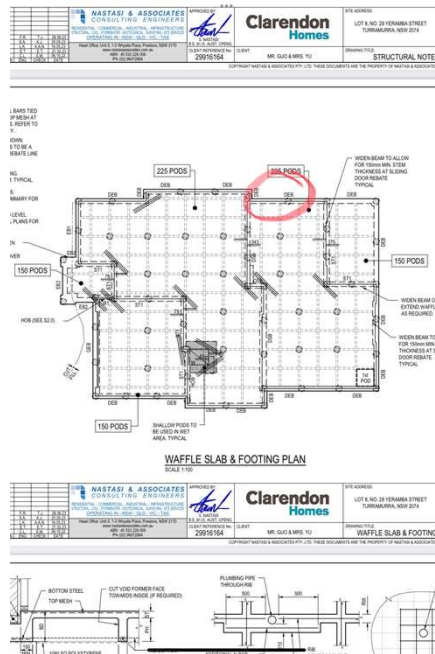
Location: As per mark out.
Details: No cover to trench mesh what's so ever.

As per section 3.2.3.2 of the NCC
 FOOTINGS AND SLABS REO COVER
 40 mm to unprotected ground
 30 mm to a membrane
 20 mm to an internal surface

Recommendation: Add additional bar chairs ensuring minimum cover to reo is achieved.

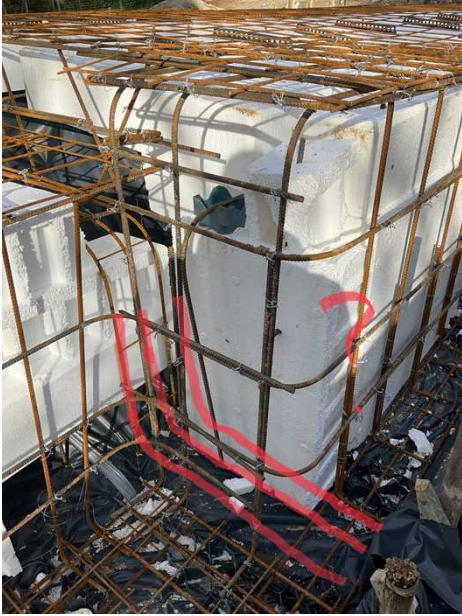
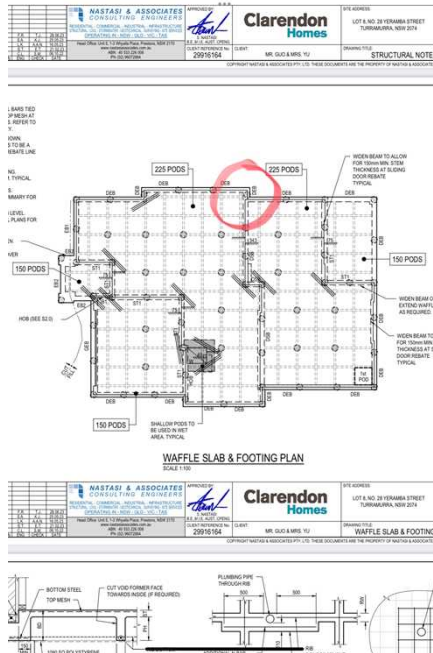
Location: As per mark out.

Details: Step beam and deep edge beam trench mesh are not tied in together?

Recommendation: Engineer to provide written advice on this corner.

If this is ok as is we require written comments detailing this corner.

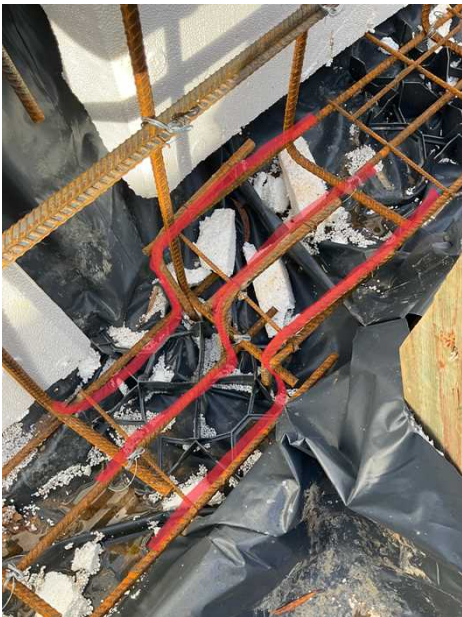
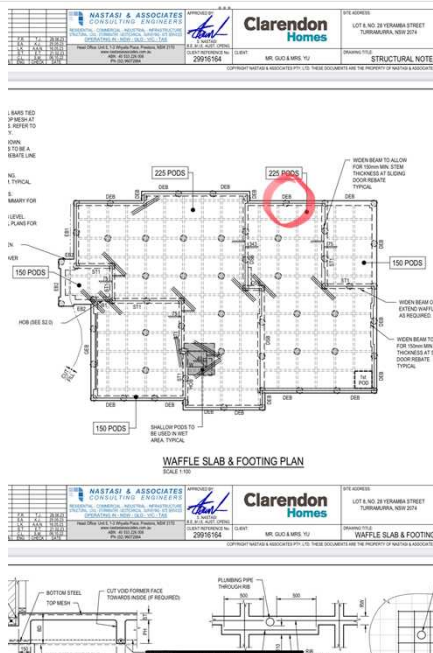
Location: As per mark out

Details: Minimum splice of 500mm to either side of butt jointed trench mesh not completed.

Recommendation: Replace 3 bars ensuring 500mm splice/lap to either side of butt jointed trench mesh.

Bars need to be 1m long.

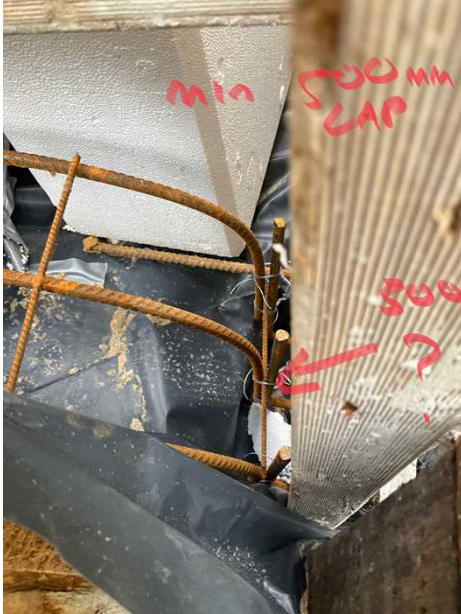
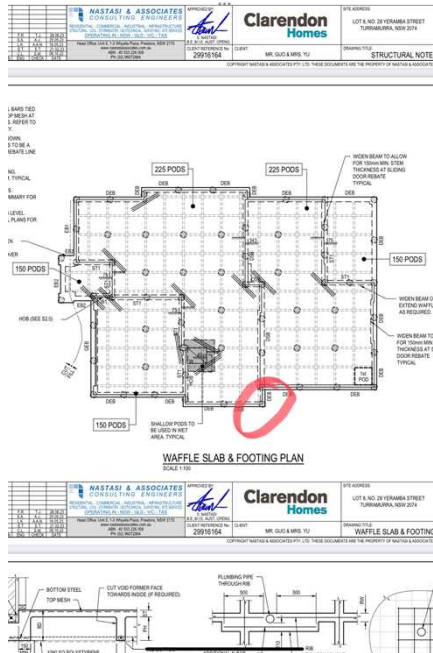
Location: As per mark out.
Details: Insufficient splicing.
Requires minimum 500mm lap/splice
Only 300mm on one side.

Recommendation: This needs to be replaced with 3 bars, 1m long with 500mm lap either side.

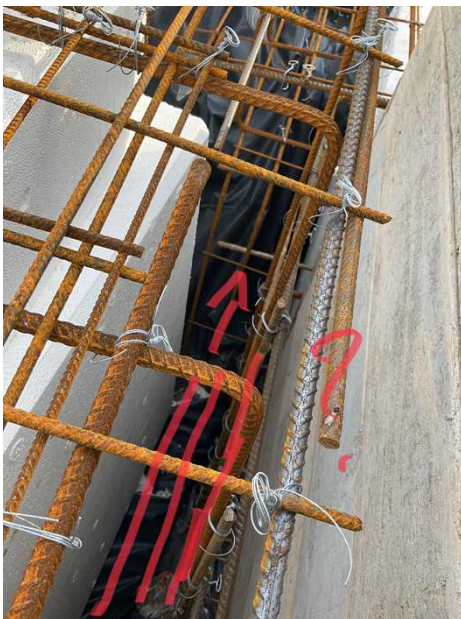
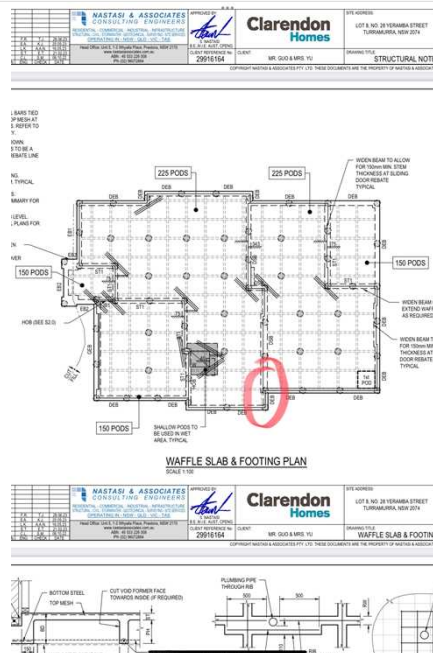
Location: As per mark out.
Details: Step beam and deep edge beam trench mesh is not tied into to each other.
Step beam edge beam finishes short in the middle of no where.
Both ends are the same.

Recommendation: Engineer to provide detail comments on this in writing detailing if this is as per design.

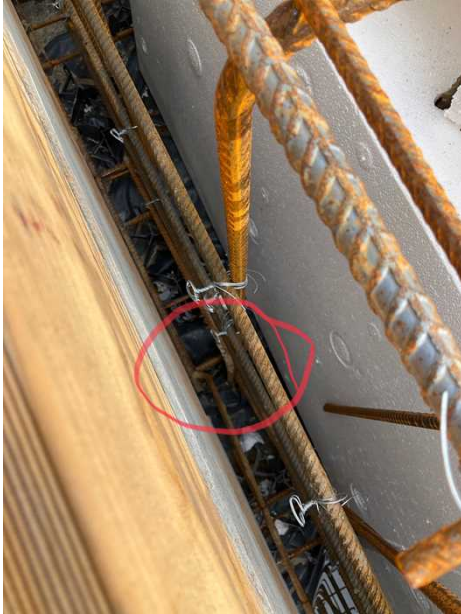
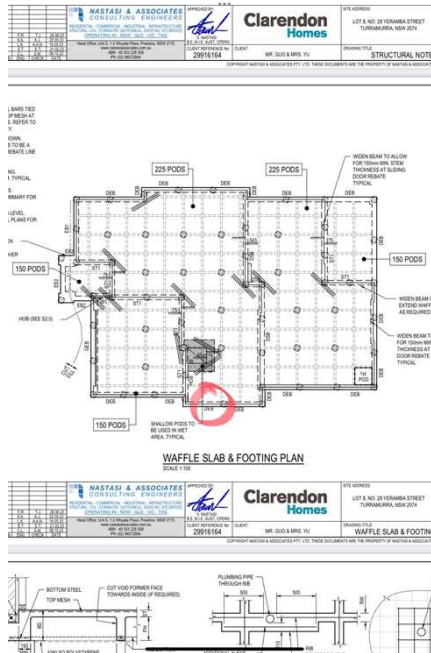
Location: As per mark out.
Details: Trench mesh not spliced correctly.
Minimum lap of 500mm either side on but jointed bars.

Recommendation: Replace bars ensuring minimum 500mm lap either side.

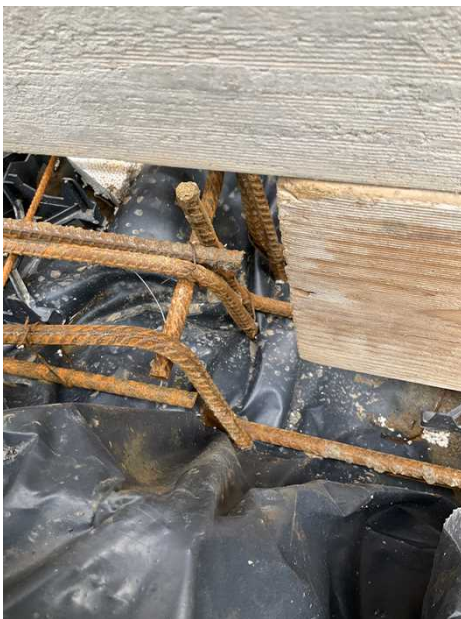
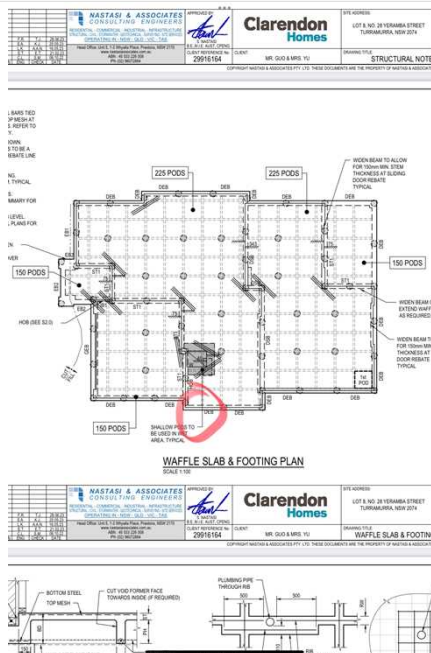
Location: Further images of previous defect.
Details:
Recommendation:

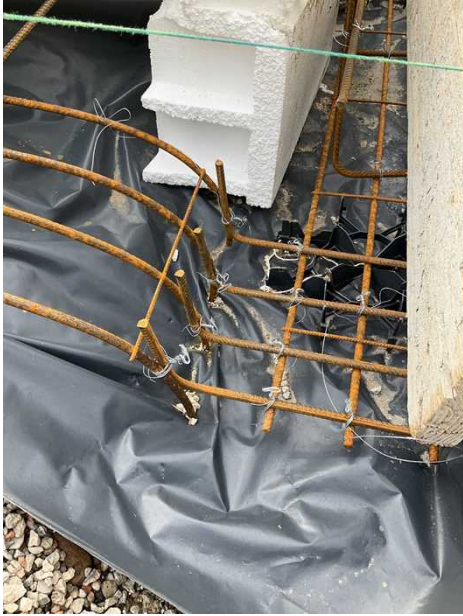
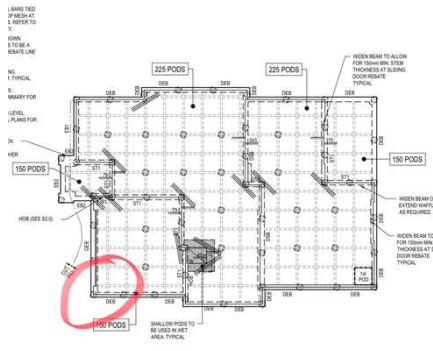
Location: As per mark out.
Details: As per previous defects with splicing issues?
Recommendation: Requires minimum 500mm lap.

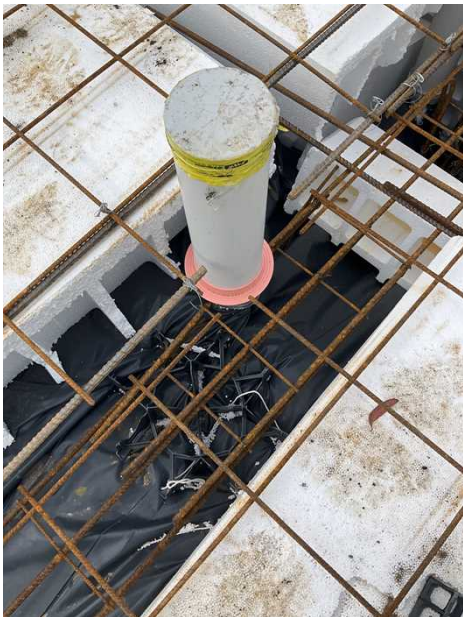
Location: ST1 beam at garage.
Details: Trench mesh cut at pipe penetration and additional bar not added as per engineers design.
Recommendation: Add addition 1m long bar ensuring 500mm lap either side.

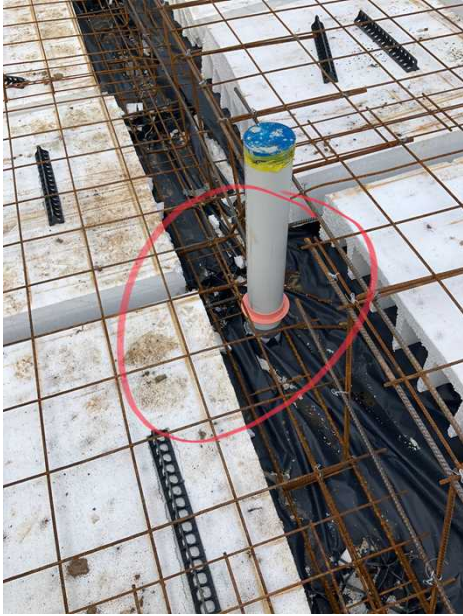
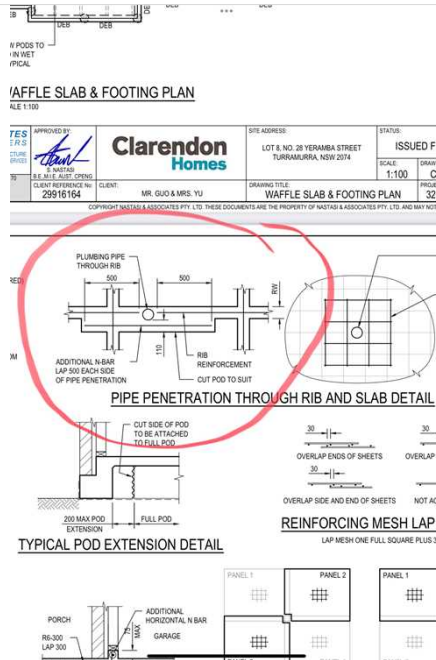
Location: Deep step beam

Details: Penetration through trench mesh. Reo has been cut and no additional bar added as per design.

One bar is touching pvc pipe. This requires minimum 30mm cover.

Recommendation: Add additional 1m bar ensuring 500mm lap either side.

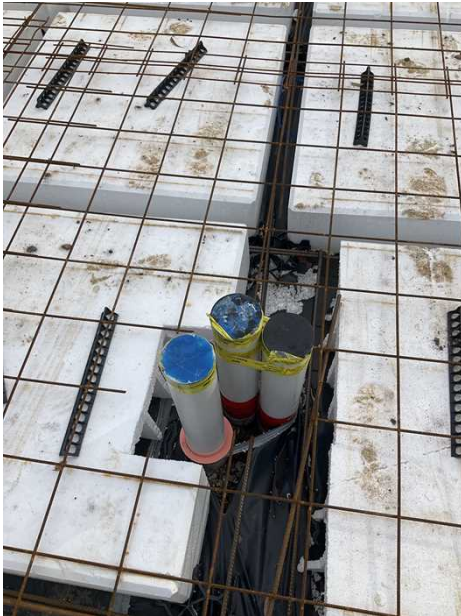
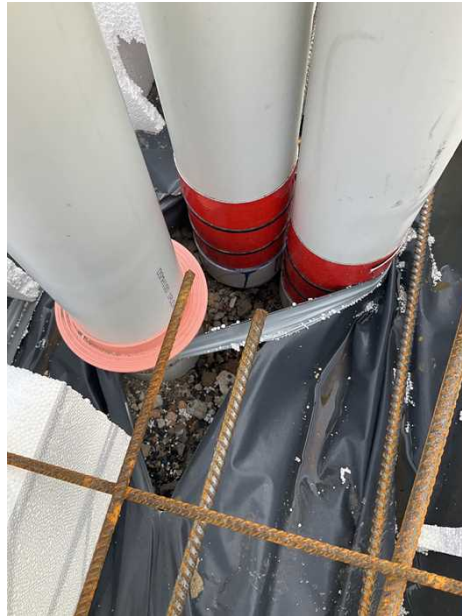
Location: 3 pipe penetration at kitchen area.
Details: Vapour barrier is insufficient.

VAPOUR BARRIERS 3.2.2.6
a vapour barrier must be installed under slab on ground construction.
Must be branded AS2870 concrete underlay , 0.2 medium impact resistance
Installed
Not lap less then 200 mm at all joints
And tape or seal with a close fitting sleeve around service penetrations
And fully seal were punctured with additional polyethylene film and tape.

Recommendation: Additional sheet to be added to penetrations. Taping opening will not work.

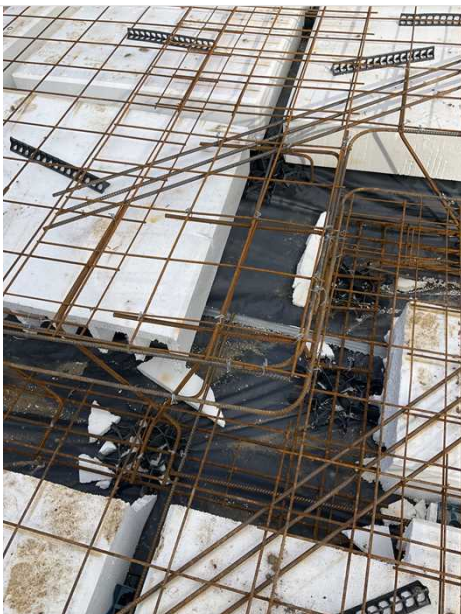
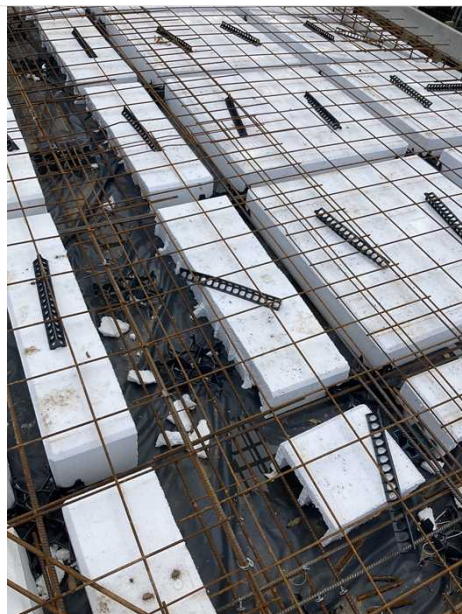
Location: Throughout all areas.
Details: Polystyrene debris everywhere.

Footing preparations 3.2.2
Footing excavations must be free of loose earth, tree roots, mud and debris immediately before pouring concrete.

Recommendation: Full clean out prior to pouring required. Ensuring loose polystyrene is removed.

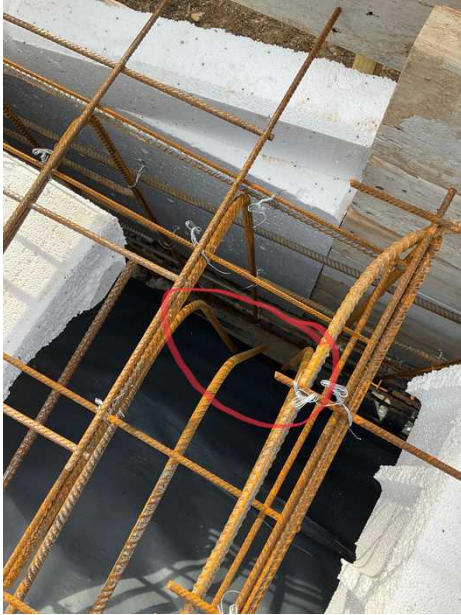
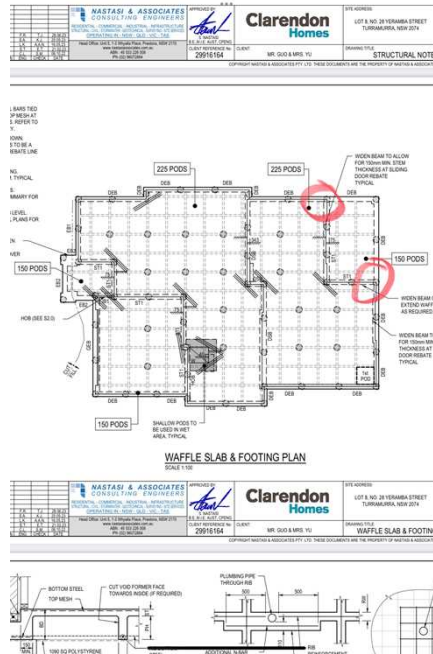
Location: ST1 and deep edge beam junction to alfresco.

Details: Trench mesh is not tied into lower trench mesh of deep edge beam.

Recommendation: Engineer to confirm junction detail.
