NEW CONSTRUCTION STAGE PROPERTY INSPECTION REPORT

AS4349.0-2007

New Construction Stage Inspection Report.

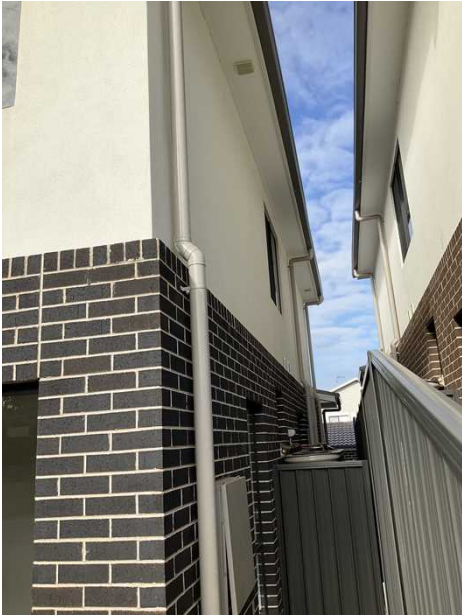
Showing example of Brickwork completed

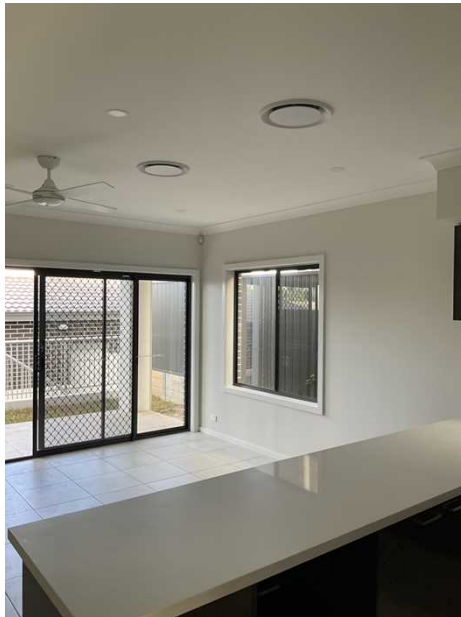
Showing example of wall, floor & ceiling coverings
