NEW CONSTRUCTION STAGE PROPERTY INSPECTION REPORT AS4349.0-2007

Type of Inspection Completed	Pre-Slab Inspection
Have Architectural and/or Structural Engineering Plans been provided for this inspection:	Yes
It is the responsibility of you (the client) to provide us (the inspector) with a full set of construction and engineering drawings for us to compare the construction drawings to what is being built on site. Without these drawing we can Not comment on incorrect home and room dimensions, specified levels, engineer specifications and any relevant Australian Standards that has been referenced for the project.	
Prevailing weather conditions at the time of inspection:	Dry
In respect of significant items:	
Was there any MAJOR DEFECTS evident from this inspection?	Yes
Was there any MINOR DEFECTS evident from this inspection?	Yes

New Construction Stage Inspection Report.

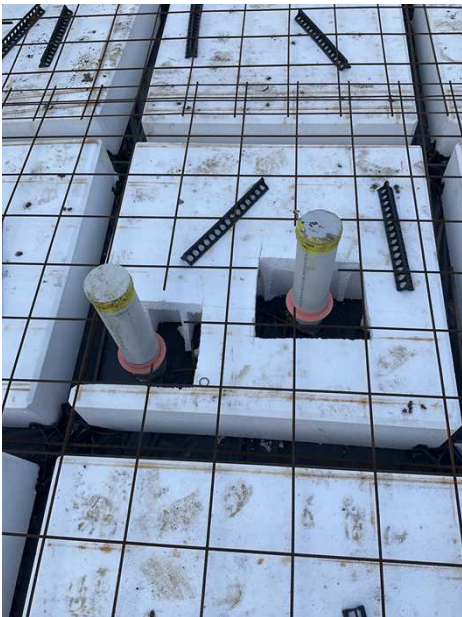
Details: 2m long crack control bars have not been installed.

Recommendation: Install 3/n12 2m long to underside of mesh as per design.
