Clear View Property Inspections
Suite 1A-59 Level 2
802-808 Pacific Highway GORDON 2072
P: 02 8329 7997
E: admin@cvpi.com.au
W: clearviewpropertyinspections.com.au

PROPERTY & TIMBER PEST REPORT AS4349.1-2007 & AS4349.3-2010

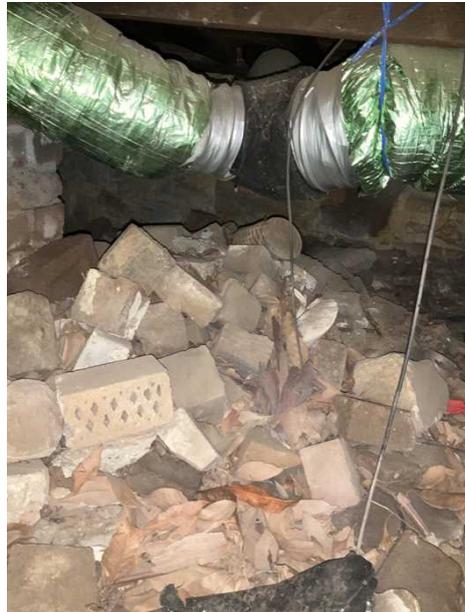
+ Example of blocked access to entire subfloor by ac ductwork

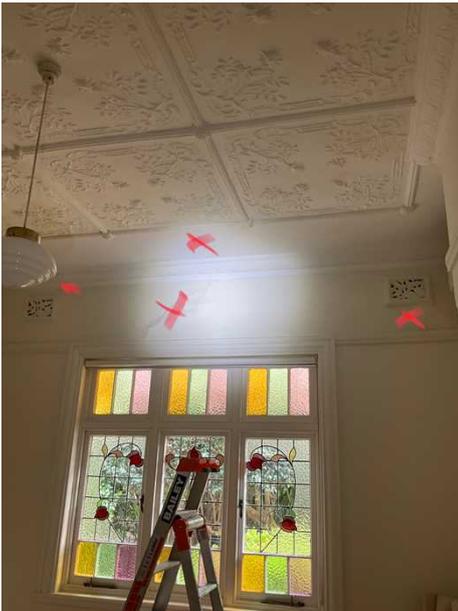
Movement cracks to ceiling/cornice- recommend engaging a plasterer for repairs to prevent further deterioration., + Severe cracking to ceiling and walls in bedroom 2. Clear evidence of patch work completed to hide defects. Large gaps to cornice and wall. Major movement evident. Recommend engaging a structural engineer for advice to control and prevent further deterioration.

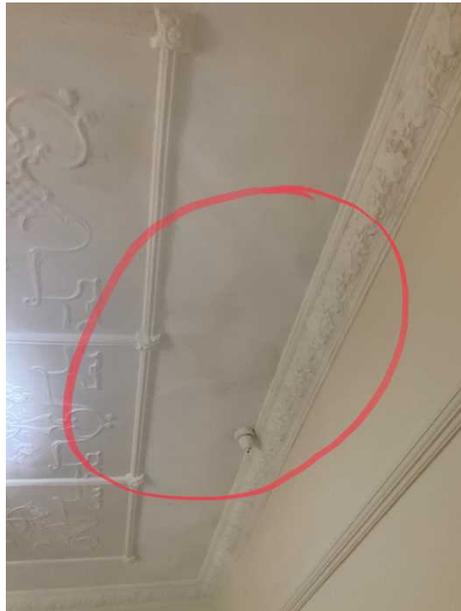
Sagging ceiling lining. Engage plasterer for repairs to prevent further deterioration., + Bedroom 1 has a bulge in the ceiling. Likely large crack and ceiling is sagging in this area. Ceilings of this age are at the end of their lifespan and require ongoing maintenance or replacement. House has foundation movement and floors are sinking which adds to the ceiling movement causing cracks and delaminating. Recommend engaging engineer for advice to prevent and control further deterioration.

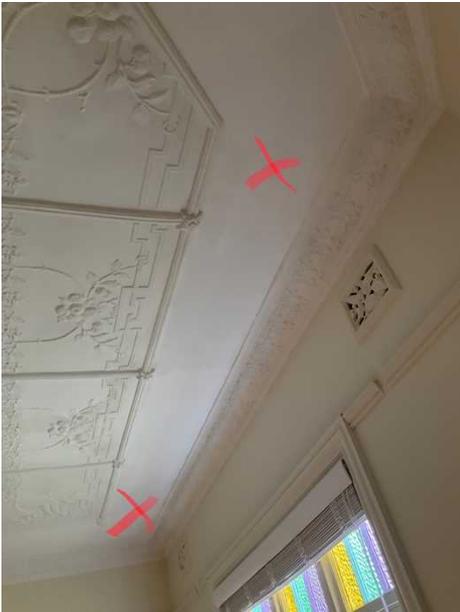
+ Example of repaired movement cracks to ceiling. Located in dining area.

Ceilings throughout the homes have cracks throughout which have been recently repaired and painted.

Cracks will return in the near future.

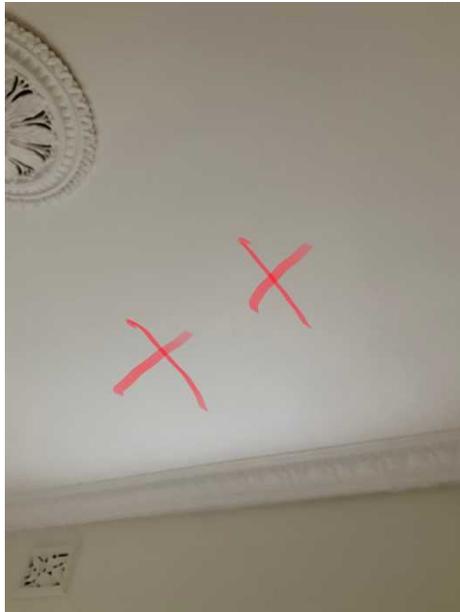
+ Difficult to see as cracks have been repaired. Example of cracks in bedroom 3 ceiling.

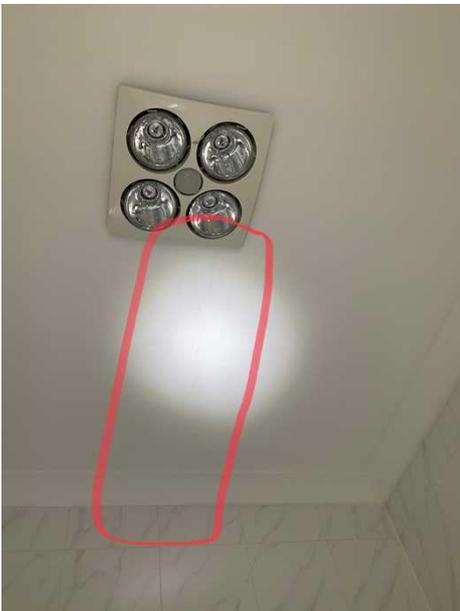
+ Ceiling in laundry bathroom has been replaced in the passed. Evidence of large crack which has been repaired. This aligns with the movement of the foundations causing cracks throughout ceilings, walls and undulated flooring.

Will require engineer advice to prevent further deterioration.

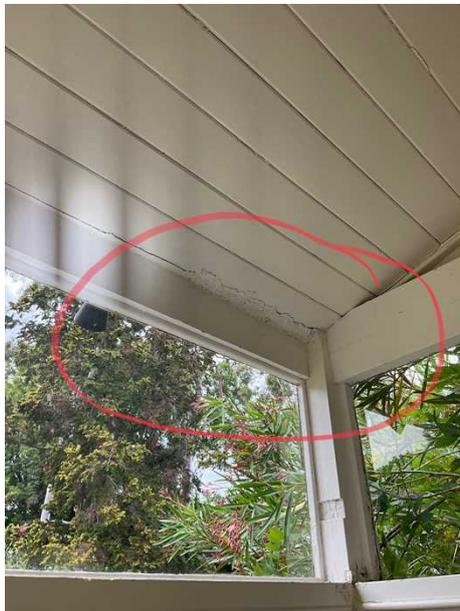
+ Example of poorly repaired timber ceiling in study.

Timber is likely wood decayed.

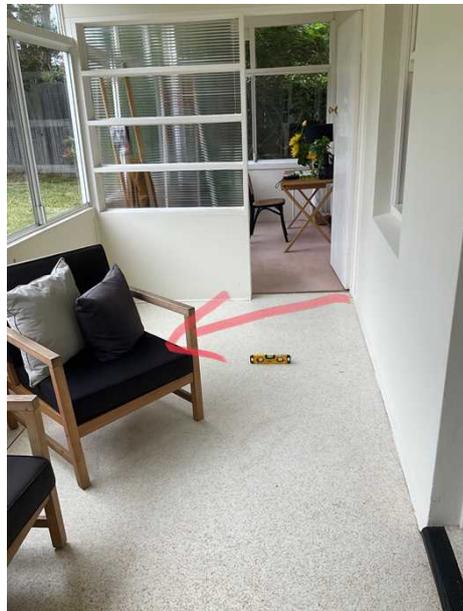
+ Example of fall in sunroom and study floor.

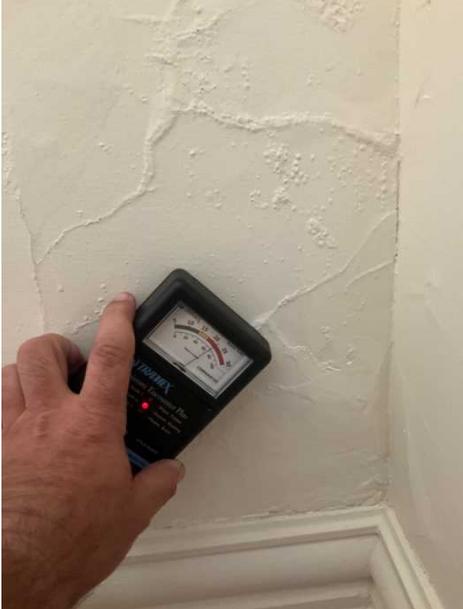
+ High moisture readings to bathroom walls. Moisture damage evident to walls and cracking. Unable to access subfloor for further inspection. There maybe damage to subfloor Timbers in this area.
Engage builder for further invasive inspection to help identify cause and remedial works.

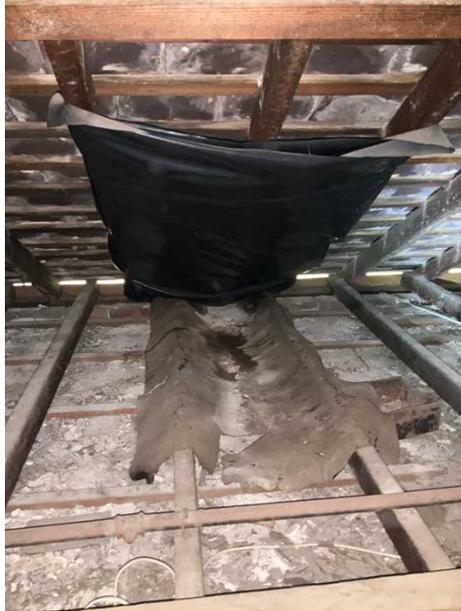
+ Plastic installed to what seems to be a way to control water ingress.
Engage roofer for water testing to identify leaks and do suitable repaired to prevent water ingress.

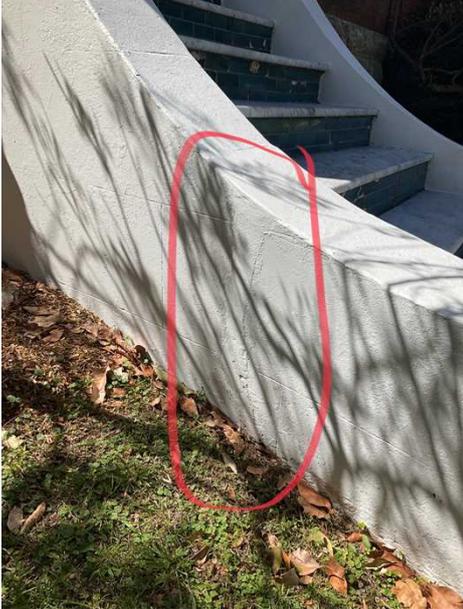
+ Cracking to porch stairs.
Engage engineer for advice to prevent and control further cracking.

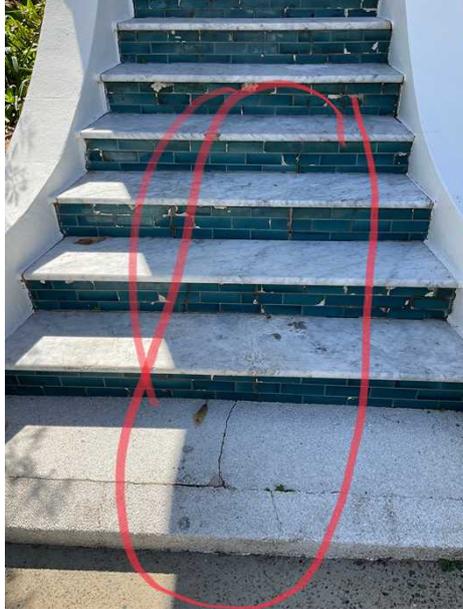
+ Example of cracking to porch stairs. Engage engineer for advice to control and prevent further cracking.

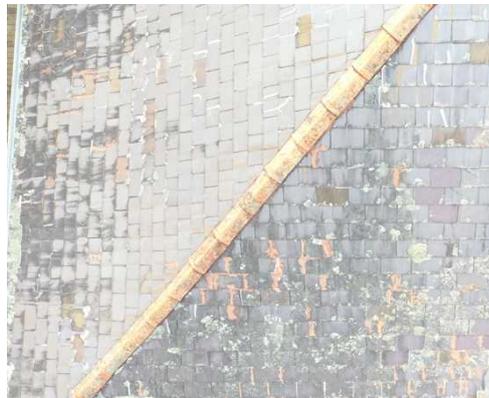
+ Example of drone images. Roof looks aged and weathered. Engage roofer for repairs and maintenance.

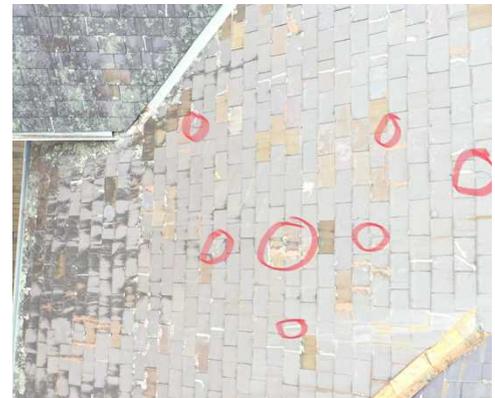
+ Example of cracked or chipped slate roofing. Some tiles have slide. Engage roofer for full inspection and maintenance to prev water ingress.

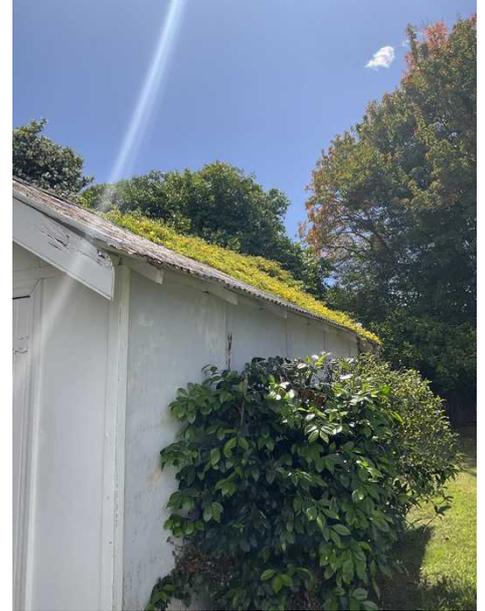
+ Example of no down pipes or gutters to rear garage.

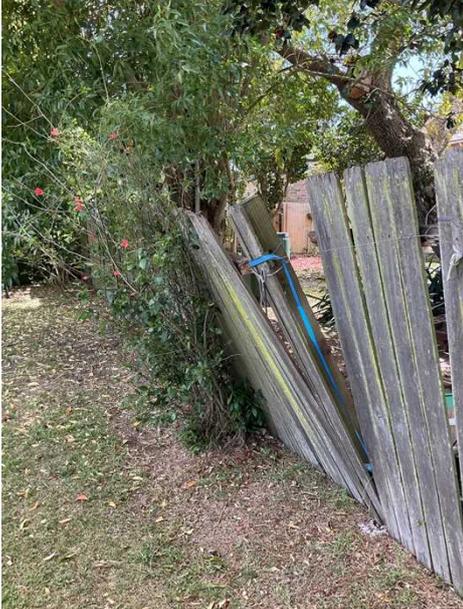
Leaning fence to areas-recommend engaging a fencer to repair and prevent further deterioration., Wood rot/fungal decay to fence-recommended engaging a fencer for repairs to prevent further deterioration

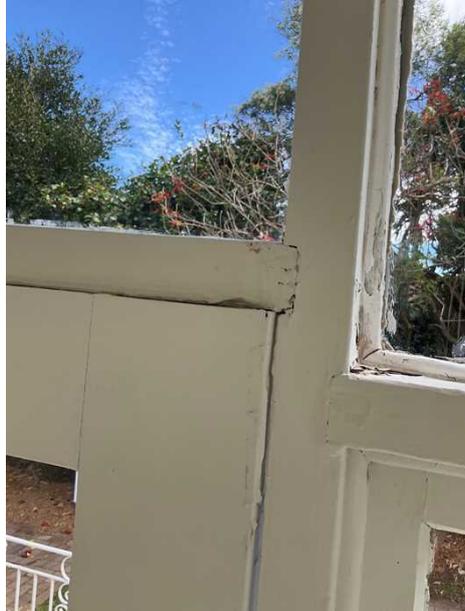
Example of doors requiring adjustment.

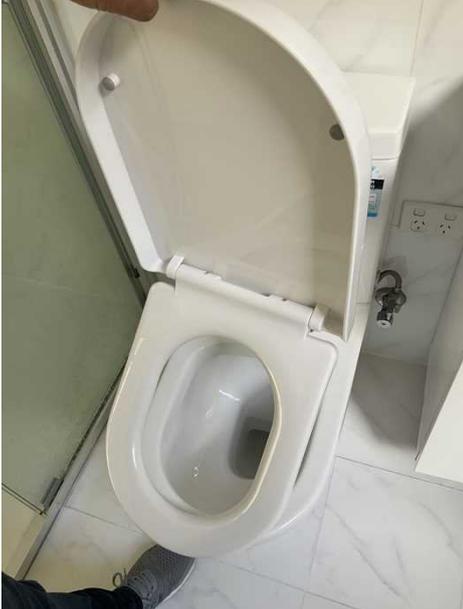
Example of broken toilet seat.

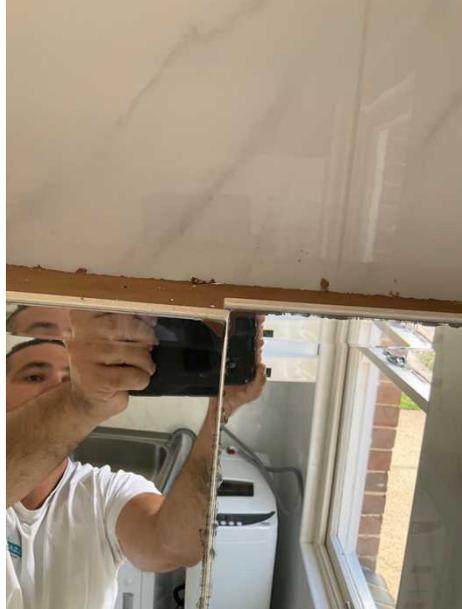
Example of cabinets requiring adjustment,

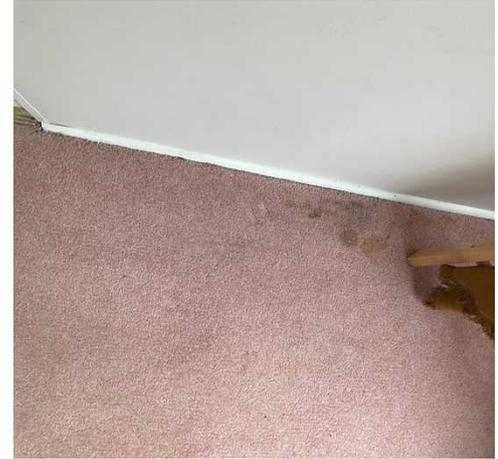
Example of carpet stains.
