NEW CONSTRUCTION STAGE PROPERTY INSPECTION REPORT

AS4349.0-2007

New Construction Stage Inspection Report.

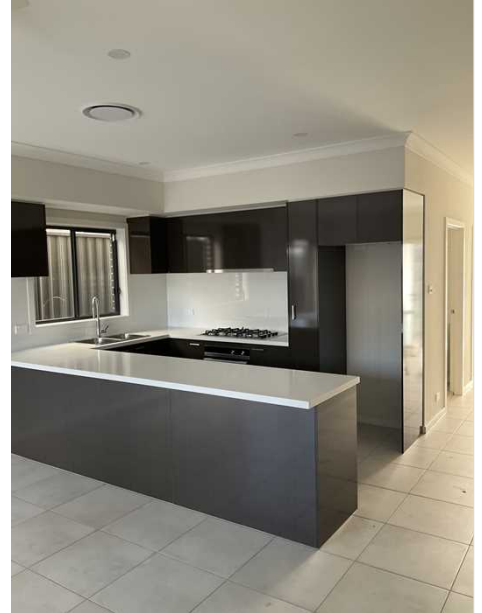
Showing example of cabinetry

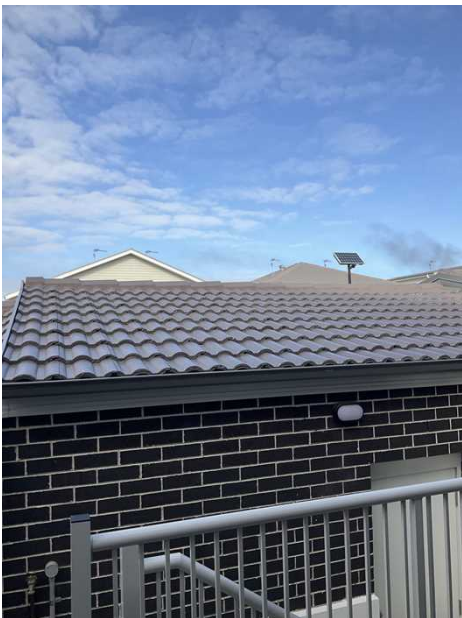
+ Roof coverings.
